## MEMORANDUM

**Resolution 2015-\_\_\_, a Resolution Adopting Minimum Acceptable Facility Condition Scores In Accordance With The Facility Asset Management System Created Pursuant to Resolution No. 2013-40, and Presentation of the State of the County Facility Inventory (Public Works/Terry Lease)**

Santa Fe County Facilities Condition Assessment 2014

# Facilities Condition Assessments

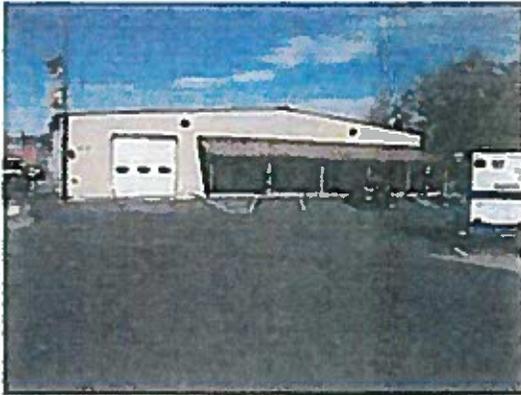
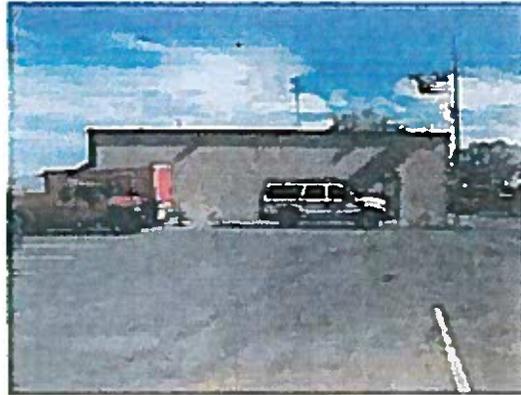
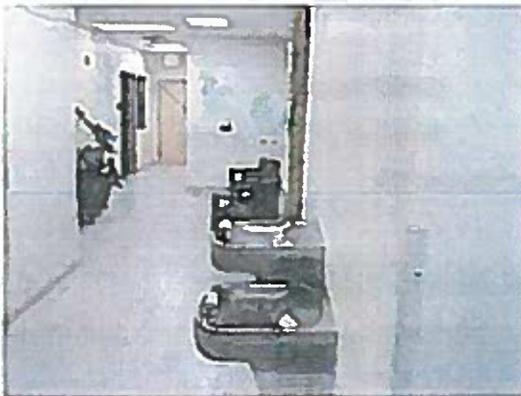
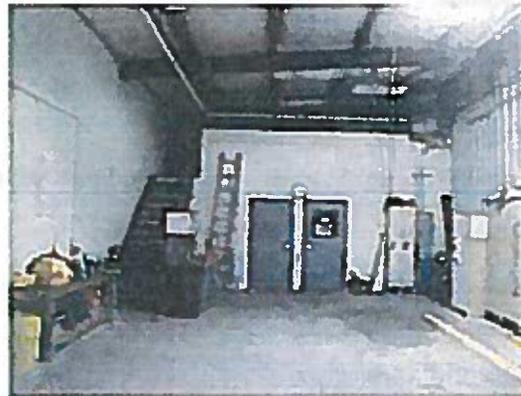
**Photos**

6) Flooring: The office area corridor and restroom floors are ceramic tile. The office floors are carpeted. All are in excellent condition. The bay area is concrete. The bay floor has minor cracking and stains.

7) Wall Systems: There is a fire wall between the bay and the office areas. The bay is a combination of gypsum board and metal panel wall finishes. They are in fair condition, but have exposed conduit along the bay walls. The office area is painted, framed gypsum and in excellent condition.

Description	Cost Code	Qty.	Unit	Sev.	Unit Cost	Subtotal Cost
1. Install eye wash	6.506	1	Each	1.00	937.65	\$ 938
2. Fill cracks, seal and paint floor	4.520	1,450	SF	1.10	0.98	\$ 1,563
<b>Total of Maximum Allowable Construction Cost:</b>						<b>\$ 2,501</b>
<b>Total Project Budget</b>						<b>\$ 3,351</b>

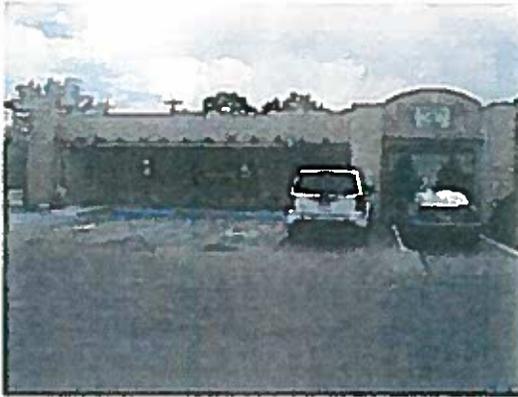
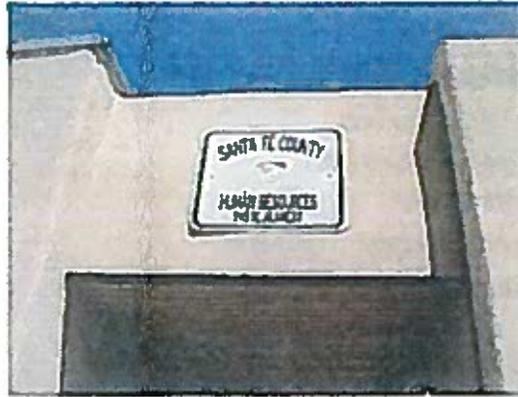
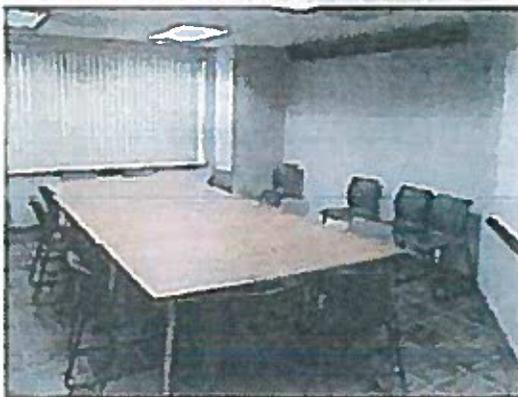
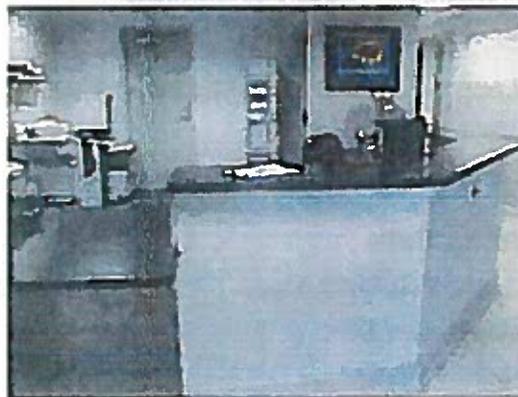
Photos

1) **Parking and Traffic Areas:** The site is off of Alameda Blvd. which is a busy street, but a major artery for the city. Patrons of the shopping center speed through the access points; one of which is by the facility. The asphalt in front of the building is alligating and should be replaced.

3) **Walks and Courts:** The street sidewalks are heaving and breaking apart. There is no connection from the street sidewalk to the building without walking through the vehicle entrance and parking lot. The entrance patio is concrete, badly cracked and spalling.

- 12 Exterior Surfacing: The building is framed with a stucco finish. The stucco has minor cracks and some distortions from past signage. The color is inconsistent and evidence of past clean up from graffiti is evident.

Sidewalks along Alameda are heaving and broken. There is no access from the street sidewalk to the building. Replace sidewalk along the street. Install an accessible walkway (ramp) from the street sidewalk to the building.

Parking lot asphalt is breaking apart. Wheel stops are disintegrating. ADA parking spaces are not to current code. ADA ramp is not to current code. Replace asphalt at front of building. Re-stripe. Re-stripe ADA space to be a van accessible space with walkway, ramp and signage that meet current code. Patrons of center speed through entrance. Install a speed bump.

**Concrete entrance patio is breaking apart and spalling. Replace.**

Exterior stucco has minor cracking and is a variety of colors from past tagging cover ups and renovations. Building identification signs are small and difficult to read from the street. Repair cracks and stucco patches. Fog coat building to a consistent color. Replace signs on both Alameda St. and the shopping center parking lot facades.

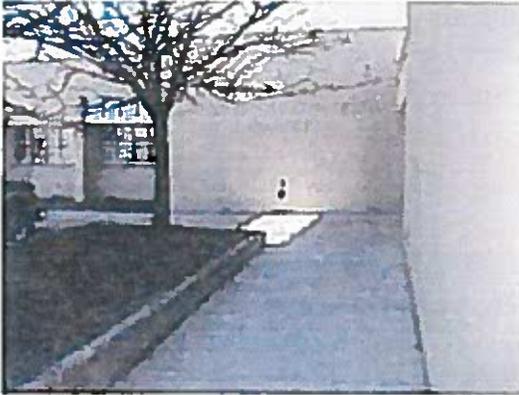
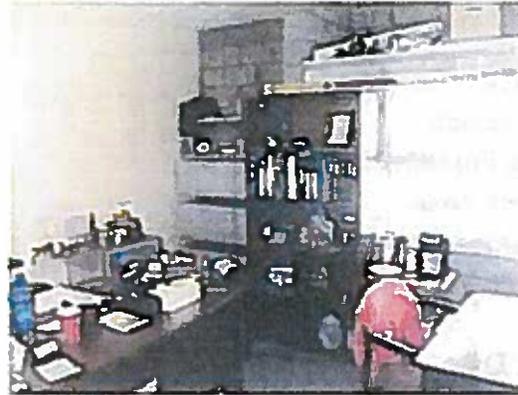
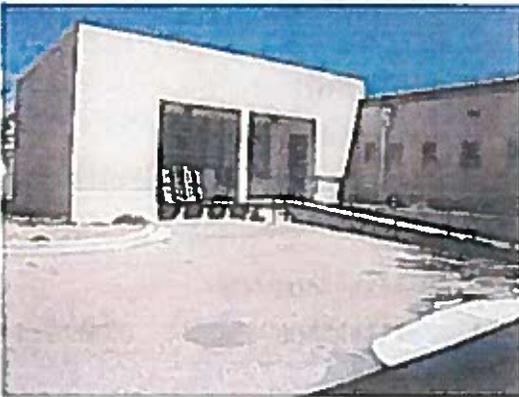
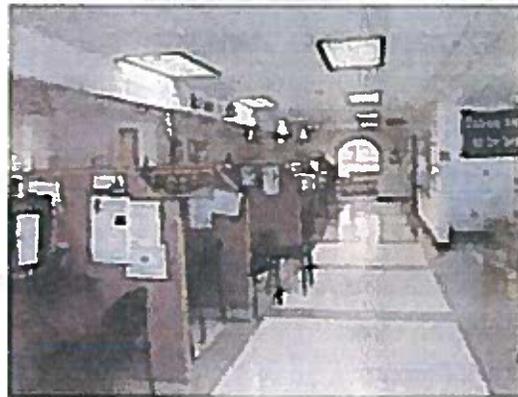
**Photos**

1) **Parking and Traffic Areas:** The parking lot is very large, and readily supports both the employees and the clients. However, it's in extremely poor condition. The asphalt is breaking apart and the aggregates are loose on the entire surface. There are large pot holes, and the

3) Walks and Courts: Walkways are a mix of new concrete and failing concrete. There are large cracks, spalling and crumbling walks both around the structure and along the street.

1) Structure: There has been some structural movement, mostly where the addition and original building connect. Minor cracking has occurred in the walls, and there is some floor movement that has cracked VCT tiles. The wall over the basement entrance has cracked significantly, and is drafty.

11) Roofing, Parapets, Roof Drainage: The roofs are built up roofing, with the older part of the building being fully adhered, while the addition is ballasted built up roofing. The roofs are aging and should be replaced. There are leaks in areas, and the most problematic areas are slated for replacement within 60 days. The addition's parapets are cracking and flaking, and should have parapet caps installed, when the stucco is redone. Some of the flashing is gone, and other flashing has come unfastened.
