Lead-based Paint and Asbestos Investigation

Old County Courthouse Santa Fe, NM

ACME PROJECT NUMBER 13-161

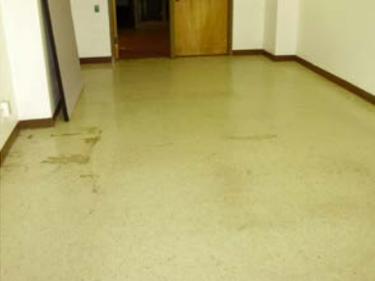
<p>Estimated quantity 1100 sf</p>

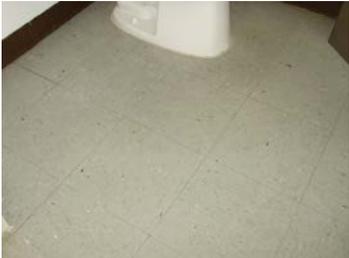
<p>Estimated quantity 900 sf</p>	<p>Fire doors are assumed asbestos containing</p> <p>No Photos</p> <p>Estimated 20 (contractor must confirm)</p>

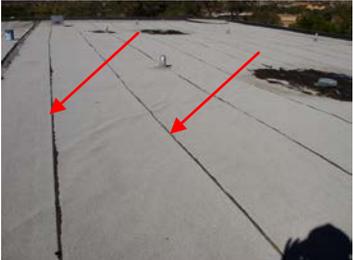
<p>Estimated quantity Unknown</p>

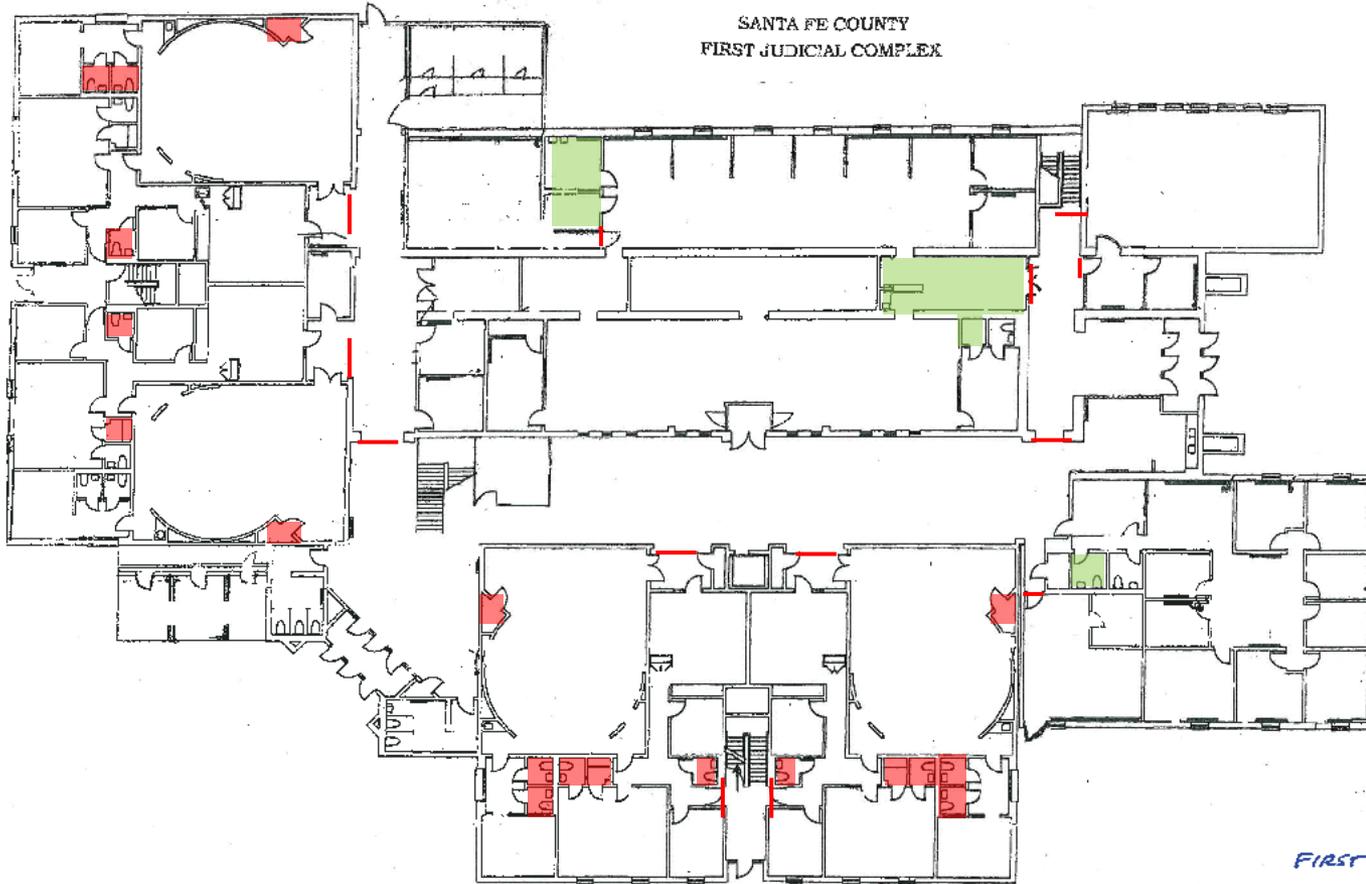
Floor tile 1
(Grey w/pattern)

Floor tile 4
(Tan w/pattern)

Approx location of ASSUMED Asbestos Fire Door
