# PRELIMINARY ENGINEERING REPORT - WATER SYSTEM IMPROVEMENTS

CHUPADERO WATER - SEWAGE CORPORATION  
SANTA FE COUNTY, NEW MEXICO

Martin/Martin, Inc. Project No.: 25.0216

August 2025

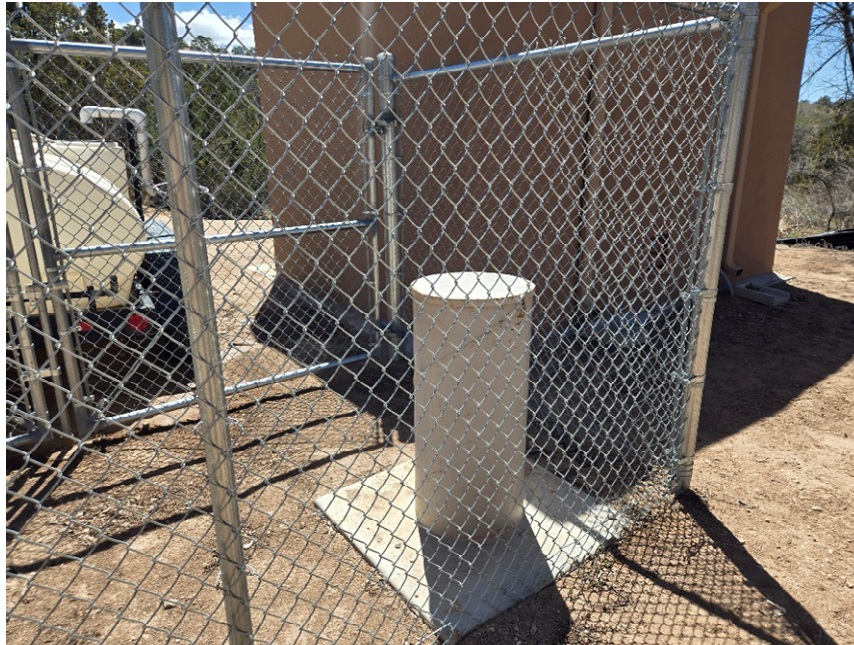
**Photo 1: Well #5**

dedicated fill line to the water storage tank on the eastern side of the service area. The wellhead is surrounded by a 6 foot security fence. Photo 1 shows Well #5, the security fence enclosure and the treatment building in the background.

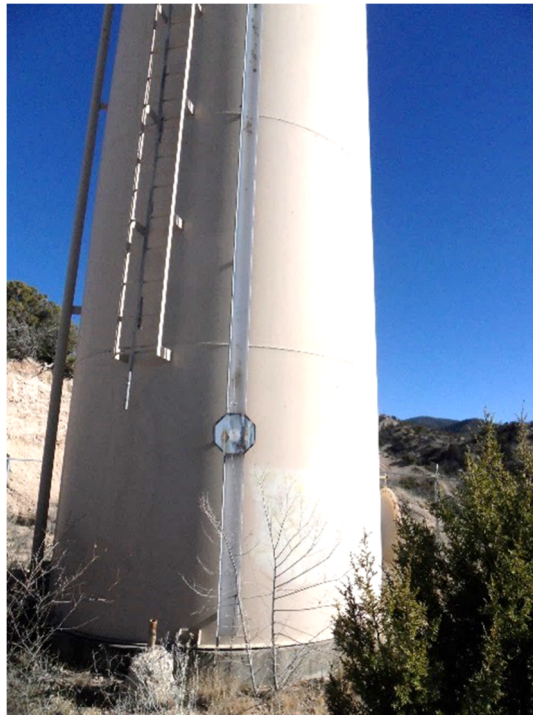
***Photo 2: Water Storage Tank (2017)***

During the 2017 site visit, it was observed that the exterior of the tank appeared in good condition. At the time, the tank did not have adequate security measures in place. Since the visit, it is reported that the security measures recommended in the 2018 PER have been installed. These measures included a safety cage with improved fall protection apparatus for the exterior ladder, a locking ladder access hatch, and the completion of the security fence around the tank site. The tank does not have markings for its external level reader. The tank is equipped with a float level sensor that communicates via radio with groundwater supply pumps to fill the tank. Photographs of the existing tank taken during the 2017 site visit are provided below:

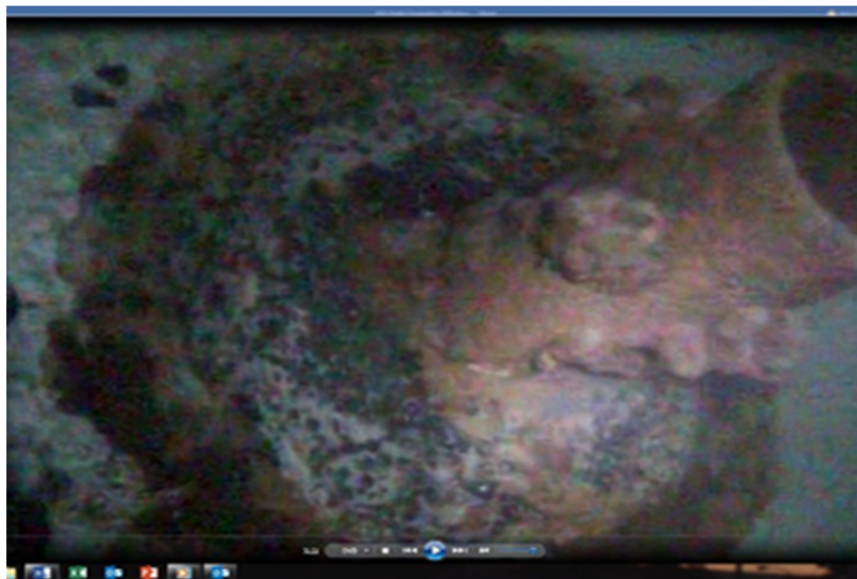
***Photo 4: Old Tank Inspection Fill Pipe***

Chupadero provided a video of an internal tank inspection conducted by Inland Potable Services, Colorado. Chupadero thinks the inspection was over 10 years old when provided to Martin/Martin in 2018. The tank inspection video viewed by Martin/Martin, Inc. indicates that the paint on the inside of the tank is peeling off in multiple places, there is some corrosion and rust spots on the floors and walls and paint “blisters” were visible on the tank floor. Select photographs of the video are provided below.

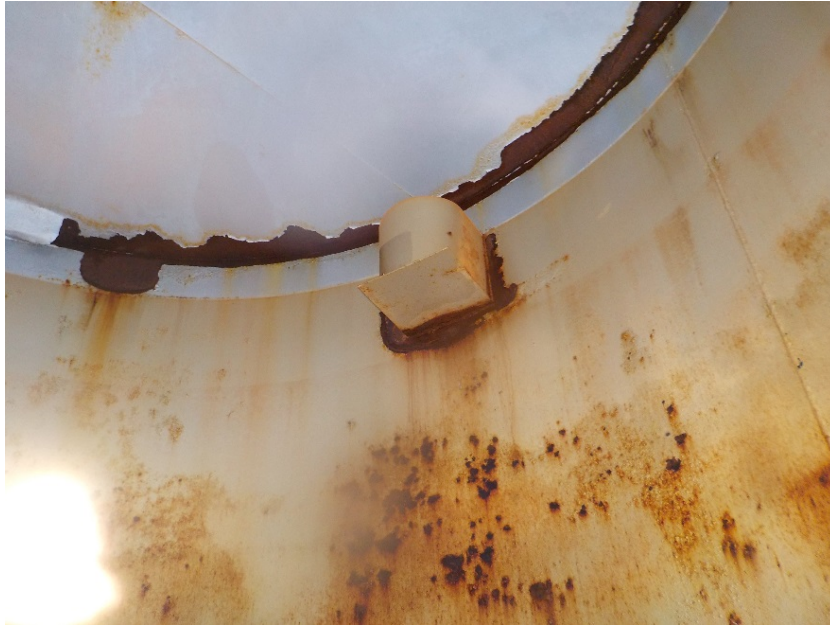
***Photo 6: Tank Inspection Interior Ceiling (2018)***

- Tank interior requires sandblasting and repainting with NSF 61 approved paint.
- Corrosion is uniform and measurable corrosion not identified therefore interior welding repairs not anticipated.
- Interior ladder has some corrosion that can be repaired by repainting.
- Exterior ladder requires safety cage and improved fall arrest.
- Vegetation around tank foundation will be removed.

Storage tank improvements will include refurbishing the existing tank by sandblasting and painting the interior. A new 40,000 gal. tank will also be installed at the tank site. The tanks will require a new foundation as well as interconnecting piping with the existing tank such that the tanks can operate in tandem. The tank site and dirt access road will be regraded for stormwater control and a new riprap swale will be installed to collect and transport stormwater to a natural drainage channel located at State Hwy. 592. The overflow and drain pipes from the tanks will be routed to the stormwater swale. Maintaining a minimum of 30,000 gal. in the two storage tanks is expected to allow Chupadero to provide ISO Category 8 fire flow (250 gpm for 2 hours). The existing security fence at the tank site will be extended to surround the new water storage tank.

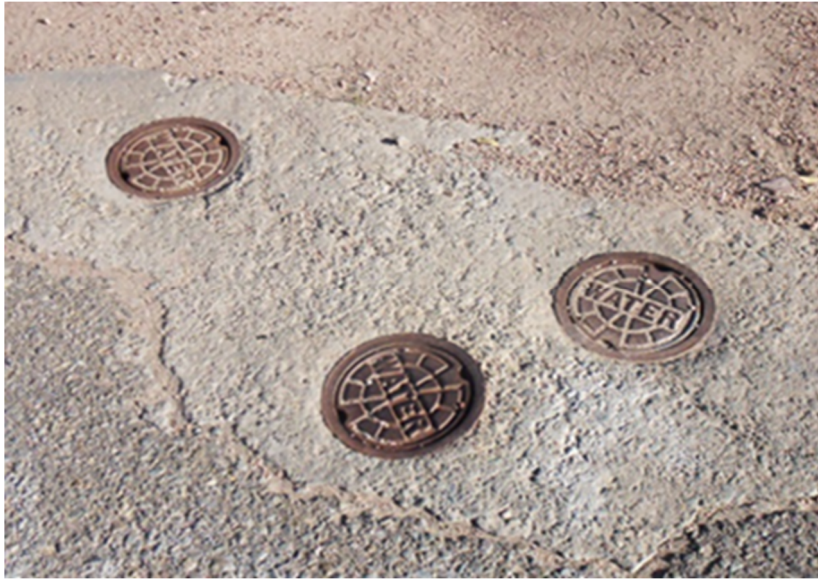
***Photo 9: Water Main/Lateral Isolation Valves***

Chupadero has reported a number of leaks occurring in their water main and at some of their isolation valves. An assumed leak (wetted surface extending approximately 20 ft.) was observed by Martin/Martin, Inc. on Camino de Pastores Road during the field reconnaissance conducted on December 27, 2017. In 2024, it was reported that the leak is no longer present. Chupadero has also reported that there may be as many as 10 illegal connections and laterals on their water main.

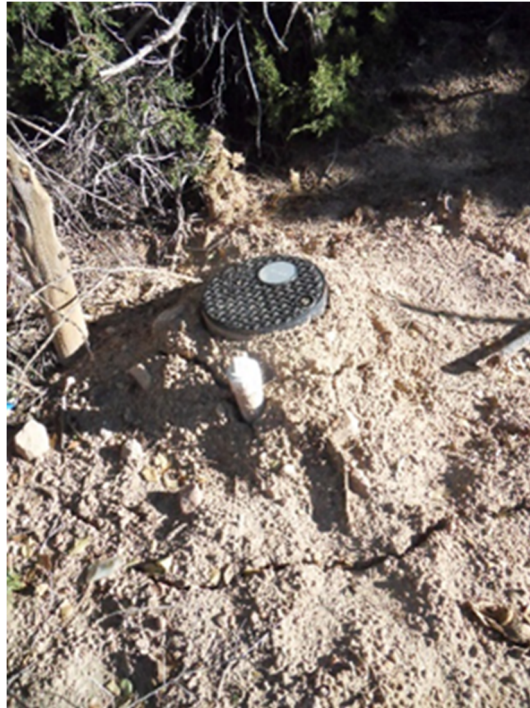
***Photo 12: Water Service Meter (2018)***

Prior to the 2018 PER, Chupadero replaced old water meters with new radio read meters. Chupadero uses a set monthly rate for customer billing. A photograph of one of the new water meters is provided below.

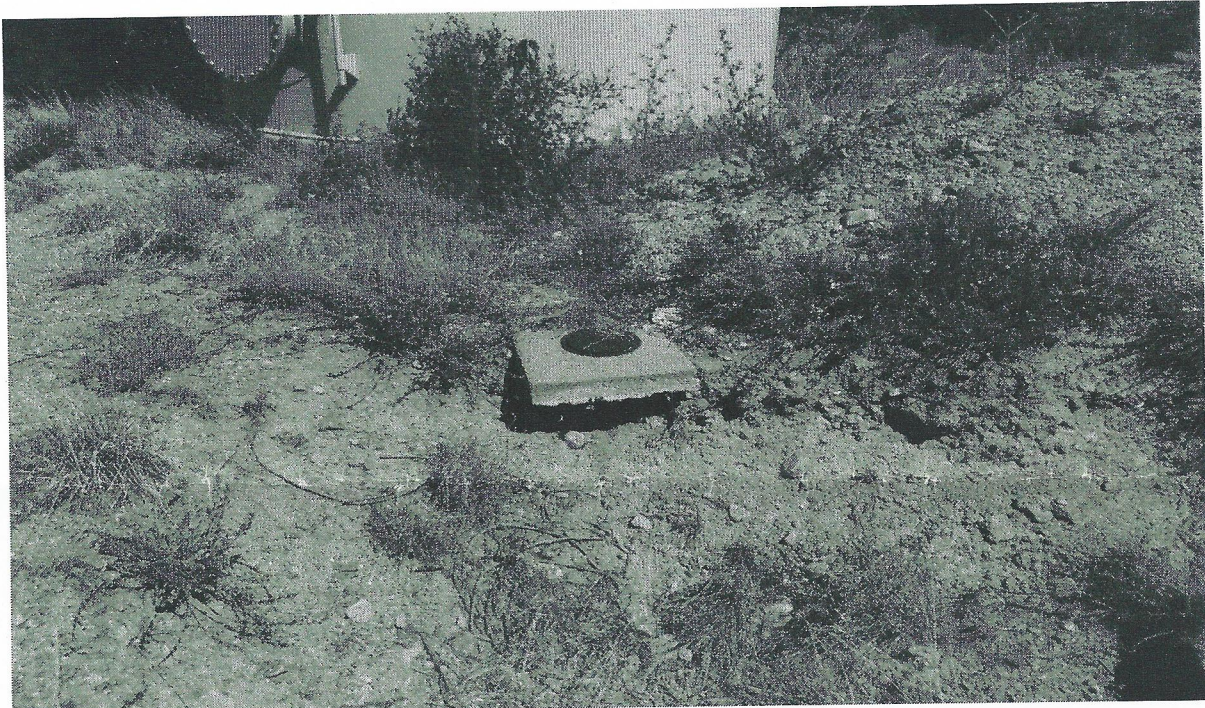
Figure 1. Significant Deficiency #2. Erosion near storage tank facility.

**Corrective Action:** Implement erosion control measures to mitigate erosion at the storage facility. (See Figures 1 & 2).

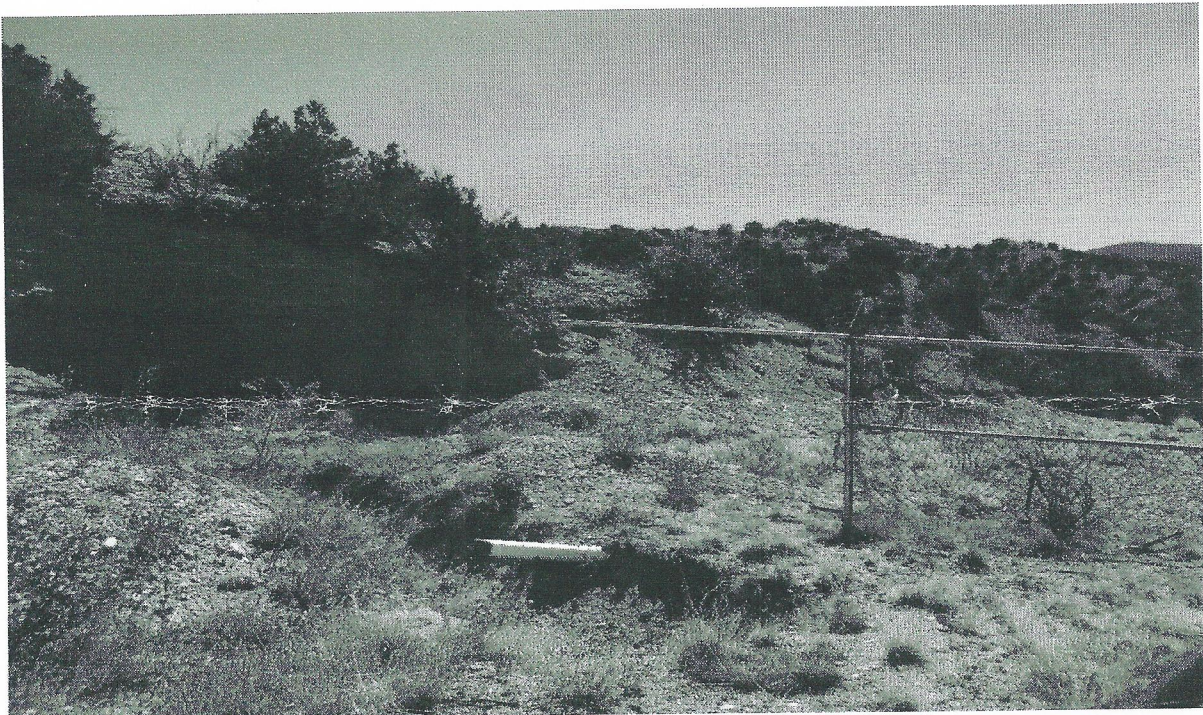
Figure 2. Significant Deficiency #2. Erosion near storage facility.

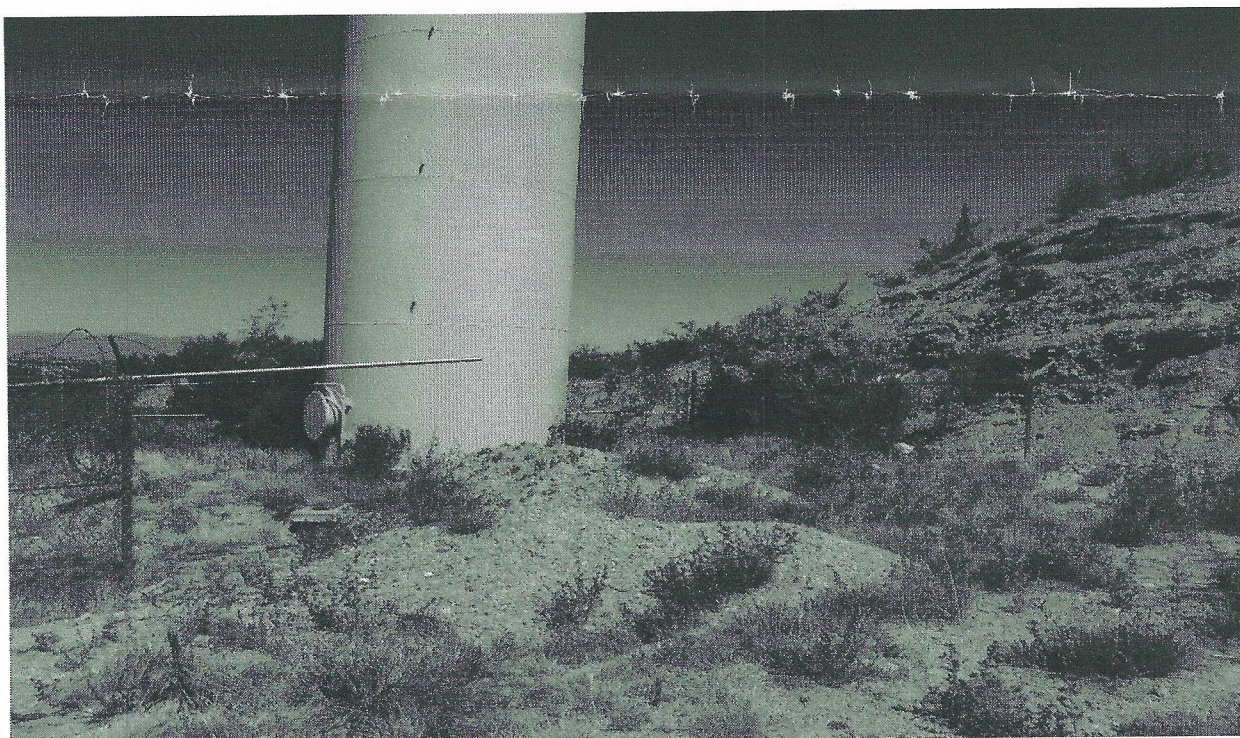
Figure 3. Significant Deficiency #3. Perimeter fence at storage tank is down.

Corrective Action: Reinstall/repair breaks in the perimeter fence around the storage tank.  
(See Figure 3)

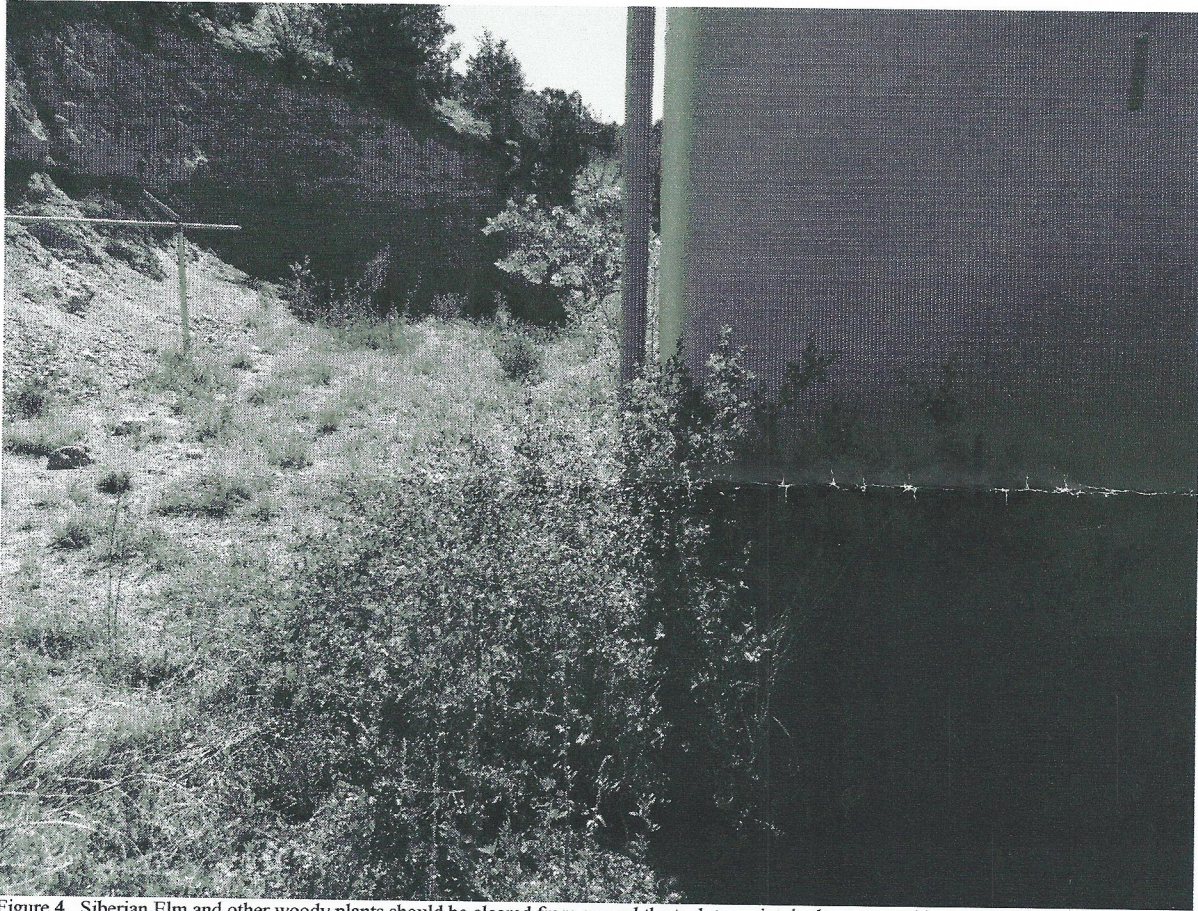
Figure 4. Siberian Elm and other woody plants should be cleared from around the tank to maintain the structural integrity of the facility.

Remove vegetation (Siberian Elm) from around the storage tank. Vegetation could compromise the integrity of the tank foundation and the tank. See Figure 4.
