Communities of La Cienega & La Cieneguilla Road Safety Audit Santa Fe, NM

Draft Report
January 2026

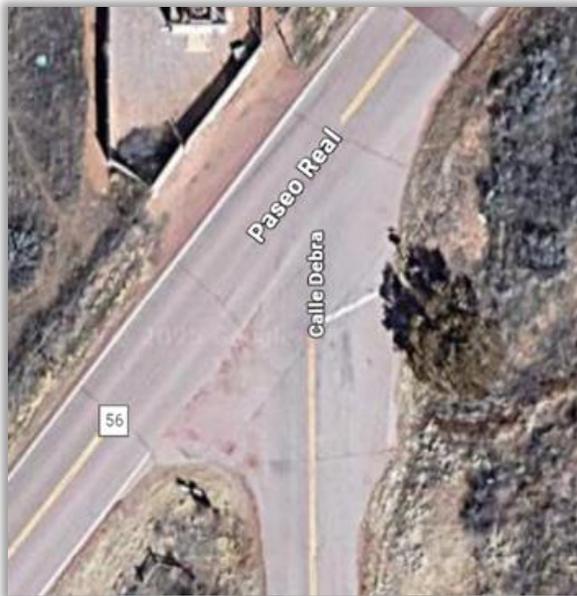
Figure 32: Paseo Real and Calle Debra (Existing Condition)

During the RSA field review, the team observed common challenges: skewed intersections with issues such as limited sight distance, non-adherence to yielding before making a right turn, sign visibility constraints due to unconventional road geometry, and vegetation outgrowth. These attributes can lead to safety issues and hazardous conditions, particularly at night or in adverse weather. Figure 32 through Figure 35 shows existing geometry and Figure 36 through Figure 39 depicts the proposed improvements at these intersections in the study area. Additionally, Figure 40 demonstrates the typical spacing of a stop sign at the intersection.

Recommended Countermeasure: Geometric improvements at the intersection

- It is recommended to change the approach geometry to align the stopped vehicles perpendicular to the main roadway. Acute minor street alignments, or cutting the corner, reduce sight distance, discourage stop sign compliance, and increase the potential for sign knockdowns. Varied use of striping, paving, and rolled curbing can encourage the desired alignment. In many cases, striping alone is not enough to induce behavioral change. Therefore, a rolled curb is recommended at the intersections of Paseo Real and Calle Debra, Los Pinos Road and I-25 Frontage Road, Las Estrellas and I-25 Frontage Road to encourage passenger vehicles to “square up” at the intersection rather than cutting the corner. The curbing also allows off-tracking for right-turning RV traffic and other heavy vehicles. Figure 41 depicts an example of a traversable curb constructed to guide passenger vehicles, while allowing heavy vehicles to off-track.

- It is recommended to make tighter turning radii through geometric improvements, as such, it encourages the motorists to comply with the Stop Sign and helps reduce the potential for ‘failure to yield’ related crashes.

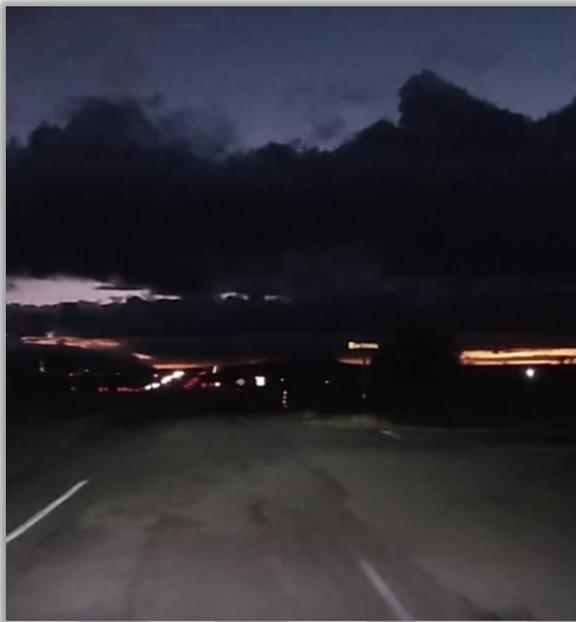
Figure 48: Current condition Los Pinos Rd and I-25 Frontage Road

From the crash data analysis and during the nighttime field review of the study corridor, it was observed that nighttime visibility is a serious challenge, especially on these narrow and winding roads within the communities. Safety lighting at the intersections and delineation features along the horizontal curves significantly improve the visibility of the roadway. Currently, the intersection lacks sufficient lighting, which reduces driver awareness of roadway geometry, signage, and potential conflicts during nighttime or adverse weather conditions. Insufficient illumination is particularly hazardous for vulnerable road users such as pedestrians and cyclists, and older drivers. Installing lighting will improve safety, visibility, and overall intersection safety. Enhanced delineation treatments can alert drivers to upcoming curves, the direction and sharpness of the curve, and appropriate operating speed. Figure 48 through Figure 52 shows the existing curve protection and delineation inadequacy.

- Based on the data analysis and the field review, we recommend installing safety lighting at these four intersections, as shown in Figure 53 through Figure 56, i.e.; Los Pinos Road and I-25 Frontage Road, Las Estrella and I-25 Frontage Road, Entrada La Cienega and I-25 Frontage Road, and Paseo Real and Los Pinos Road. Two luminaires at the intersection of Los Pinos Road and I-25 Frontage Road, two luminaires at the intersection of Las Estrellas and I-25 Frontage Road, three luminaires at the intersection of Entrada La Cienega and I-25 Frontage Road, and two luminaires at the intersection of Paseo Real and Los Pinos Road. The approximate locations of the luminaires are shown in the figures below. In accordance with NMDOT standards, the luminaires shall be night-sky-compliant with full cutoff, as required by the New Mexico Night Sky Protection Act. Typically, NMDOT does not bear the ongoing cost of illumination electrical service; therefore, a lighting agreement must be established between the communities, the County, and NMDOT to successfully install luminaires at this intersection.

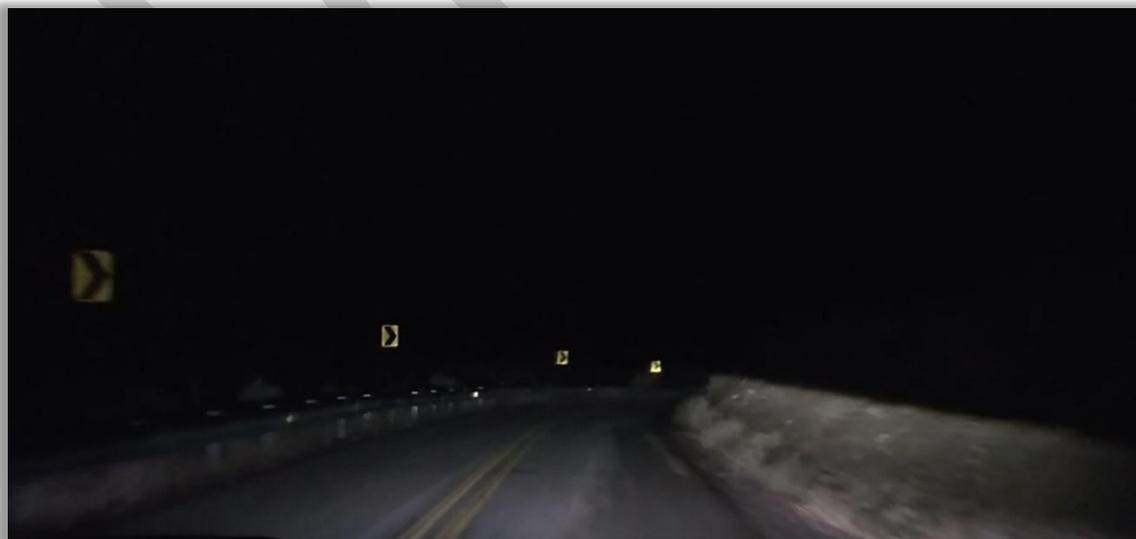
Figure 50 Limited delineation and worn-out reflectors

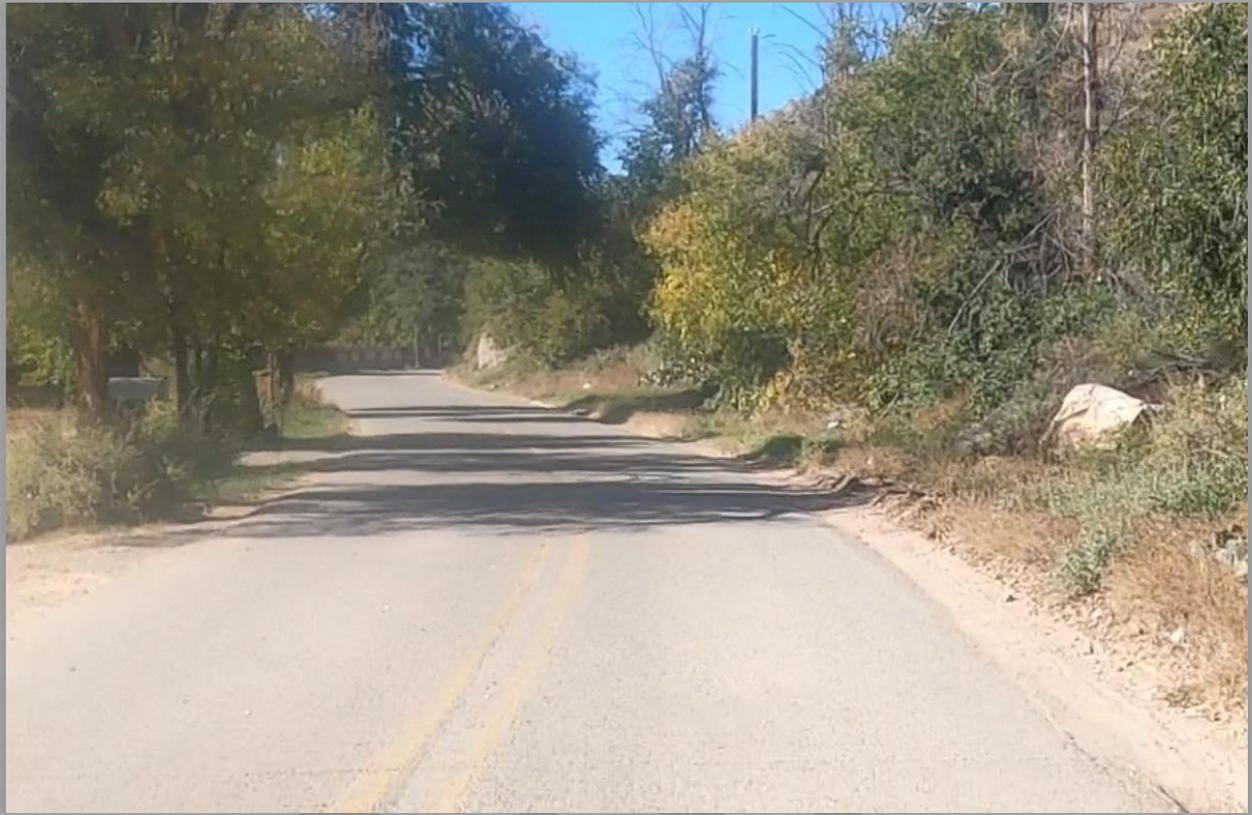
Figure 51 Worn-out centerline striping on Los Pinos Road

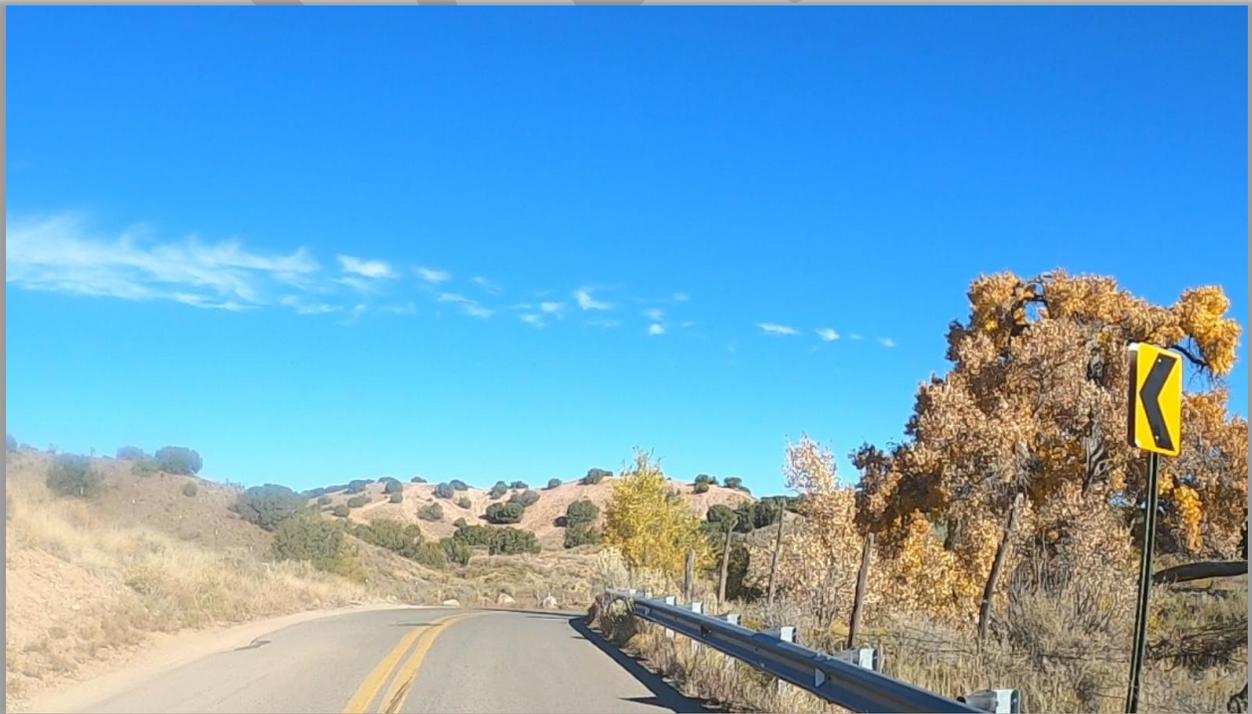
Figure 52 Inadequate curve protection in the absence of chevron alignment sign and delineators

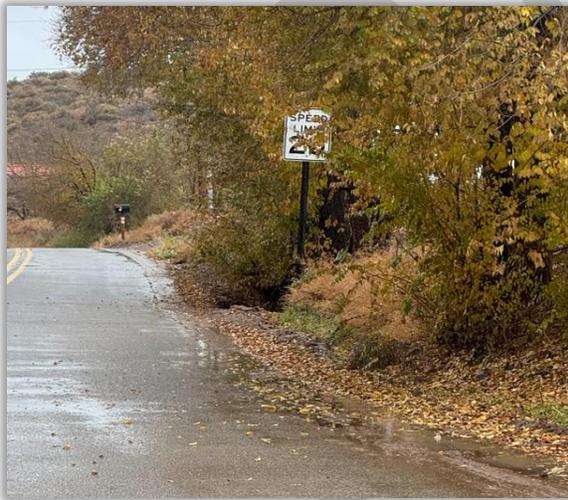
Figure 67 Vegetation outgrowth obstructs sign visibility

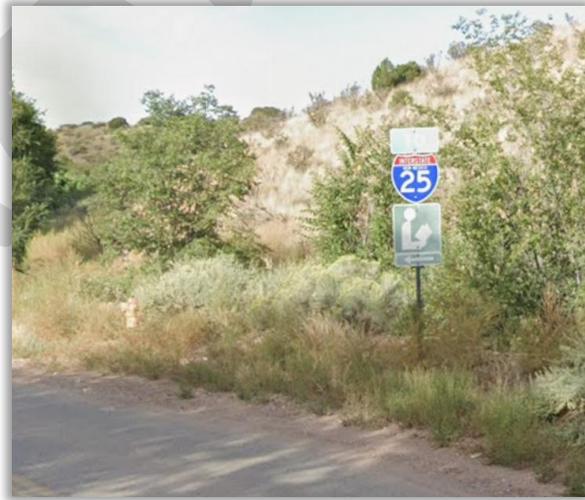
Figure 68 Missing Directional Arrow plaque

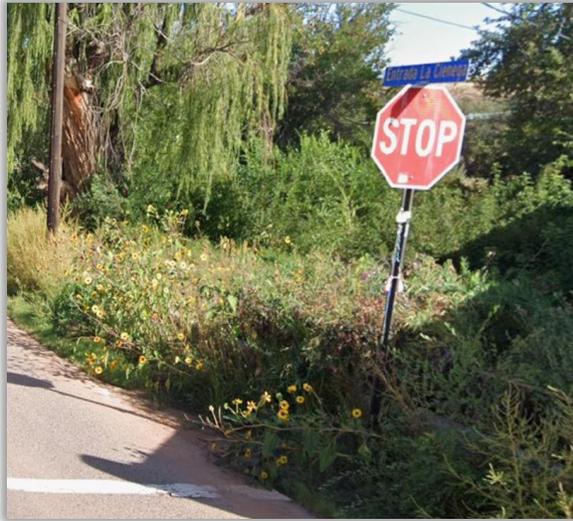
Figure 69 Missing All-Way plaque

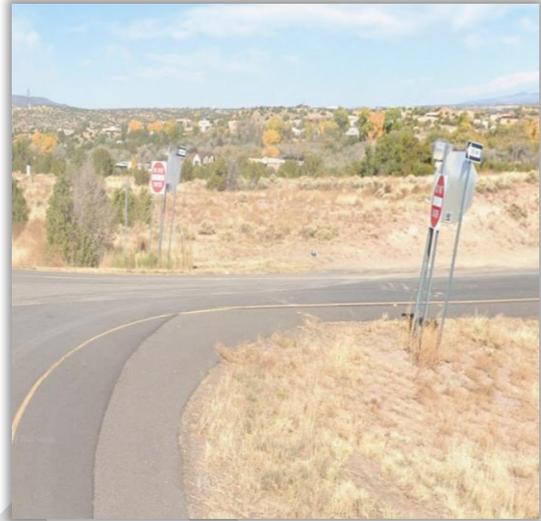
Figure 70 Disoriented traffic sign and missing No Right-Turn Sign

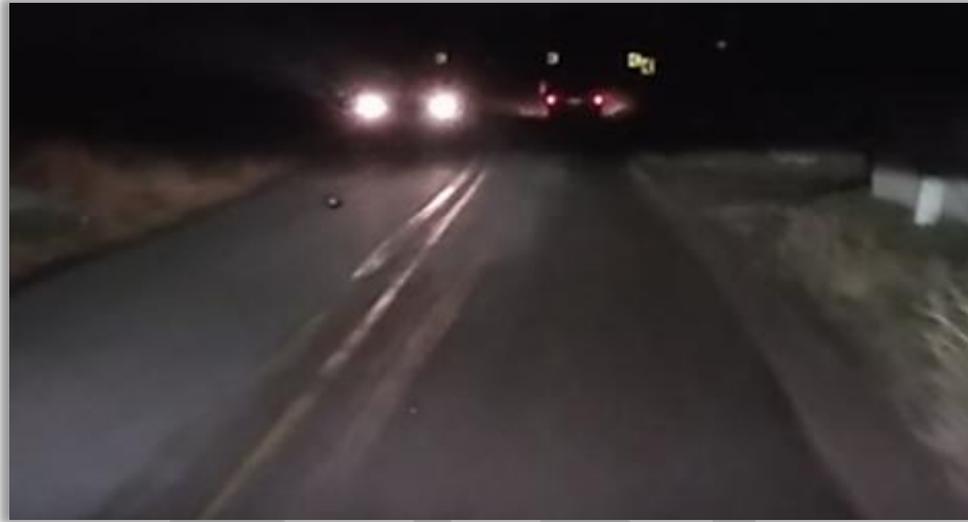
During the field visit, the RSA team observed majority of striping, pavement and pavement marking are intact on most of the locations with little wear and tear within the study area. However, several issues related to faded or missing pavement markings. Deficiency in pavement markings reduces clarity for road users and limits visibility, especially during night or low-light conditions. Additionally, the broad and undefined geometry of the intersections in addition to the skew contributes to driver uncertainty and unsafe turning maneuvers. Figure 75 to Figure 77 depict issues related to striping, paving, and pavement markings within the study area. Figure 78 shows FHWA example of on-pavement speed marking.

Figure 75: Worn-out centerline striping

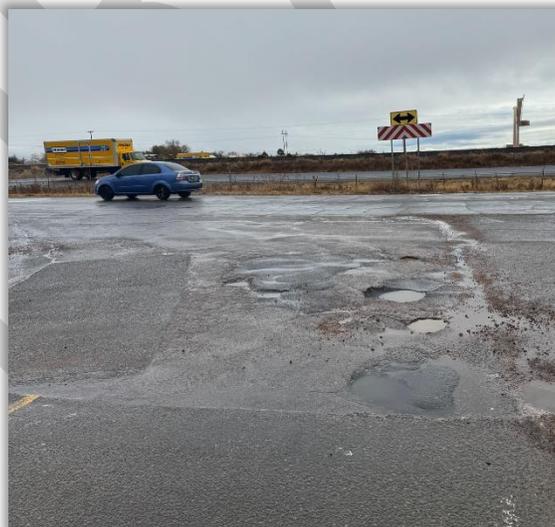
Figure 76: Faded pavement marking and pot holes on Los Pinos Road

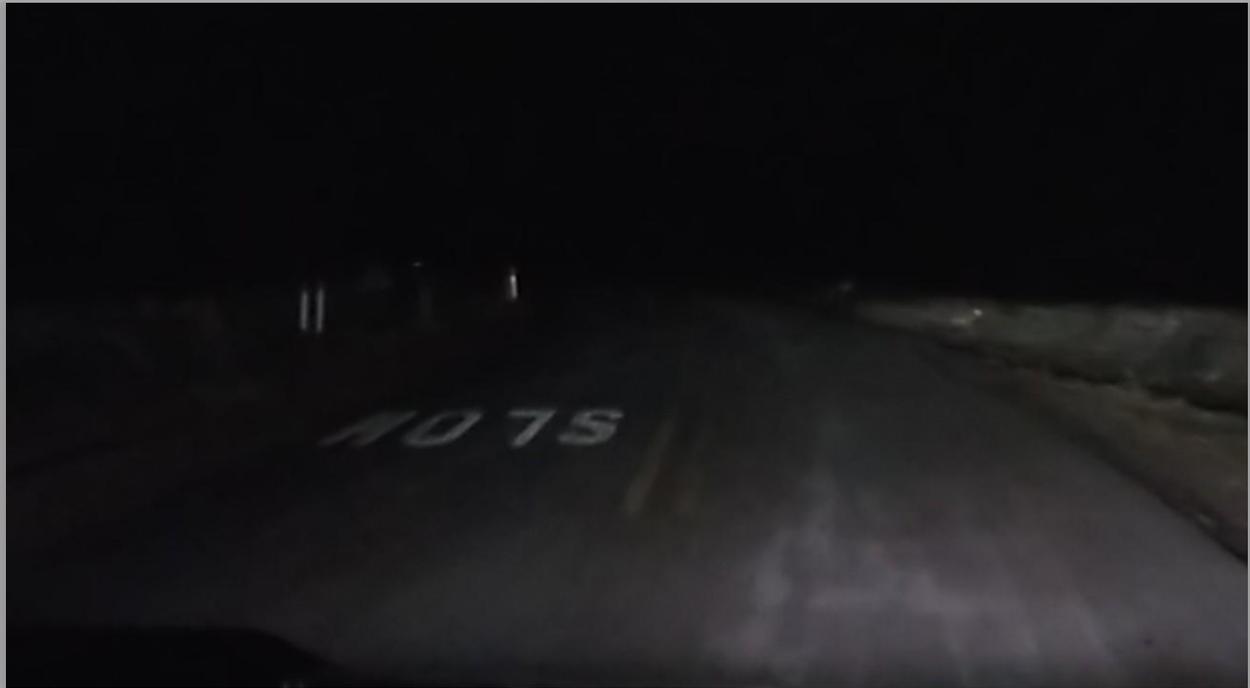
Figure 77 Worn-out centerline striping on Los Pinos Road

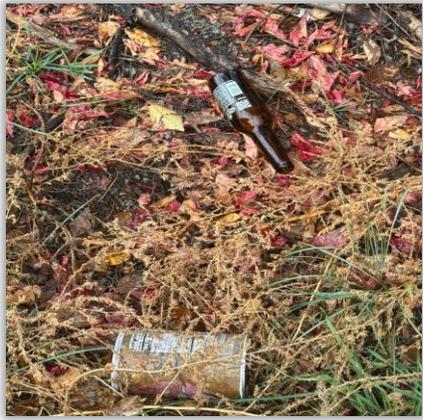
Figure 80 Littering observed during Field Review

- Repetitive messaging with Littering Prohibition signs can be planned to consistently convey the message of potential fines in the event of violation, with stricter adherence.
- Enforcement and surveillance are suggested to be supplemented with custom regulatory signs. In addition, community members are encouraged to be vigilant of such events and conduct their due diligence.
