Tesuque Roads Safety Study.

Final Report | Jan. 2023

Tesuque Roads Safety Study

Final Report

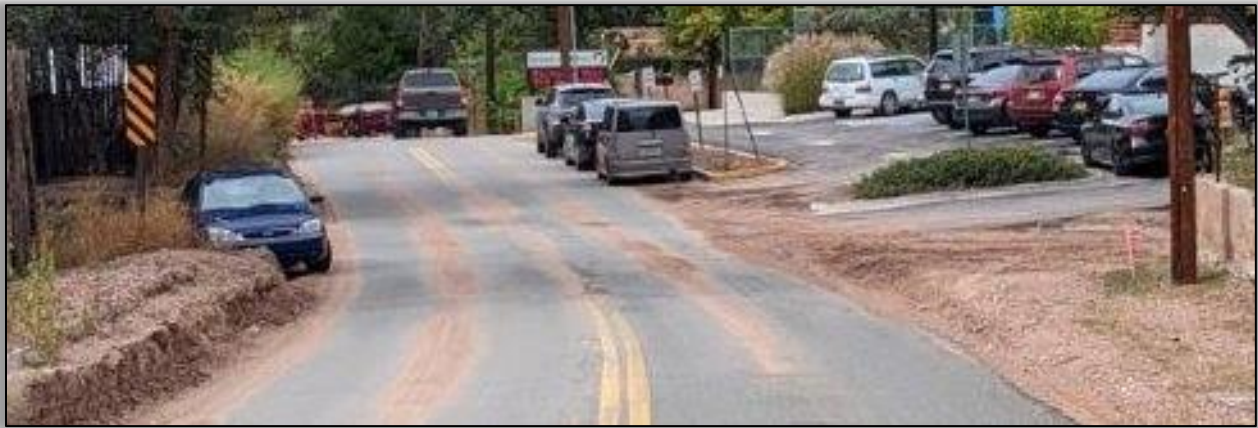
The rustic nature of Tesuque contributes to its charm. However, multiple arroyos with dry creek beds deposit significant sediment where the arroyos intersect with Bishops Lodge and Arroyo Griego Roads. Arroyo Griego Road is a paved portion of the arroyo with an engineered culvert filled with sedimentation, rendering it ineffective. These sediment deposits and buildup on the road's edges obstruct and cover the edge line pavement markings; the significant sediment buildup on the road shoulder is shown in Figure 27. Figure 28 shows the sediment buildup on the paved portion of Arroyo Griego Road. Curvy, hilly roads with loose debris may cause vehicles to lose traction and prevent motorists from understanding the road's delineation. The loose debris poses a safety challenge for bicyclists, and sediment buildup on the shoulders eliminates road space for pedestrians and bicycles.

Figure 27: Sediment deposits on Bishops Lodge Road

The recommended countermeasures include removing the existing sediment buildup on the roadside and the culvert on Arroyo Griego Road. Once these deposits have been removed, a plan for routine sediment removal is recommended to be developed and prioritized after storm events. Currently, no practical solutions are readily available to address future sediment deposition. Before developing any mitigations to address this challenge, understanding the water flows is necessary; this may be accomplished by performing a sedimentation and erosion study.

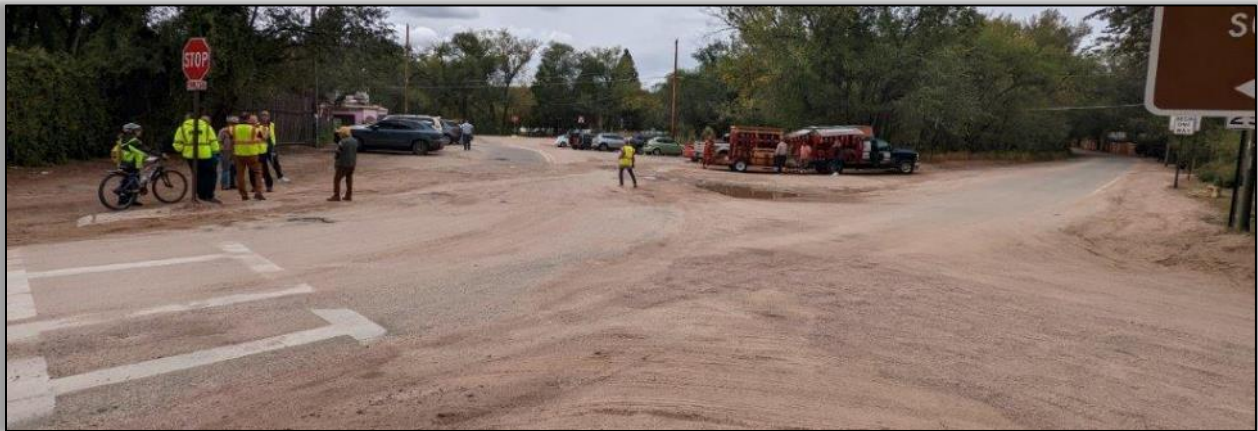
Figure 28: Sediment deposits on Arroyo Griego Road

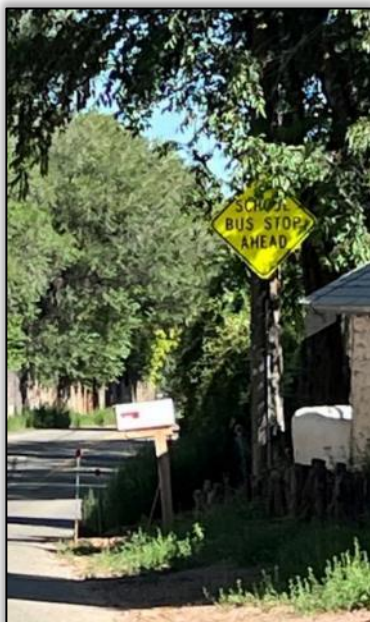
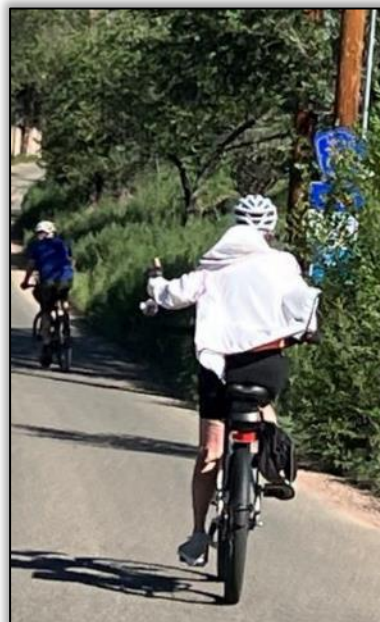
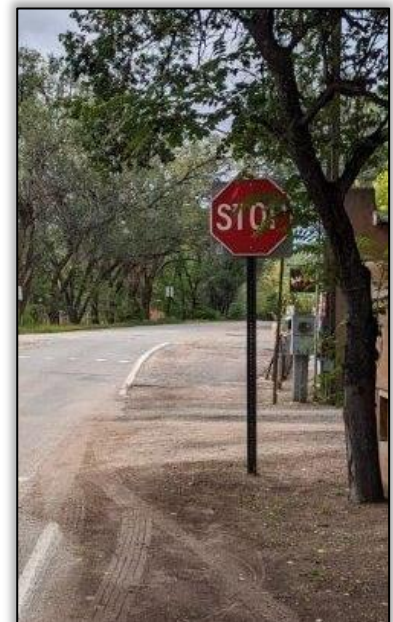
The MUTCD defines standards and guidance for Traffic Control Devices (TCDs). TCDs, i.e., roadway signs, are vital to road safety because they convey regulations and roadway conditions and guide road users. The messages, shapes, colors, and locations are well-researched and effective. However, the efficacy of roadway signs is diminished when they are not visible. Visibility can be reduced by vegetation or other objects; Figure 29 shows examples of roadway signs obstructed by vegetation in Tesuque.

Figure 29: Examples of Vegetation Obstructing Roadway Signs

The safety countermeasure for this challenge is performing routine maintenance to maintain the visibility of roadside signs and replace the signs that are no longer reflective at night.

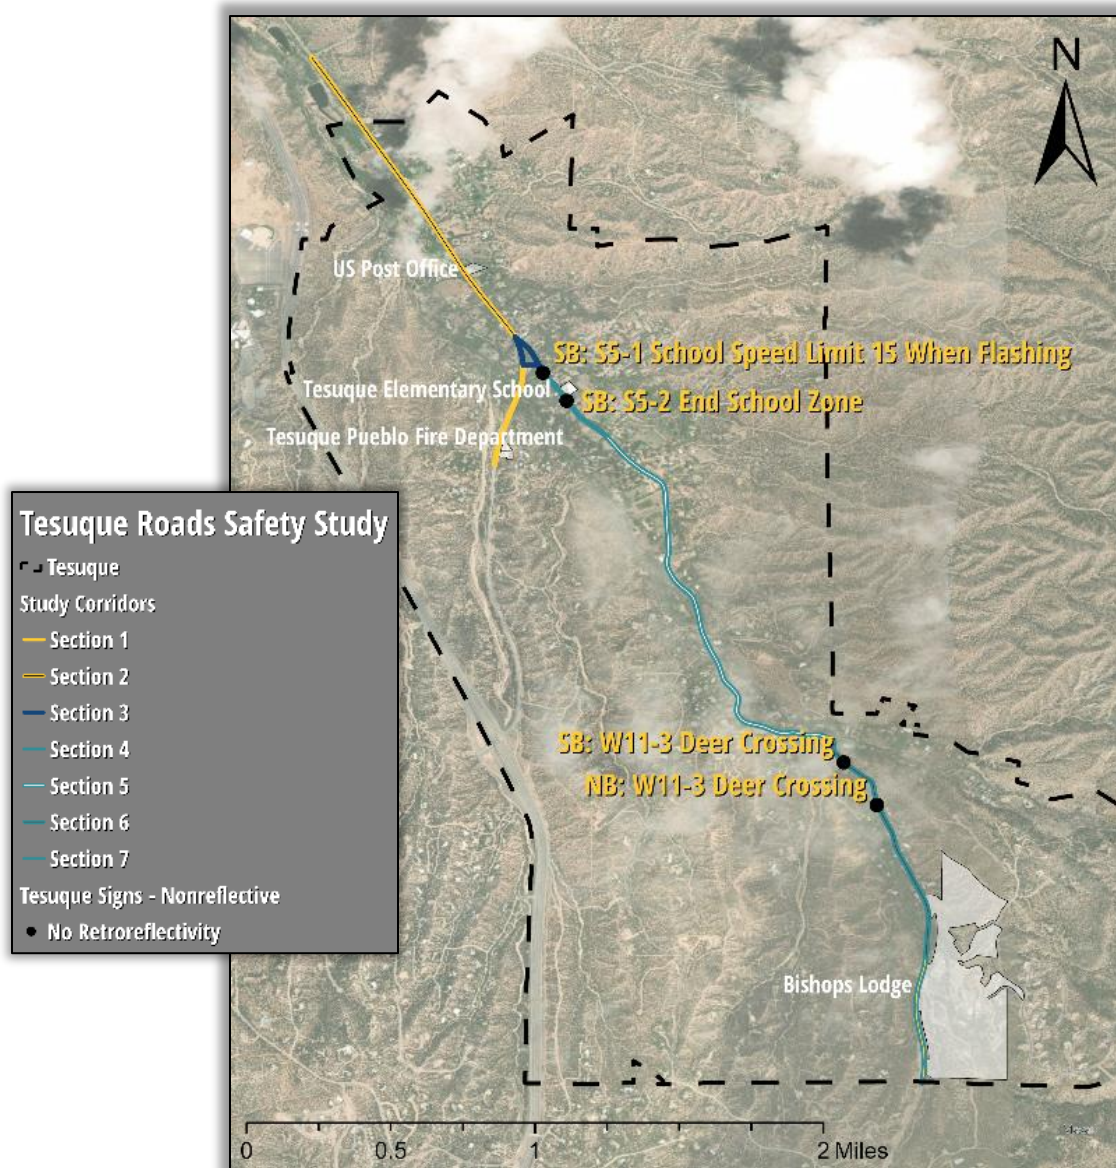
Additionally, nighttime visibility is diminished when a roadway sign loses its retroreflectivity. During the “Dark” field reviews, the project team identified four MUTCD signs that were no longer reflective. These signs and their locations are shown in Figure 30.

Figure 30: Non-Reflective Signs

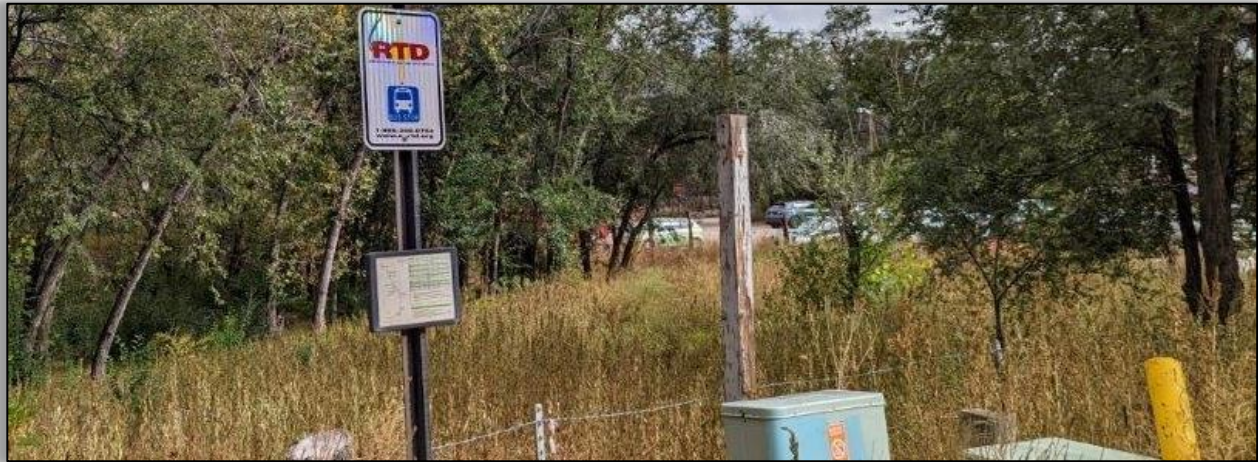
Tesuque Village Road lies along Transit Route 220 of the North Central Regional Transit Districts network. The current schedule shows five northbound and five southbound stops at Tesuque Village Market and Tesuque Post Office. However, only northbound stops are identified by signs, as shown in Figure 31 and Figure 32. As discussed, the Tesuque Village Road corridor exhibits the highest ADT and lowest compliance with the posted speed limits. These stops are not ADA Accessible and are separated by ambiguous edge line markings from motor vehicles traveling at high speeds.

Figure 31: Tesuque Village Market Transit Stop

This recommendation establishes bidirectional transit stops that meet and exceed PROWAG guidance of 4-foot-wide access routes and 5-foot-wide passing spaces. Additionally, transit stops should comply with section R308.1 of PROWAG

by providing a "...level and stable surface for boarding vehicles."² Another recommendation is to enhance the transit stops from a posted sign to a transit shelter, as seen in Figure 33. CRFs were researched; however, a CRF is not available for these countermeasures.

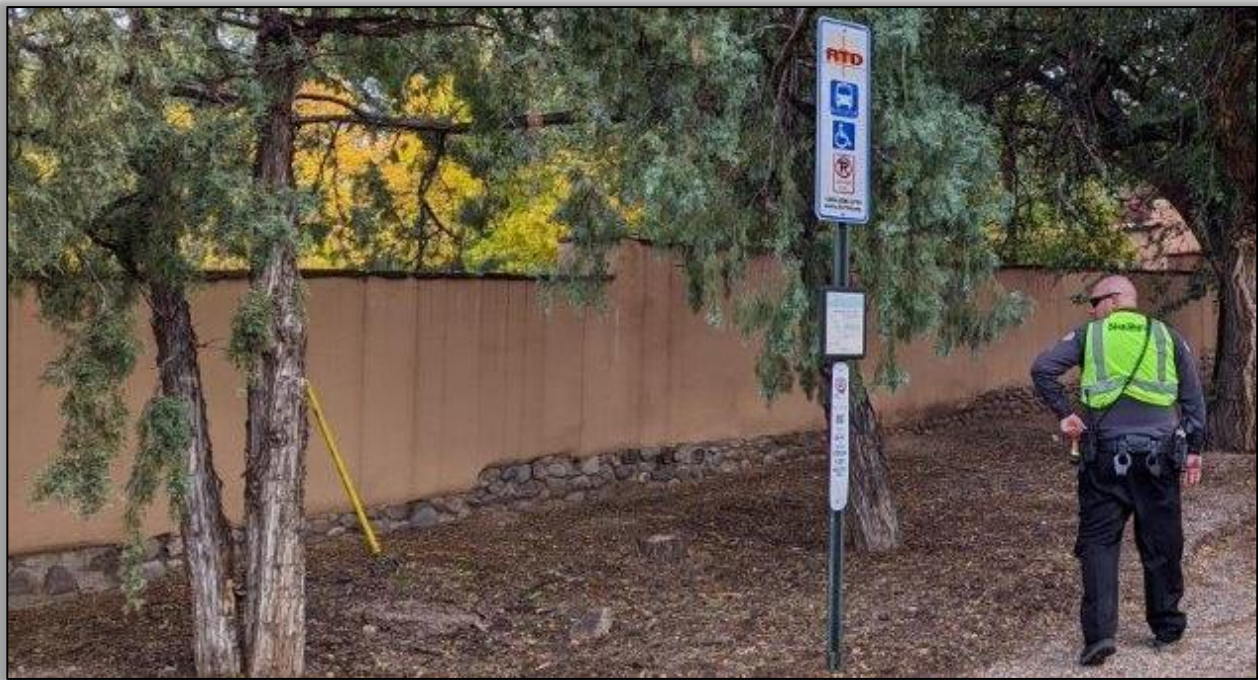
Figure 32: Tesuque Post Office Transit Stop

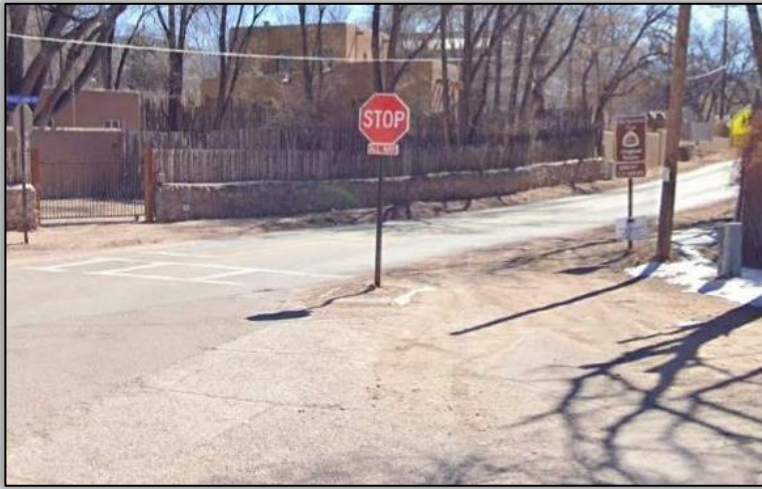
The lack of clear delineations and worn concrete infrastructure leads to ad hoc movements like the channelized right turn at Bishops Lodge Road, shown in Figure 37. Additionally, there is no striping for the parking spaces on either side of Arroyo Griego Road. This creates a lack of clarity for road users and increases the risk of conflicts between motorists, pedestrians, and bicyclists near Tesuque Village Market. Additionally, the area’s decrepit infrastructure, shown in Figure 38, poses a safety challenge for pedestrians who park and patronize the local businesses.

Figure 37: Ad hoc channelized right-turn at Bishops Lodge Road

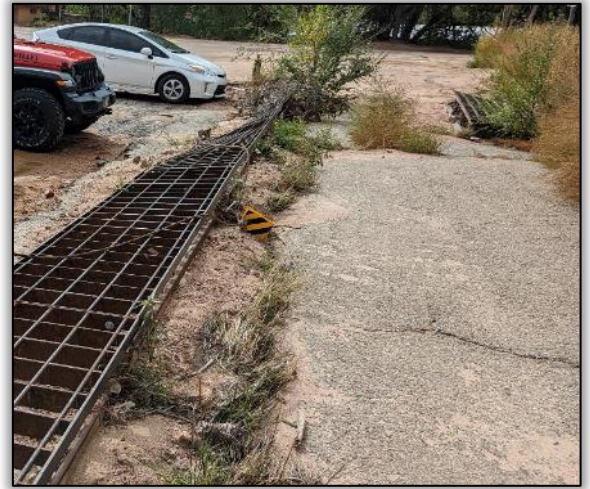
Figure 38: Decrepit infrastructure posing a safety challenge for pedestrians

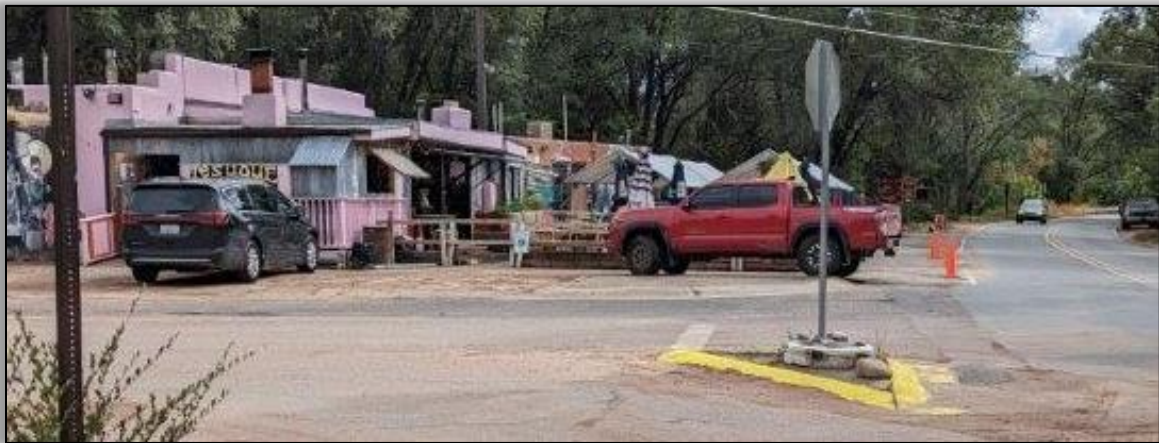
Figure 41: Ad hoc parking at Tesuque Village Market

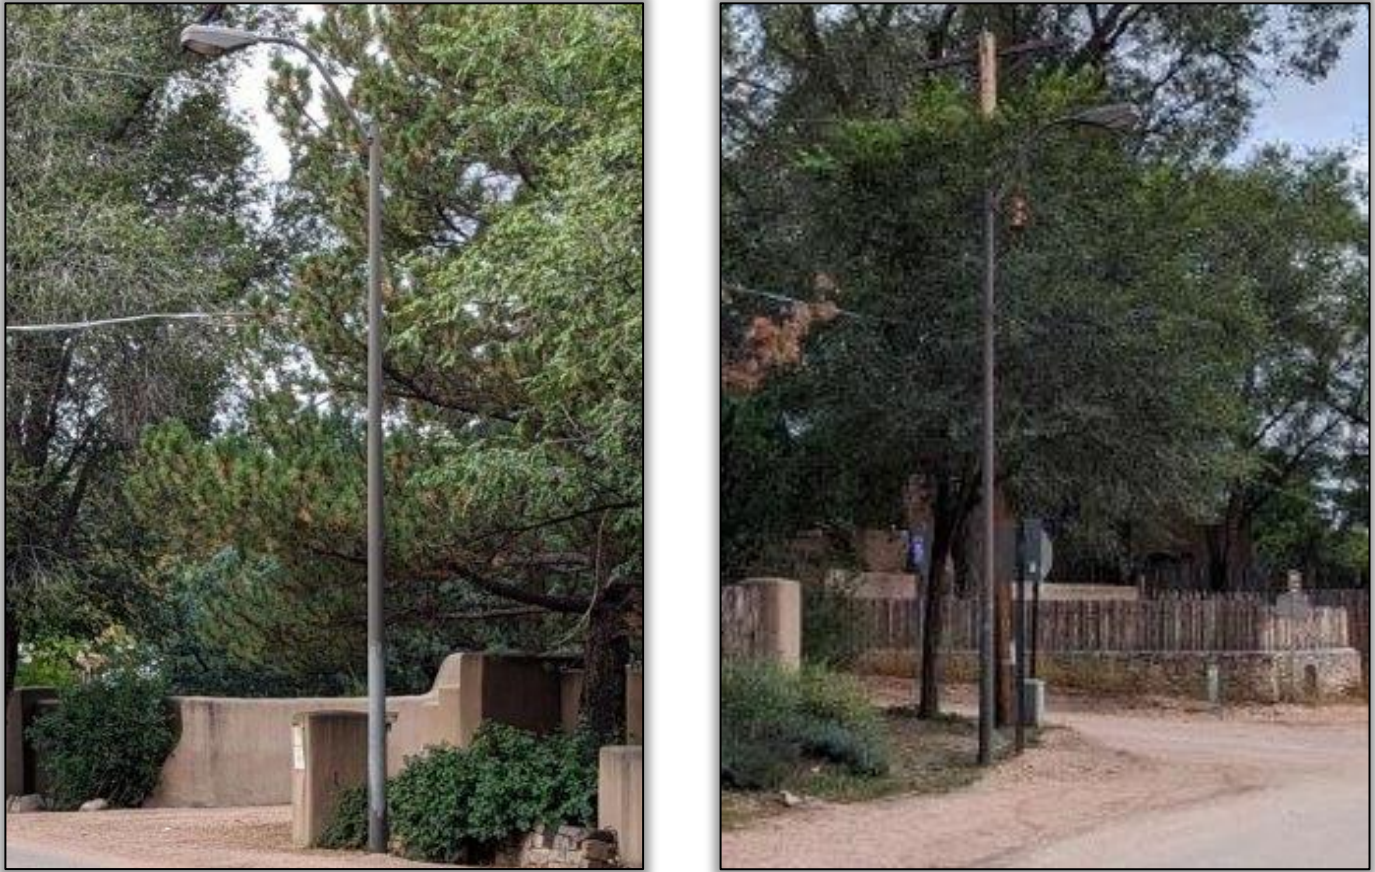
During Dark field reviews, several luminaires on the one-way segment of Bishops Lodge Road were nonoperational at night. Two of these luminaires are shown in Figure 42.

Figure 42: Nonoperational Luminaries on Bishops Lodge Road

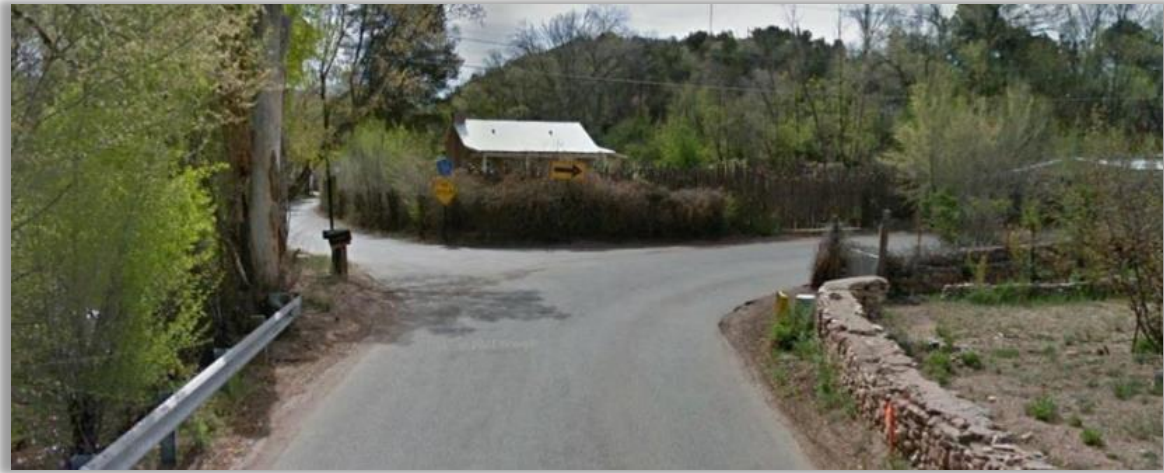
At the intersection of Bishops Lodge Road and Big Tesuque Canyon, there is a sharp horizontal curve on Bishops Lodge Road. While there is a stop sign on Big Tesuque Canyon, Bishops Lodge Road traffic is free-flowing through the curve. The limited visibility and additional conflict points created by the curve at this intersection pose a safety challenge to road users.

Figure 48: Southbound Bishops Lodge Road at Big Tesuque Canyon
