Riparian Vegetation on the Santa Fe River at Cañon, Santa Fe County, New Mexico

**2013 Survey Report
Prepared for New Mexico Forestry Division**

**Robert Sivinski, Contract Botanist
Santa Fe, New Mexico**

June, 2013

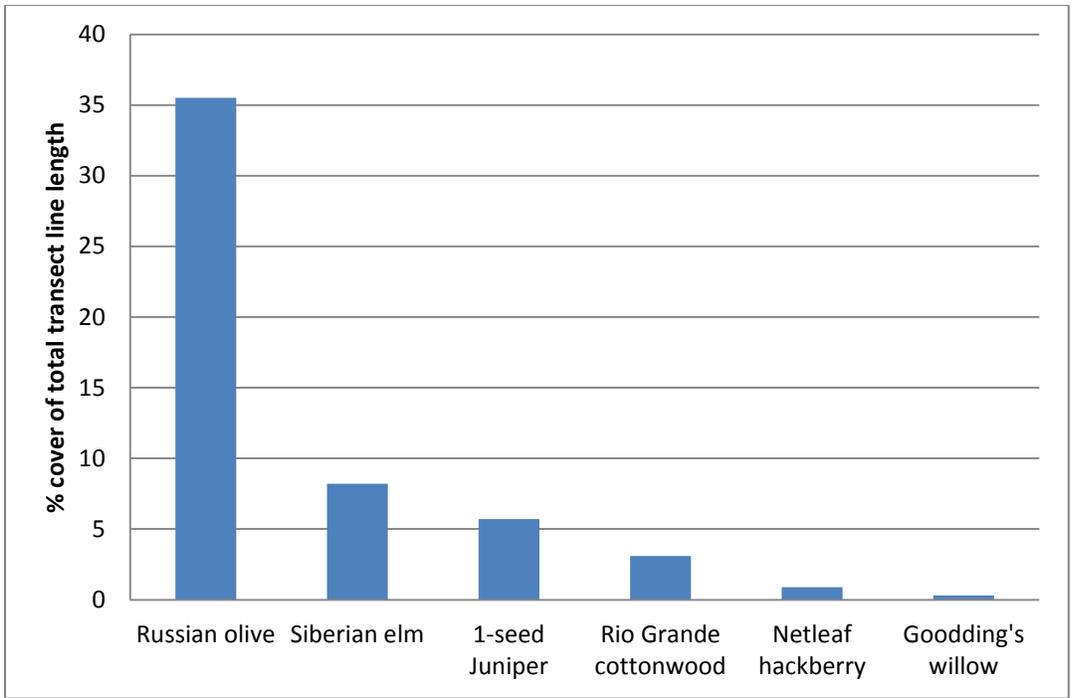
Visual inspection and data analysis of the vegetation in the study area reveals a highly degraded and relatively un-natural riparian ecosystem. Tree canopy is predominantly composed of exotic Russian olive (*Elaeagnus angustifolia*) and to a lesser extent Siberian elm (*Ulmus pumila*) (Table

One-seed juniper (*Juniperus monosperma*) has the greatest amount of cover of any native tree/large shrub in the Santa Fe River canyon, but on the drier edges of the riparian woodland (Figure 6). It is rare in the valley bottom near the river channel. Rio Grande cottonwood (*Populus deltoides* var. *wislizeni*) and Goodding's willow (*Salix gooddingii*) are remnant native trees that persist as old individuals surviving decades of abusive livestock grazing. Goodding's willow is very rare in the study area, but Rio Grande Cottonwood persists as several very large, old trees. Neither has been able to produce a sapling or younger cohort in the presence of continuous grazing. Surprisingly, there is a population of native netleaf hackberry (*Celtis reticulata*) in the canyon that might increase if the Russian olive cover were to decrease. This species is near the northern edge of its range. There are a few large netleaf hackberry trees in the study area and several saplings being suppressed under Russian olive canopy.

Figure 6. Foliar cover of tree species on the Santa Fe River near Cañon in 2013.

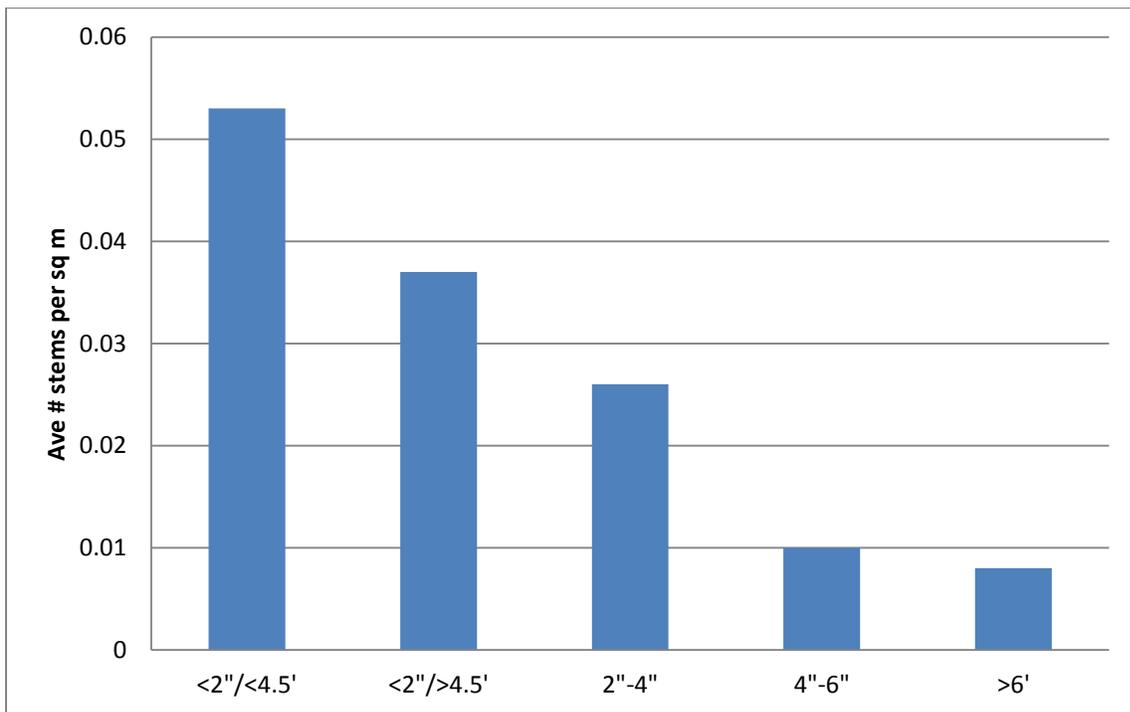
Russian olive, Siberian elm and salt cedar are also listed as Class C weeds and first two are the most problematic for land management in the study area. Russian olive has an average density of 0.079 individuals per square meter in the study area (790/hectare; 319/acre). Several parts of the riparian woodland are a closed canopy of Russian olive and some are old enough to have trunks nearly two feet in diameter. Russian olive often has a bushy growth form so there are many more woody stems than individuals (Figure 9). The 2013 survey sampled all Russian olive stems coming from the ground and found stems less than 2” in diameter to be 900/hectare (364/acre) and stems greater than 2” in diameter to be 440/hectare (178/acre).

Figure 9. Stem densities of Russian olive size classes on the Santa Fe River near Cañon in 2013.

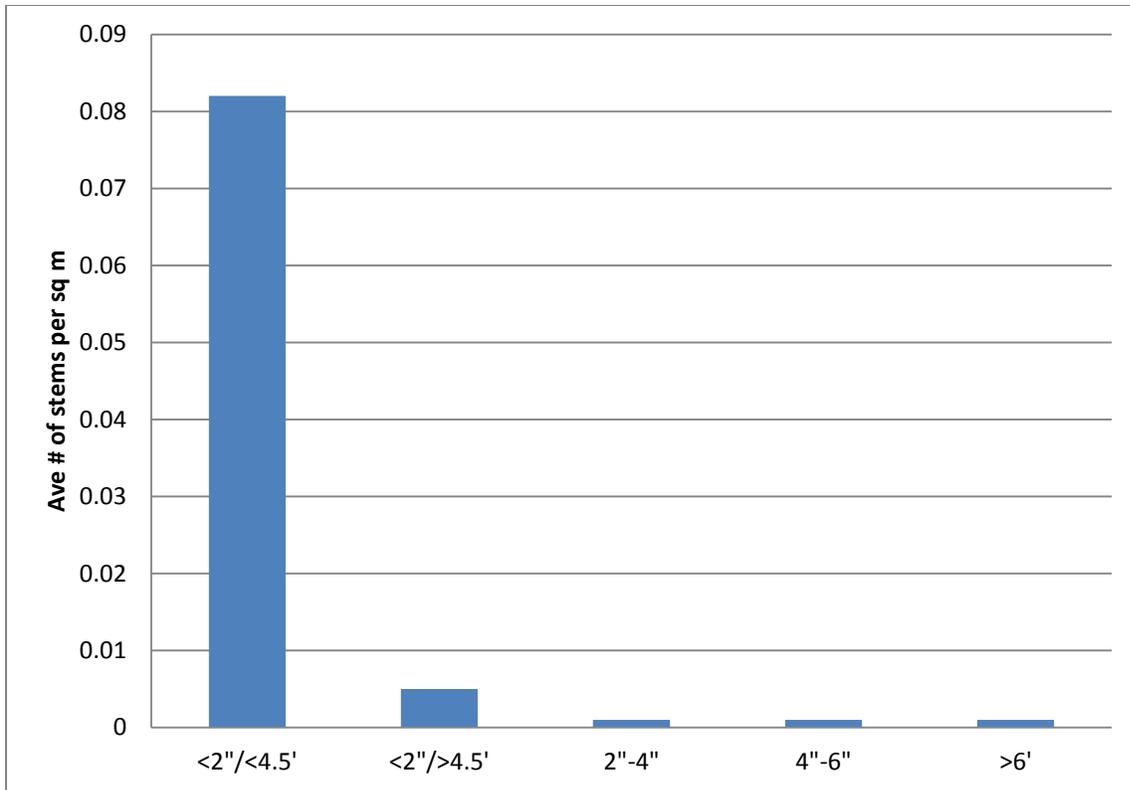
Siberian elm has an average density of 0.085 per square meter (850/hectare; 344/acre). It can also have multiple stems per individual and grow to large trees, but there are relatively few of the old, large size classes in the study area compared to an abundance of seedling and sapling trees. The 2013 survey sampled all Siberian elm stems coming from the ground and found stems less than 2” in diameter to be 870/hectare (352/acre) and stems greater than 2” in diameter to be only 30/hectare (12/acre)(Figure 10). Most of the large trees in the valley are around abandoned farm fields close to the old settlement. The numerous large Siberian elms growing on or below the active hillside acequia were not counted in this survey.

Figure 10. Stem densities of Siberian elm size classes on the Santa Fe River near Cañon in 2013.

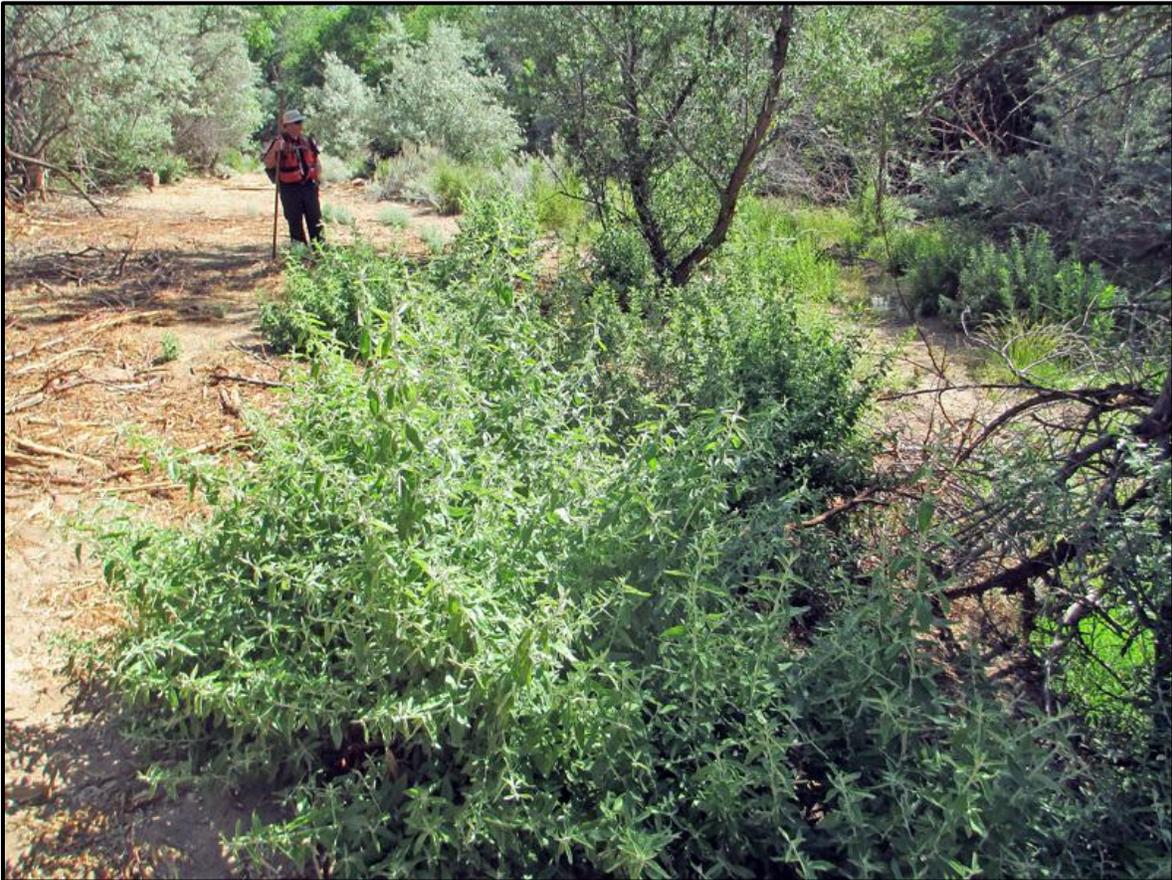
In 2012, BLM deviated from the proposed methodology in the EA by bringing a tree masticator into the riparian woodland to treat small areas near the Cañon settlement. Many Russian olive and Siberian elm trees were reduced to wood chips, but the stumps were not treated with herbicide. All the stumps and surrounding roots proliferated respouts in 2013 that will rapidly increase the overall density of weed trees well above the original density before the masticator was allowed on site (Figure 11).

also be continually mowed for good control, but larger plants respond to cutting or girdling by vigorously resprouting, resulting in thicker, denser growth, unless herbicide is immediately applied to cut surfaces after cutting". Figure 11 illustrates this in the study area where a masticator without follow-up herbicide treatment made the situation many times worse. .

Figure 11. Russian olive and Siberian elm resprouts from stumps and roots after mastication.

- All cut stumps should be spot-treated with herbicide applied with backpack sprayer within 5-15 minutes of cutting (USDA Forest Service 2012a and 2012b). If herbicide is not utilized, we recommend leaving the non-native trees and planting native woody species in a few open areas where they may compete with the weed trees. Root ball extraction and cutting small stems without herbicide treatment will not control the weed trees (USDA-Forest Service 2012a and 2012b). The Nature Conservancy (2003) states: "Pulling or digging out larger plants is both extremely labor intensive and not recommended, since it can leave behind root fragments that can resprout. Seedlings can

- A "one time" application of herbicide to cut stumps will not be completely effective as referenced in the above publications, which recommend annual monitoring with permanent plots or transects for treatment response. After BLM initially treats the project area, there should be follow-up herbicide treatments on invasive species re-sprouting for at least 1-3 years with periodic follow-up treatments based on results of monitoring required by various BLM policies (BLM 2007).
