POJOAQUE SPORTS FIELDS

SITE ASSESSMENT

May 2014

A site inventory and assessment was conducted in February 2014 to identify the extent and conditions of improvements at the site. Information collected as part of the site assessment are derived from visual inspections and interviews with representatives from Pojoaque Valley Public Schools, the previous owner responsible for maintaining the site. This information is summarized on the following pages.

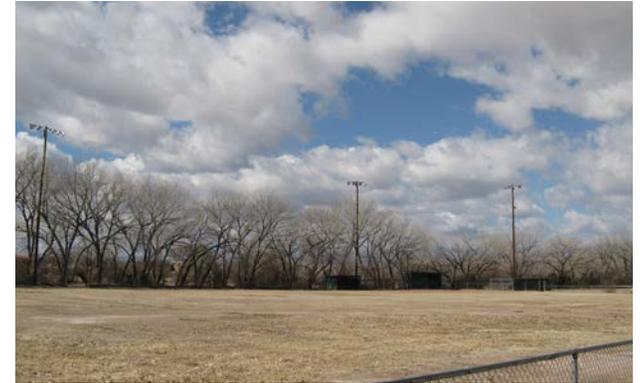
Multi-purpose field; looking southwest

- Surfacing: prepare subgrade and reestablish grass surface
- Irrigation: replace the entire existing irrigation distribution system with new equipment, including heads, lateral lines, and valves
- Grading: regrade field at current slopes to establish a smooth, consistently sloped field
- Site Furnishings: repair bleachers, replace components
- Lighting: install new sports field lighting, upgrade electrical service
- Scoreboard: repair scoreboard
- Dugouts: clean and repaint existing dugouts
- Press Box: repair / replace existing press box
- Fencing: repair holes in existing chainlink fence and repair / replace access gates

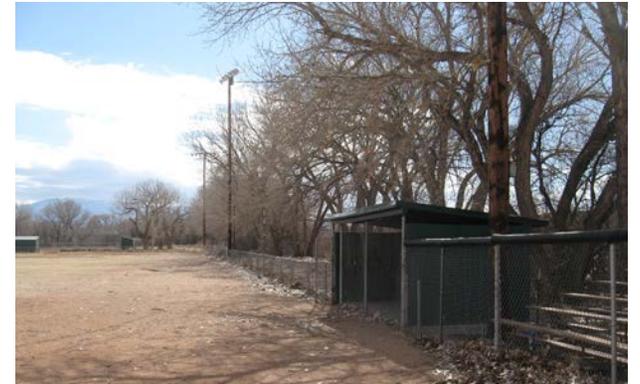
Multi-purpose field and dugout; looking east along river's edge

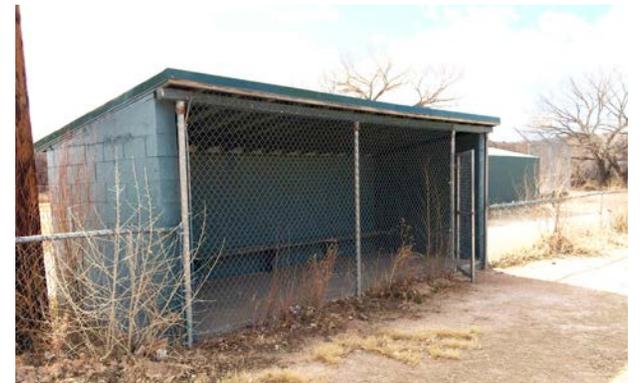
- There are two sets of dugouts around the multi-use field, each 200 sq.ft.
- Dugouts are constructed of CMU blocks and accessible via the field of play. Players are protected by a chain link fence.
- Dugouts are in deteriorating condition due to lack of maintenance.

Multi-purpose field dugout

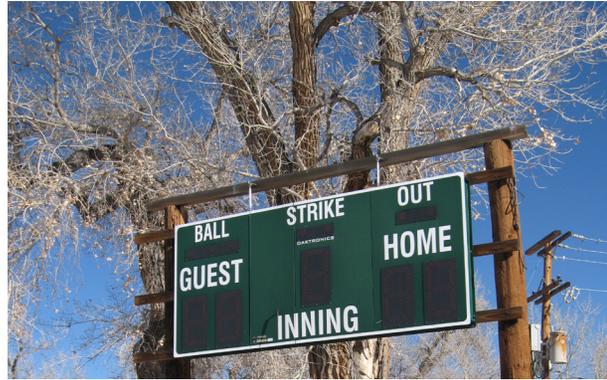
- One scoreboard is located on the north side of the field near the pump building. It is only used during tournaments and is remotely controlled.
- Two poles on the south side of the field mark the location of a former scoreboard. The electrical connections at this location have been energized and have damaged the outlets and the wiring at this location

Scoreboard; multi-purpose field

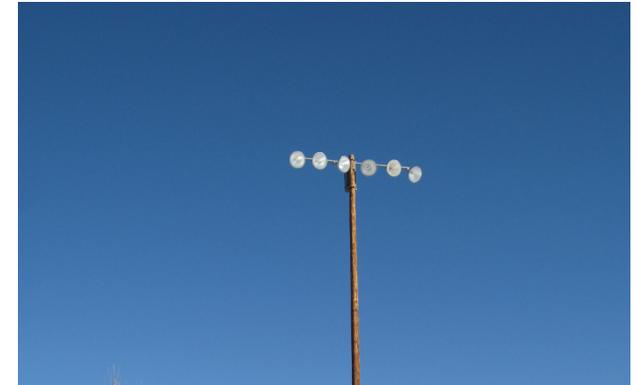
- Sports field lighting is original to the field (1985) and consists of lights mounted on creosote-soaked wooden poles.
- Bulb replacement has to be contracted out (cherry picker needed to replace bulbs)
- The field light fixtures are comprised of an external ballasted enclosure fed by a disconnect at the lower base of the pole.
- Several of the light fixtures have broken lenses which will hamper the lamp life during the fixtures operation.
- The probability of all of the lights to be in working order is unlikely and the work involved to replace the ballasts and relamp the fixtures is costly.
- Parents complain their kids area exposed to concentrations of creosote that collects at the base of the poles.

Multi-Use Field; sports lighting

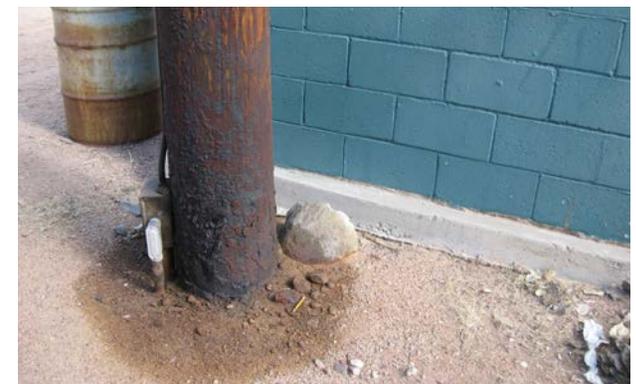
Creosote soaked light pole

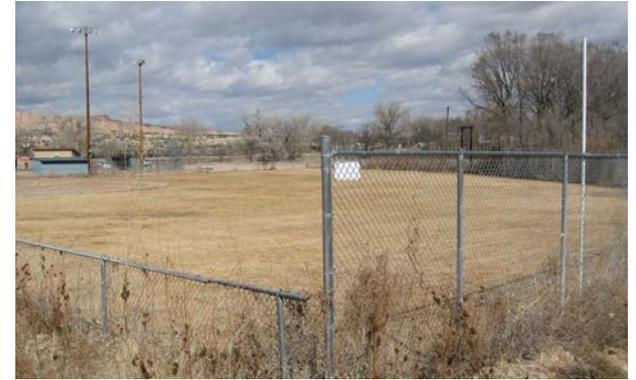
- Softball field grass appears to be well kept
- Turf is thick and well watered. Infields are dragged to minimize Goatsheads.
- The chain link fence around the field perimeter is in good condition.
- The field is accessed via pedestrian gates at the infield and a maintenance gate in left field.
- Fencing around infield is low (3') and may need to be upgraded to 6'.

Softball Field; looking North

- Irrigation: provide routine irrigation system maintenance
- Site Furnishings: install new bleachers (3)
- Scoreboard: install new scoreboard panel onto existing structure
- Lighting: install new sports field lighting
- Dugouts: clean and repaint existing dugouts
- Batting Cage: clean and repair existing
- Fencing: no repairs necessary

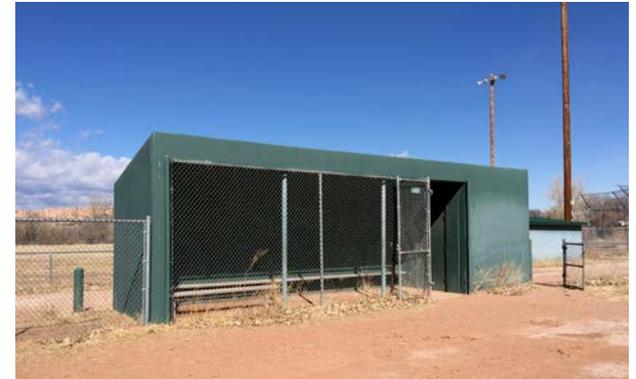
- There is one set of dugouts around the softball field. They are in good condition.
- A chain link fence separates players from the field of play.

Softball Field Dugout

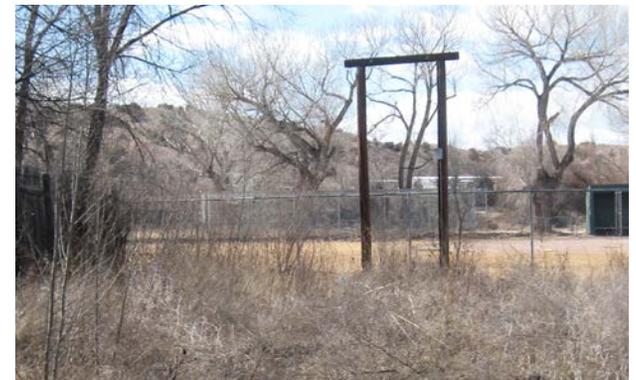
- The softball scoreboard was removed and relocated to the Pojoaque High School.
- steel posts and electrical connections remain outside of the outfield fence, the electrical connections at this location have been energized and have damaged the outlets and the wiring at this location.

Missing softball scoreboard location

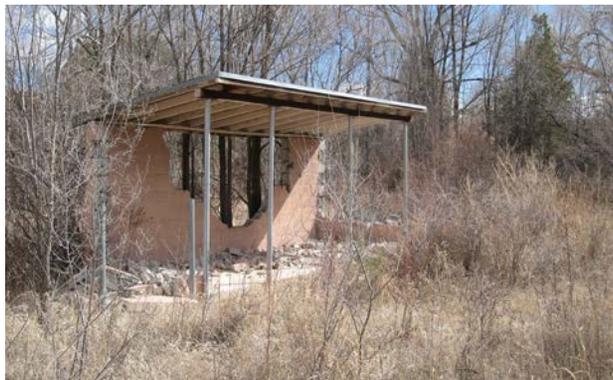
- Two dilapidated dugouts remain in the area. The concrete slab for both dugouts is in good condition.
- One of the dugout walls is damaged.
- The roofs are in good condition but the dugouts are overgrown with vegetation.

One of two existing dilapidated dugouts

- Surfacing: prepare subgrade and reestablish grass surface
- Irrigation: provide new irrigation system, tie into existing system at softball field
- Grading: grade field to establish a smooth, consistent slope, fill in ditches
- Site Furnishings: install new bleachers (3)
- Dugouts: repair existing dugouts, add side walls, and paint finish surface
- Fencing: provide new perimeter chain link fence and access gates, tie into softball field fencing

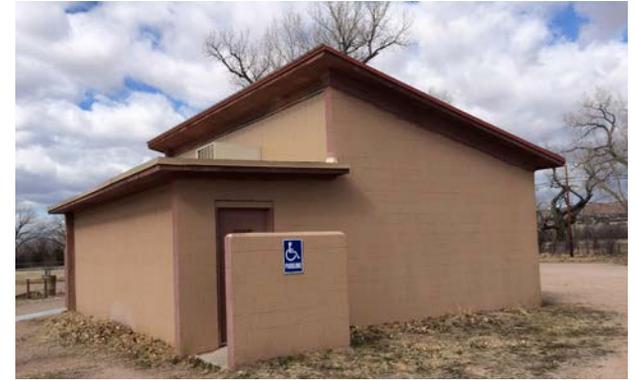
Restroom / Concession Building

- Upgrade restrooms to conform to ADA codes
- Add ADA compliant handrails and increase bathroom stall width in men's and women's restrooms.
- Provide ramp access to restrooms.
- Install exterior lights at the restroom / concession building.
- Re-key locks to match other buildings on site.
- Repair / replace concessions area fixtures to meet NMED codes.

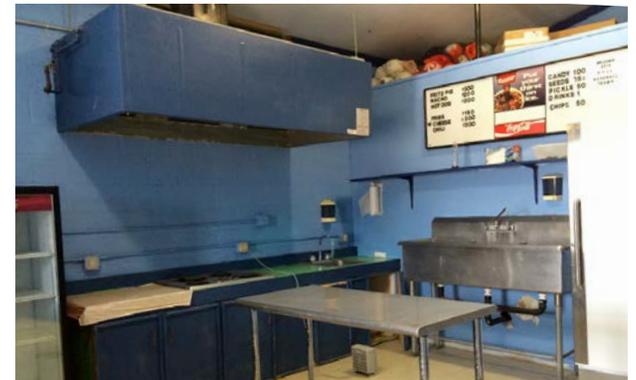
- The concession area houses a range, vent hood, storage space for kitchen equipment and utilities, and a closet.
- The kitchen hood has a roof exhaust but is missing internal filters.
- Food refrigeration is dependent on Leagues supplying their own ice chest during events.
- Hot water heater in **chase** is dated and piping is missing insulation.
- Existing plumbing on southwest wall equipped for ice machine.
- **The bathroom facility was not open for inspection by the team at the time of the site visit. Accessibility issues may be an issue.**
- Maintenance crews let the leagues maintain the restroom buildings during the season.

Restroom / Concession Building Interior

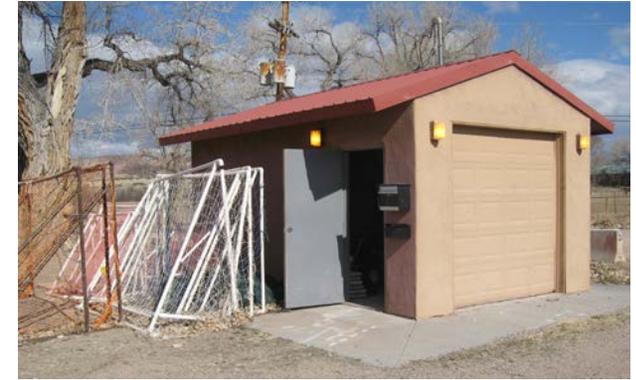
Pump Building

- Remove all items stored by leagues in the pump building; pump building to be utilized for equipment only.
- Electrical Clearances: electrical clearances are not being maintained in accordance with Sec. 110-26 of the National Electrical Code (NEC) 1) Provide at least a 3-ft clearance in front of all electrical equipment, 2) Provide a 30 in. wide working space in front of equipment operating at 600V or less, 3) Provide minimum headroom clearance of 6 ft or the height of the equipment, whichever is greater.
- Heating: replace attic cover (heating for the building may be hampered due to a missing attic cover)
- Pump: set up a routine maintenance schedule for the purging of the debris in pump filter or purchase an automatic filter purge system from the manufacturer.

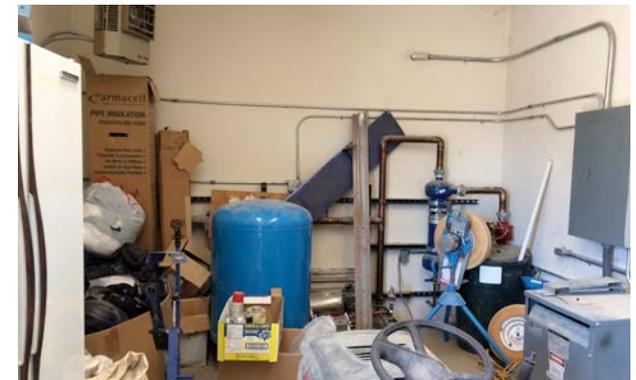
- Heated by an electric heater on the far corner wall with an attic opening nearby. The building electrical system is comprised of a 200 Amp overhead electrical power drop from an existing PNM pole. The main panel is a 480V source serving a 30 KVA transformer to a 208V panel surrounded by the well pump controller and a lighting contractor.
- The main panel is missing the upper and lower metal barriers on the panel cover.
- The domestic water system piping installed contains a Lakos separator that may need to be setup on a maintenance schedule for the purging of the debris in the filter.

Pump Building Interior

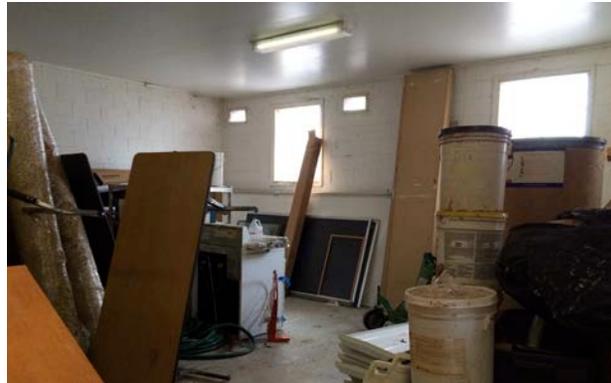
Storage Building Interior

- Clear building of all non-usable items.
- Utilize storage building for league equipment.
- Establish protocol for access, use and cleaning.
- Repair building elements as needed.

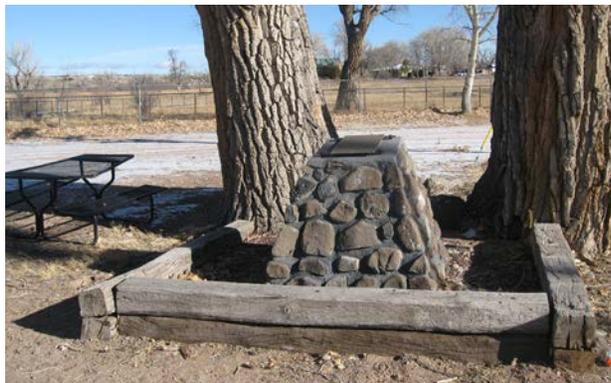
- The memorial is a bronze plaque set on a rock base. Wood timbers separate the memorial base from other use areas.
- The monument may be relocated or redesigned as park improvements are made, but plaque should be preserved.
- There is one picnic table and one fixed BBQ in poor condition, located on site near the monument due to the Cottonwood canopy.

Robert Trujillo Memorial

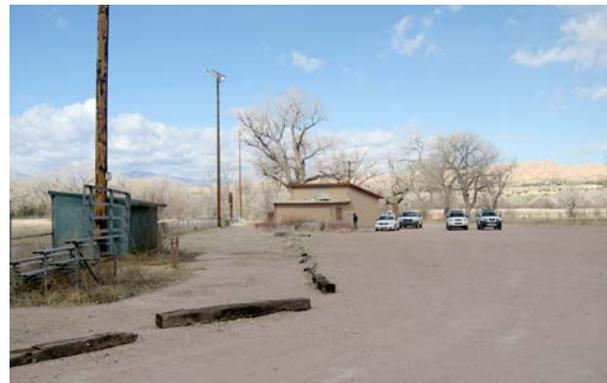
- Due to the lack of structured parking layouts, vehicles drive and park as close to facilities as possible.
- Primary parking is near the restroom/concession building.
- A set of wood railroad ties and jersey barriers near the restroom/concession building prevent people from driving on top of the septic tanks.
- Dirt parking areas are uneven and are likely difficult to use during storm events.
- There is vehicular access to the west side of the site. Parking in this area has degraded the landscape.
- There is limited vehicular access between the softball field and the multi-use field. A few parking spots exist near the batting cage.

Primary parking area looking west

- Efficiency: reconfigure parking area and add parking bumpers for greater parking efficiency
- Surfacing: grade and resurface parking for positive drainage
- Safety: improve parking layout to maximize access with minimal vehicle / pedestrian conflicts, provide fire and safety access, maintain applicable sight distances at intersections
- Accessibility: provide recommended accessible spaces and surfacing per ADA code requirements

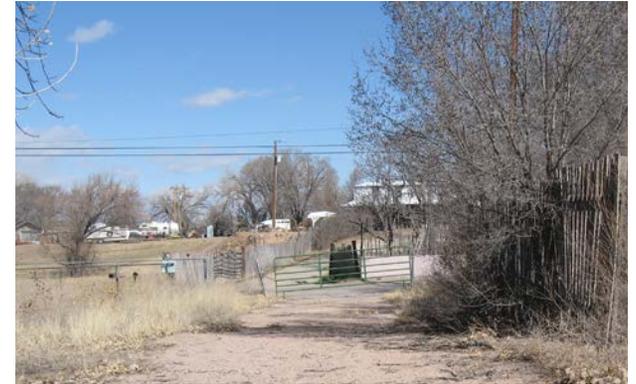
- There are two chain link entry gates along Oweenge Road that permit vehicular access.
- The primary gate (west) is chain link and in good working condition. A pull in driveway allows drivers to pull off the road when opening the gate. The gate is locked when not in use. League representatives and maintenance staff manage the keys.
- There is a pedestrian gate near the west entry gate. It remains unlocked.
- A secondary vehicular gate (east) is only opened during events. Exiting through this gate improves vehicular circulation.

Secondary vehicle access; northern edge

- Repair / replace perimeter fence and access gates along northern and southern edge to establish boundary and designated access points.
- Restrict vehicular access to Rio Tesuque from the site's interior.
- See 'recreation fields' for recreation-related fence and access upgrades.

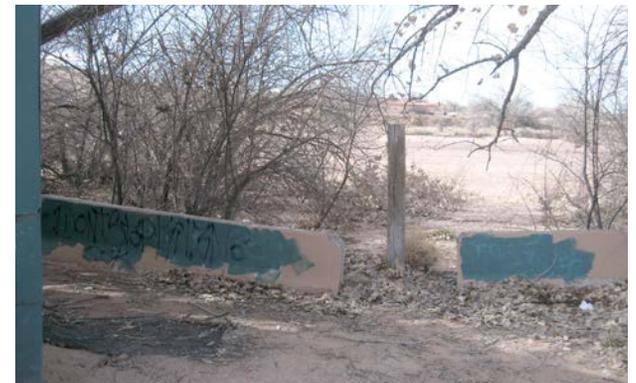
- Six jersey barriers mark the leach field location and prevent vehicles from driving on it.
- There are three clean out pipes near the leach field and two between the restroom building and the leach field. They are in poor condition.

Jersey barriers and access to Rio Tesuque
