# New Mexicans for Responsible Renewable Energy

What is UL9540A

## UL 9540A test has 4 levels

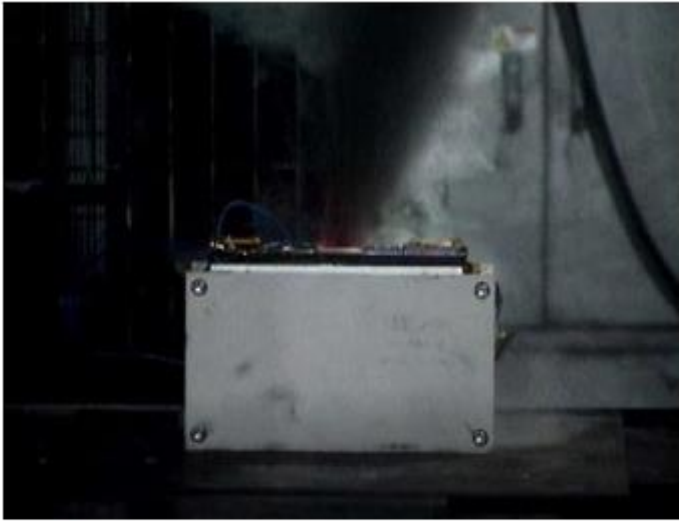
Cell 1 - Immediately before thermal runaway\*  
(00:43:54)

Requirement	Result <b>Cell Test</b>	Verdict
a) Thermal runaway cannot be induced in the cell and	Thermal runaway was achieved in all five cells	F
b) The cell vent does not present a flammable hazard	Cell vent found to be flammable	F

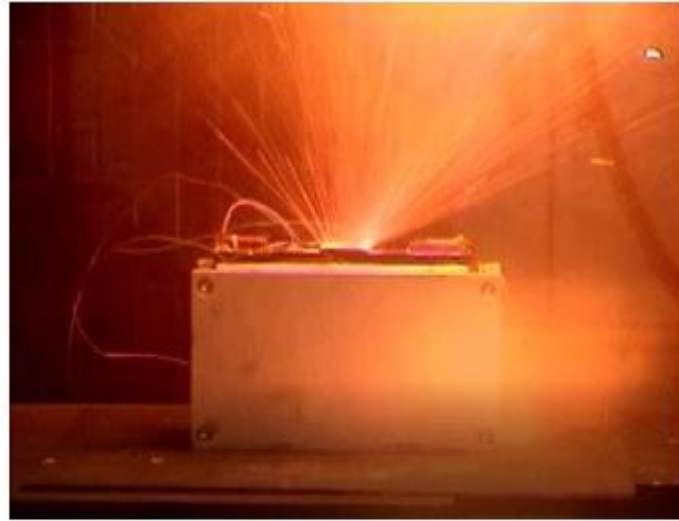
Cell 1 - Thermal runaway (00:43:55)

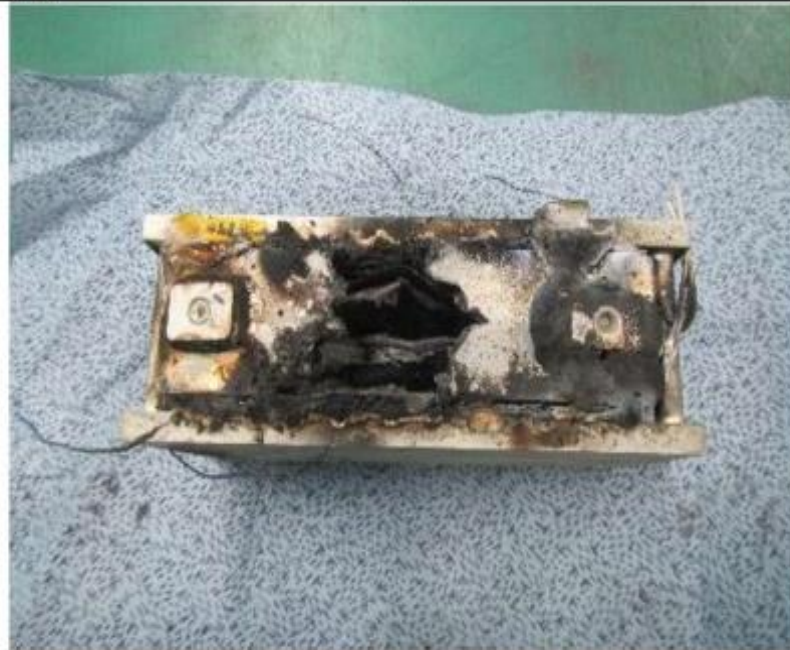
Cell 1 - After the end of test

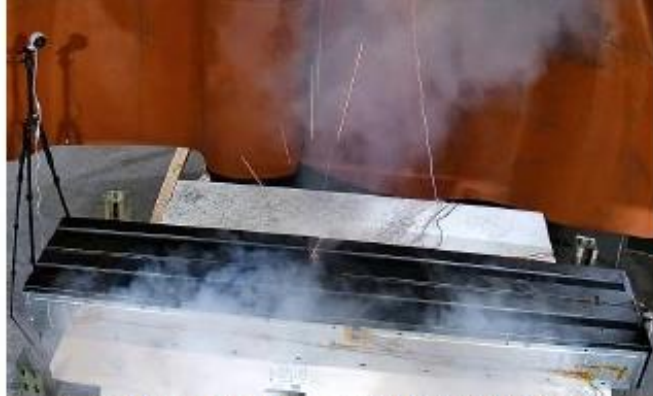
(c) Thermal Runaway (Initiating Cell)  
00:46:14

Requirement	Result <b>Module Test</b>	Verdict
a) Thermal runaway is contained	A single cell infected the majority of the cells	F
b) The cell vent is not flammable	Cell vent found to be flammable	F

Other Observations During Module Test
<p>Flying debris</p> <p>Explosive discharge of gas</p> <p>Sparks or electric arcs</p>

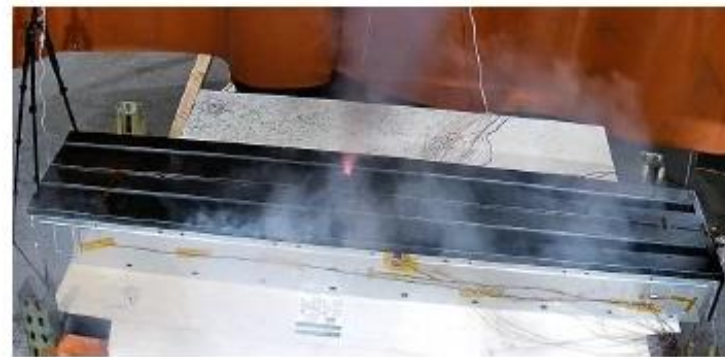
(d) First Flame  
00:46:15

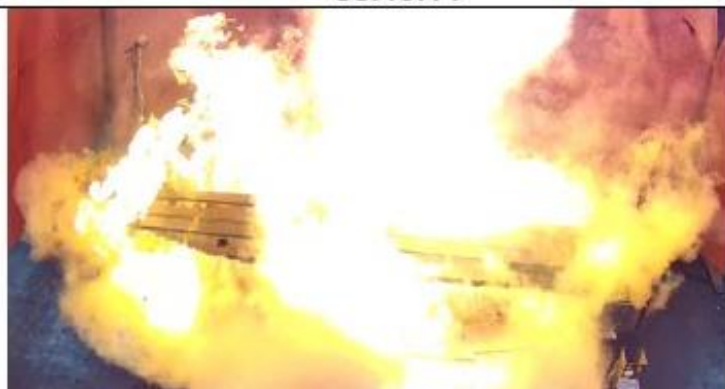
(e) Continuation of Initiating Cell Thermal Runaway  
00:46:18

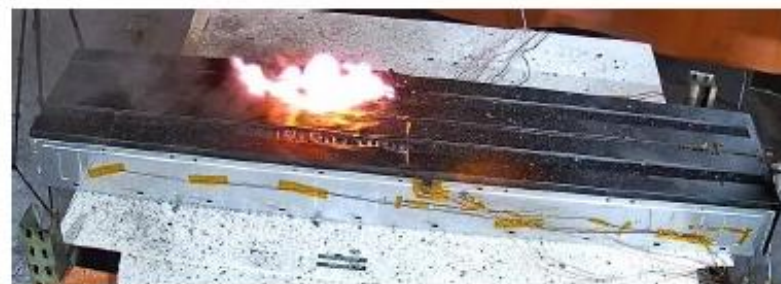
(f) Continued Flaming (post initiating cell thermal runaway)  
00:46:41

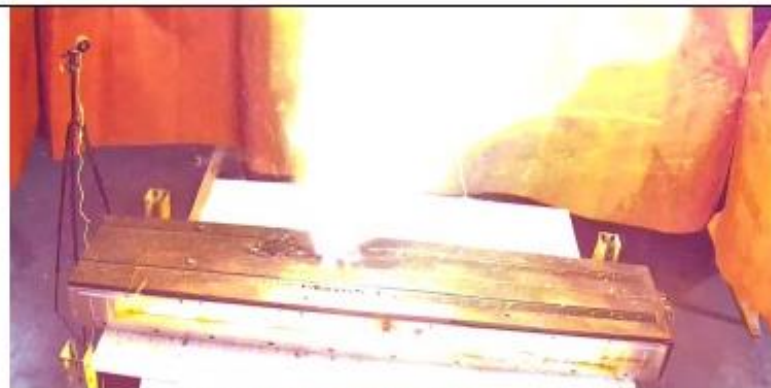
(g) First propagation after Initiating Cell (Cell 35)  
00:58:04

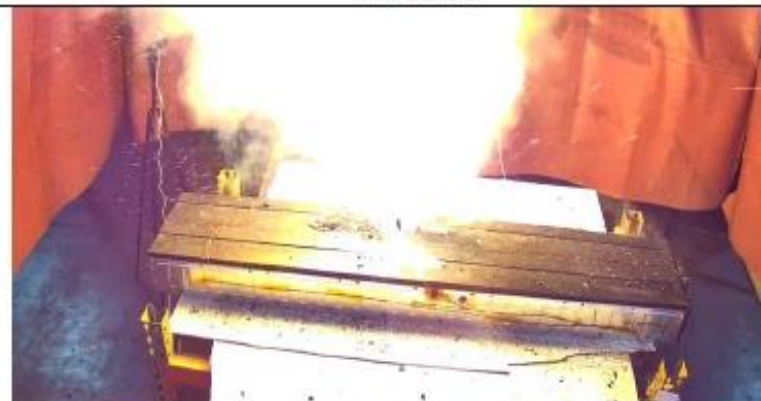
(h) Second propagation After Initiating Cell (Cell 31)  
1:13:49

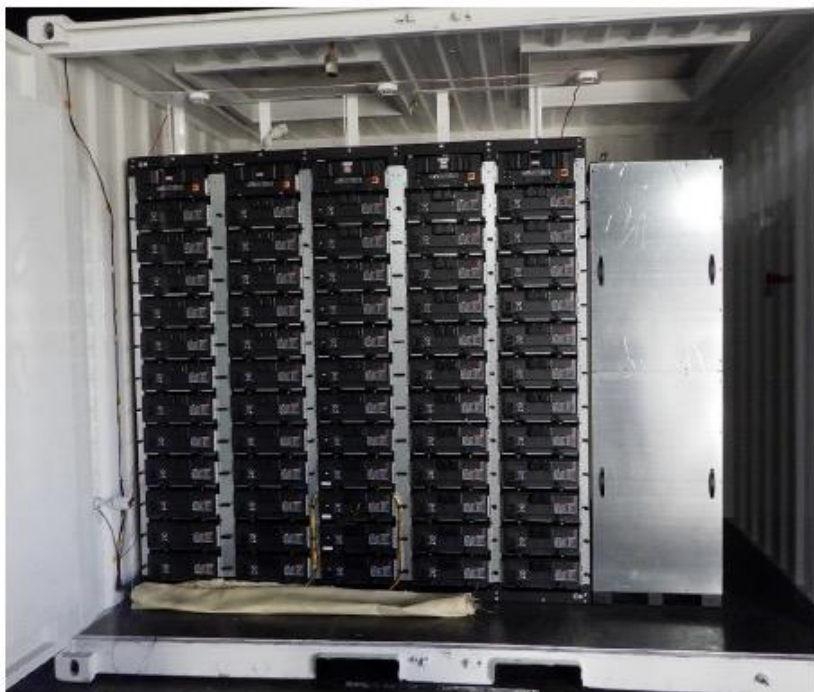
Figure 1 – Picture of the units in the container

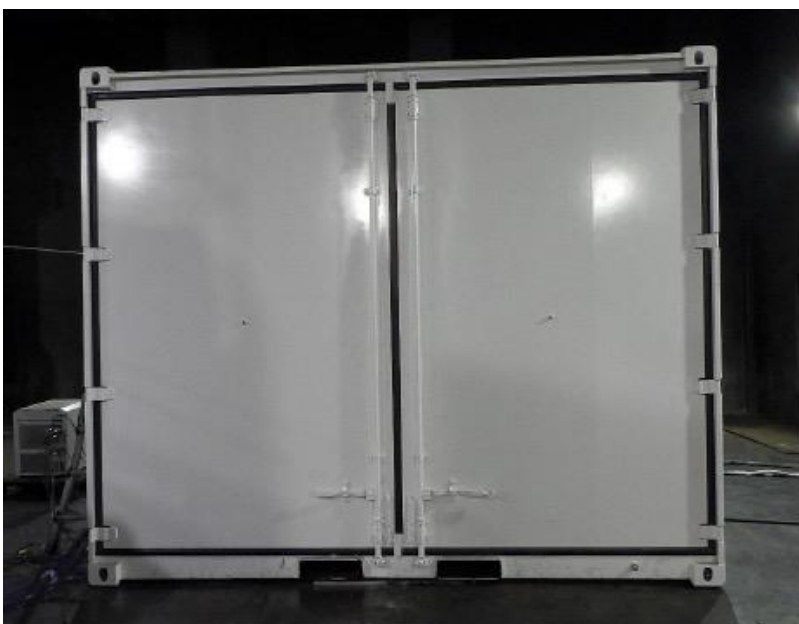
Figure 2 – Picture of the container

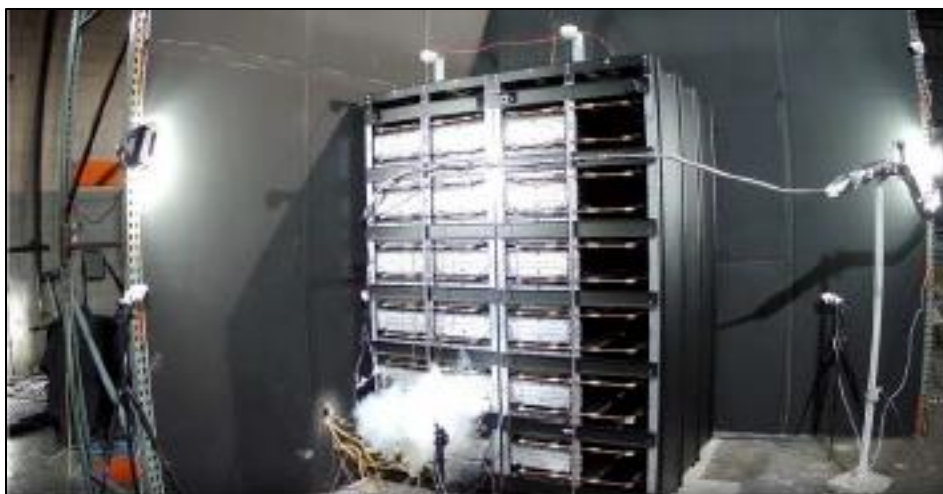
(c) Initiating Unit Thermal Runaway  
[00:42:25]

Requirement	Result <b>Unit</b> Test	Verdict	Other Observations During Unit Test
a) Flaming outside the BESS is not observed	Flaming outside the BESS was observed	F	Flaming outside of unit Explosive discharge of gas Gas analysis: 3340.26 L of total hydrocarbons 343.97 L of carbon monoxide
b) Surface temperatures on walls do not exceed 97°C	Maximum surface temperature was 169°C	F	
c) Heat flux on the center did not exceed 1.3kW/m <sup>2</sup>	Heat flux measured 6.74kWm <sup>2</sup>	F	Post Test Observations Thermal runaway behaviour during disposal

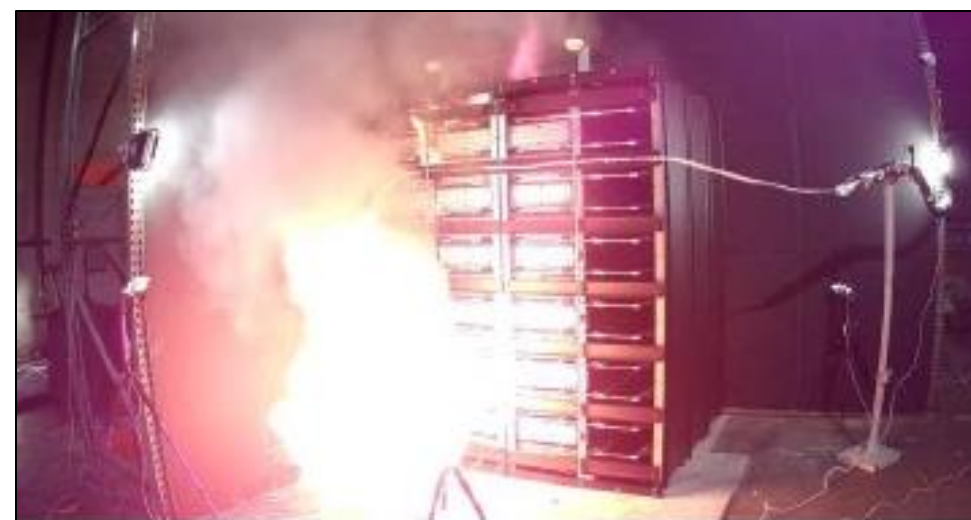
(d) Ignition  
[00:42:30]

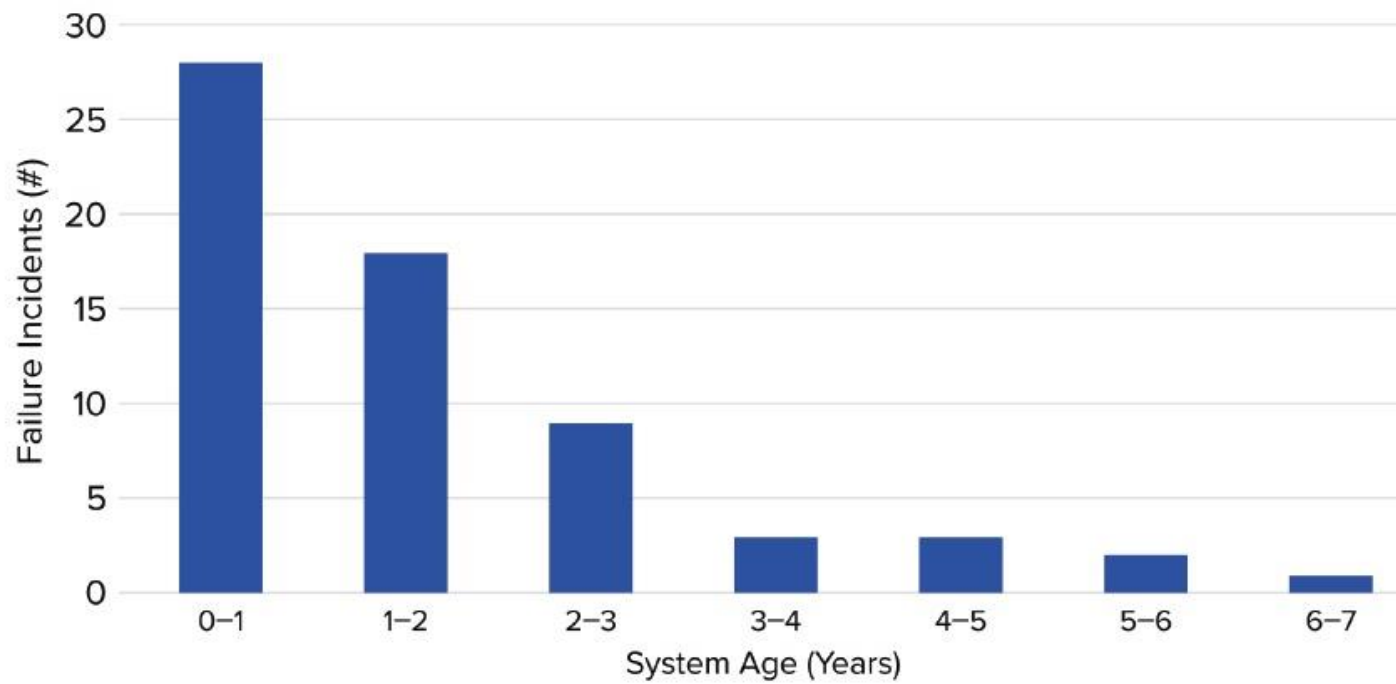
**Figure 5.** BESS Age at Failure, where known

Location	Age at incident
Moss Landing	0.5
Moss Landing	0.8
Moss Landing	1
Moss Landing	4
Escondido	7.6
San Diego	3.7
Idaho Melba	Pre-commission
Valley Center	0.2 and 1.6
NY, Warwick	0.1 and 0.1
NY, East Hampton	4.8
Rio Dell	4
AZ Chandler	3
AZ Surprise	2.1

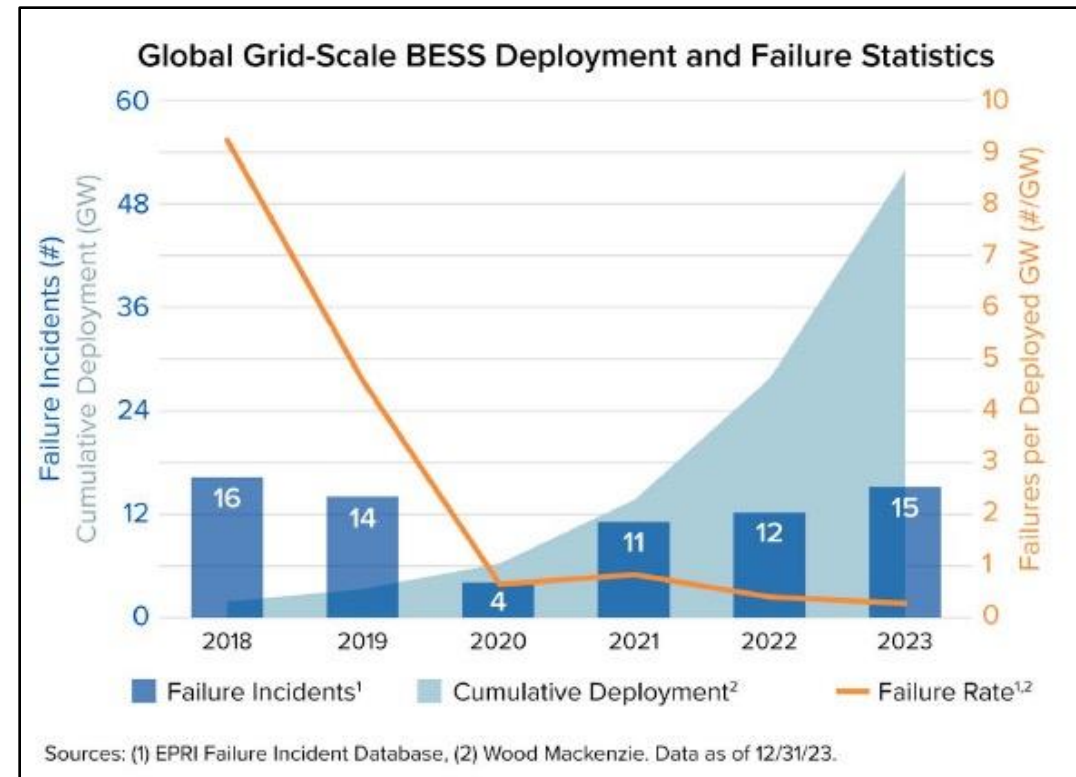
Stationary BESS failure incidents	Other lithium ion storage failure incidents
2020	4	-
2021	11	5
2022	12	7
2023	15	5
2024	6	15
2025	1	-
