**June 13, 2024 CSA Group test report on AES  
detection/suppression system**

**CSA GROUP**  
**Laboratory Test Data - Custom Test (Installation Level)**  
**ORIGINAL TEST DATA**

Master Contract:	N/A	Model:	AES Spec CEN-E5S Enclosure	Page number 1 of 36
Project / Network:	80202692	Description:	Energy Storage Installation

**Test Summary – Container System BESS Installation Level**

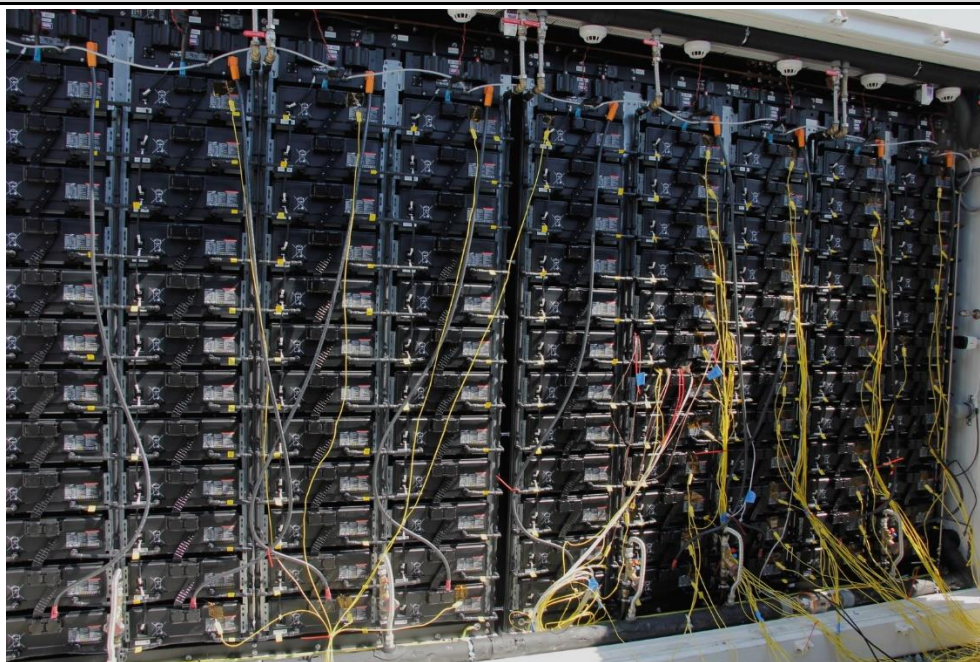
Figure 2.1: Interior of initiating container, Unit Racks 2-10 up to the dividing barrier between Unit 10 and Unit 11

b) The setup (i.e. type, quantity and positioning) of equipment for initiating thermal runaway in the module is same as that used to initiate and propagate thermal runaway within the module level test (Section 8).	<input type="checkbox"/> Conformed Alternative initiation method used compared to module level test. 480 Watt heater placed on a single surface of Cell 1 and insulated to the cover. See Figure 2.1.  Cell heating ramp of 6.79 °C/min achieved.

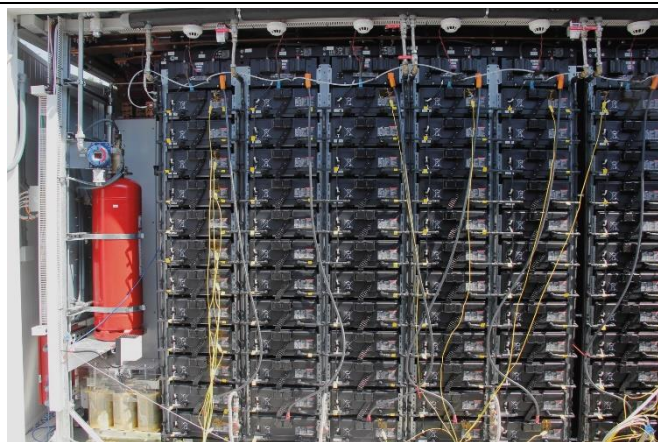
Figure 2.2: Instrumented Units 1-6 and NOVEC cylinder in container

a) The position of the module selected to present the greatest thermal exposure to adjacent modules (e.g. above, below, laterally), based on the results from the module level test; and	<input checked="" type="checkbox"/> Conformed Module 6 the mid height of Unit 8 was selected. See Figure 2.2.

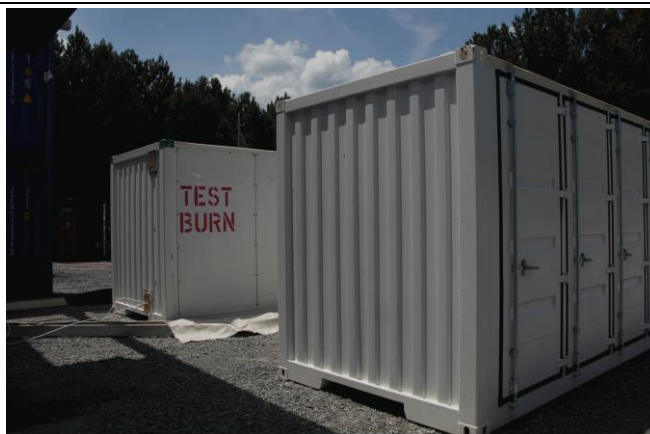
Figure 2.3: Initiating and target containers sealed and in the test area

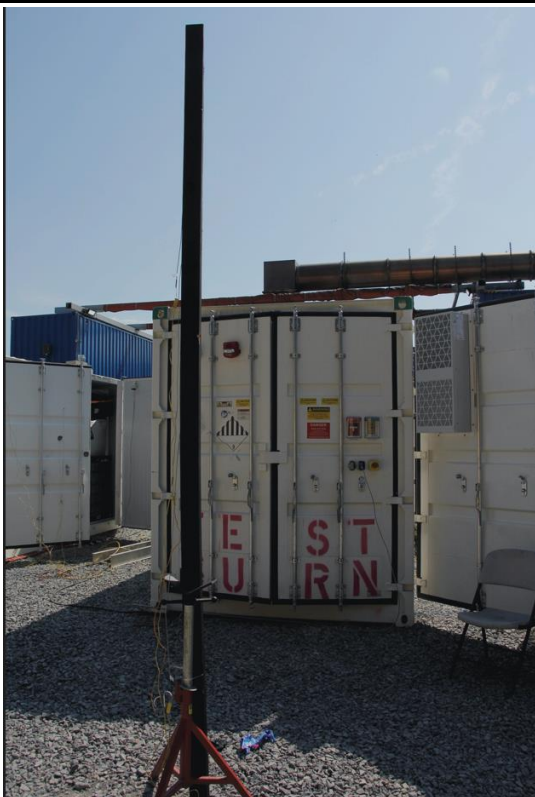
Figure 2.4: [Location of instrumented column near container](#)

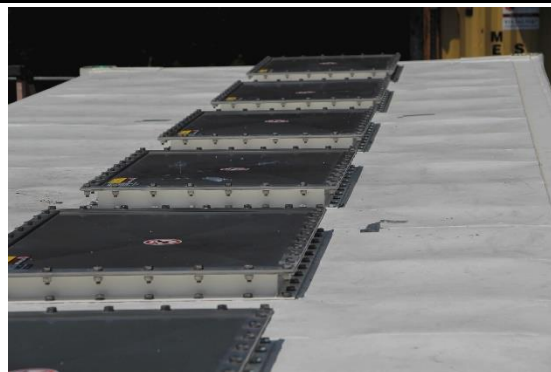
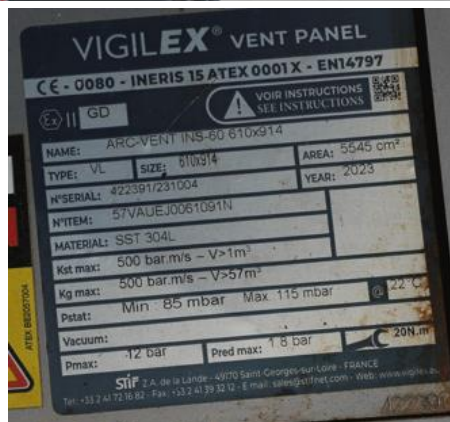
Figure 2.5: [Location and specification of deflagration panels on top of container](#)

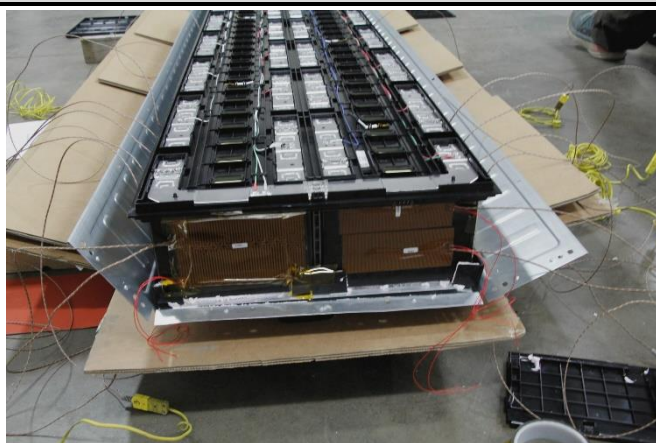
Figure 2.6: [Location of primary \(left\) and secondary \(right\) film heaters on Cells 1 and 2, respectively](#)

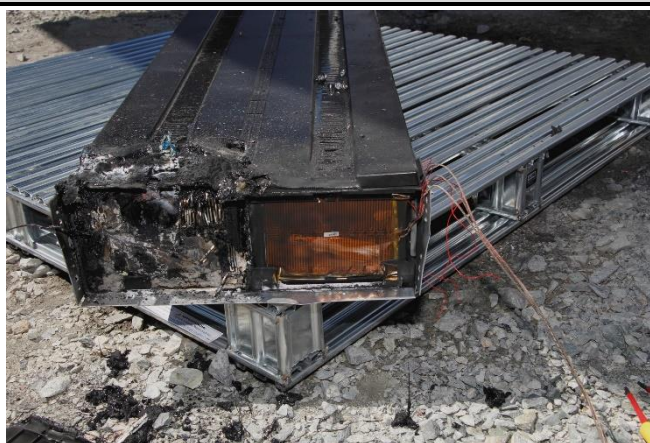
Figure 2.7: [Pre-Test conducted on single module to confirm propagation from Cell 1 to Cell 3, post test damage](#)

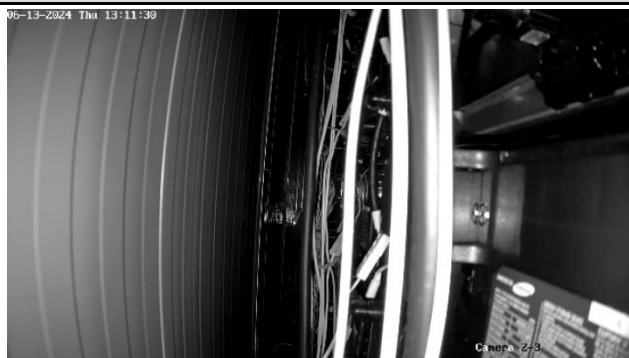
Figure 2.8: At test start (Time in 13:11)

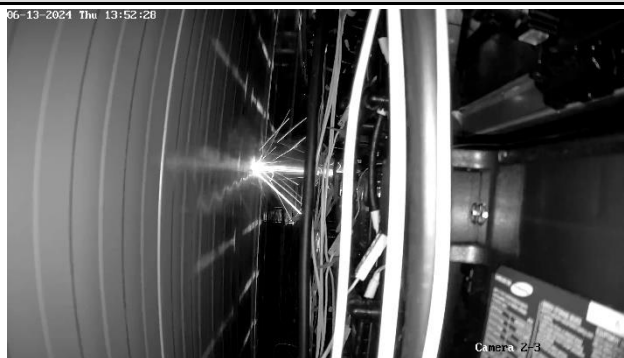
Figure 2.9: During cell venting (Time in 13:52)

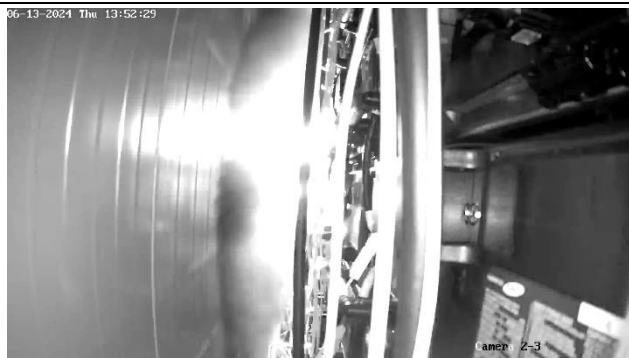
Figure 2.10: During thermal runaway (Time in 13:52)

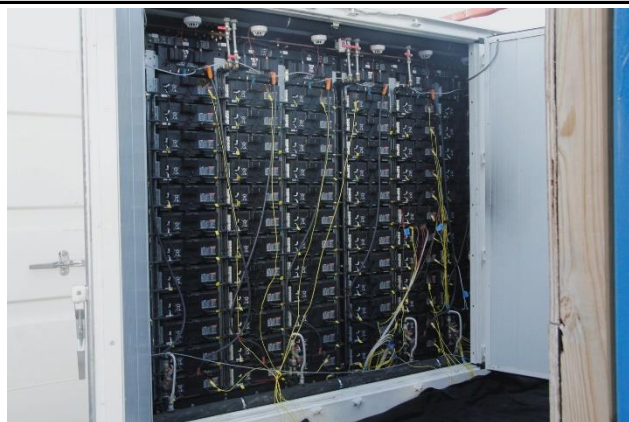
Figure 2.12: After test stopped

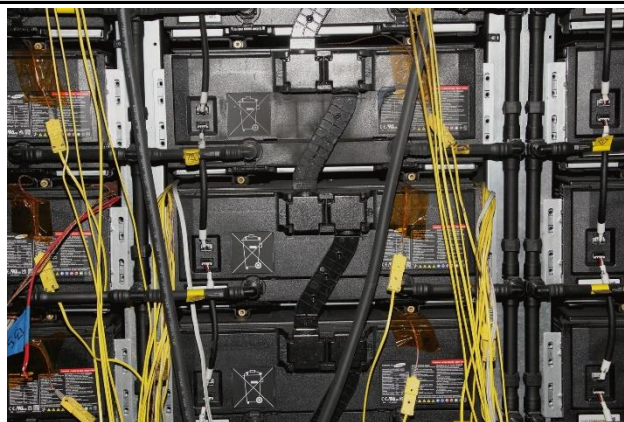
Figure 2.13: After test initiating module

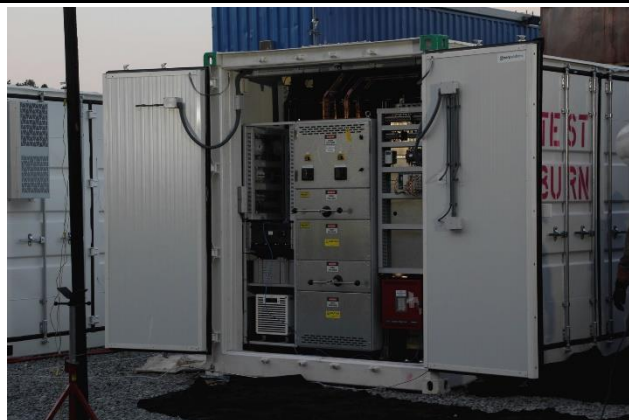
Figure 2.14: After test container

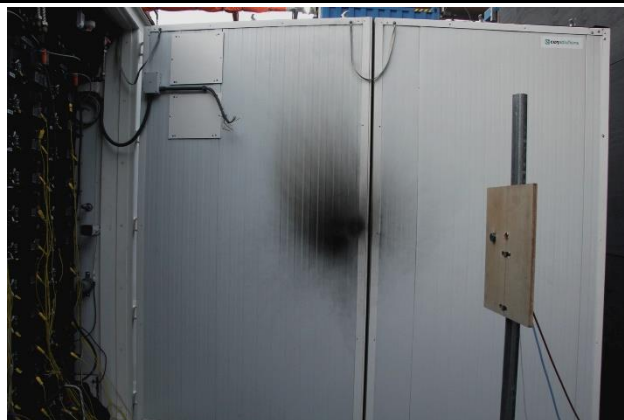
Figure 2.15: After test initiating module soot

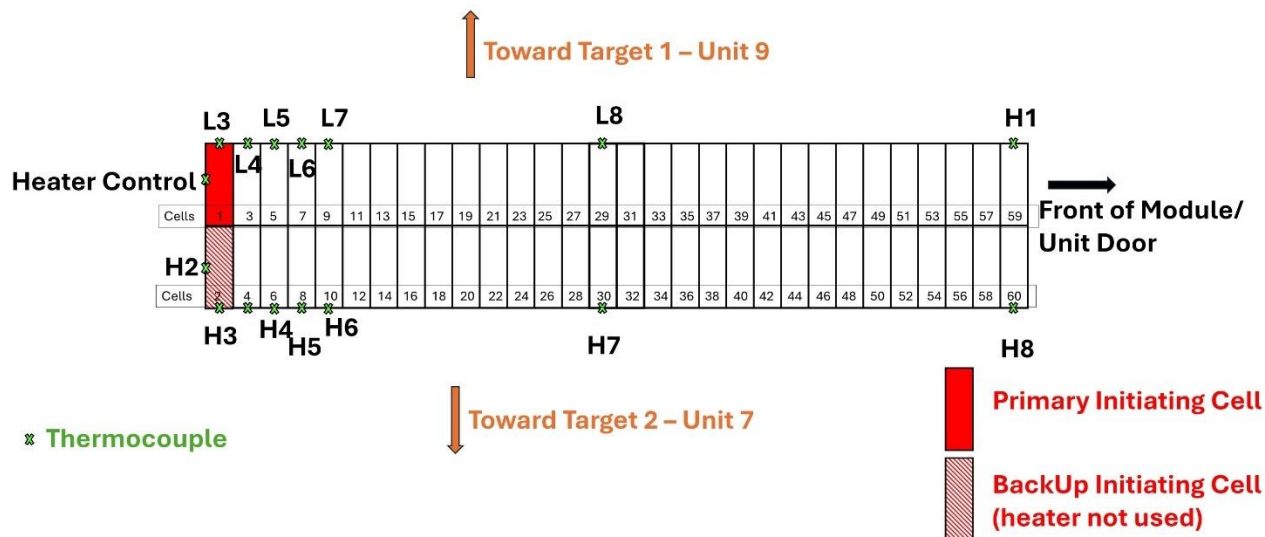
Location	Lab ID Code
Cell 1	L3
Cell 3	L4
Cell 5	L5
Cell 7	L6
Cell 9	L7
Cell 29	L8
Cell 59	H1
Cell 2	H2
Cell 4	H3
Cell 6	H4
Cell 8	H5
Cell 10	H6
Cell 30	H7
Cell 60	H8

The 200 W, 120 VAC heater was placed on the rear surface of Cell 1 only. A layer of approximately 1 inch of rock wool insulation was then placed between the heater and the module casing to direct heat toward the cell.

**Figure 2.1: Placement and Test Lab ID Code of thermocouples and heaters in the initiating module**

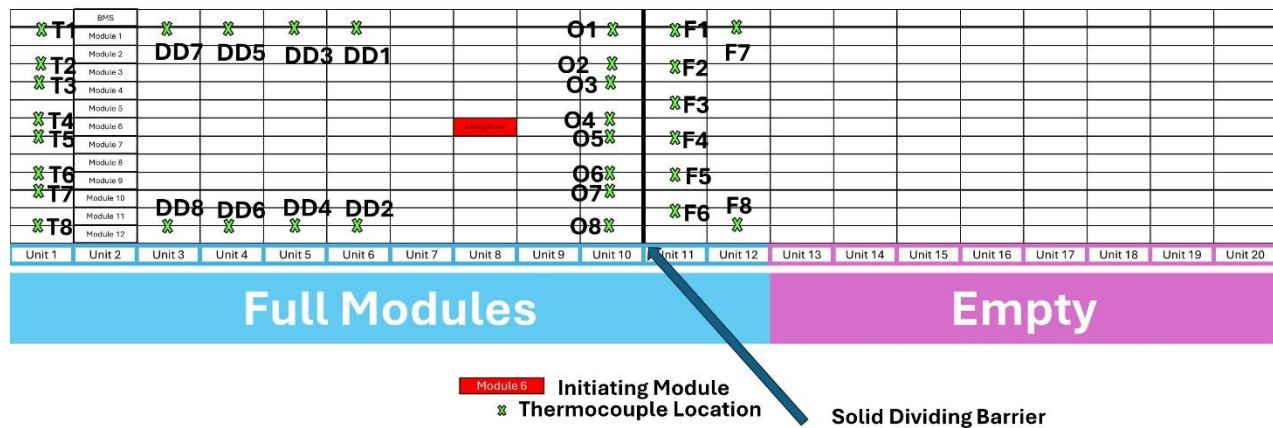
Figure 2.3 Placement and of thermocouples on modules in the container and the location of modules populating the Unit Racks in the Container

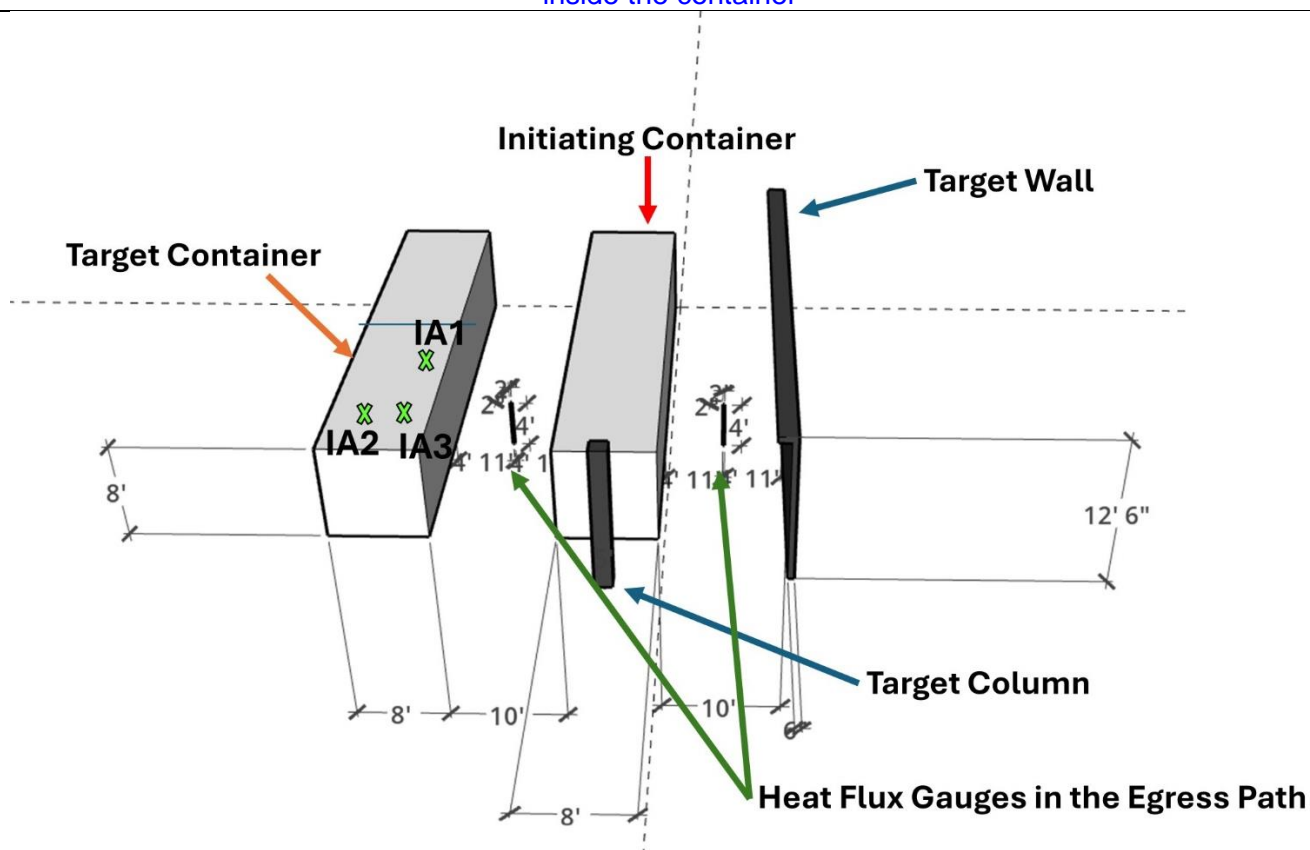
**Figure 2.5** Overall Arrangement of the test area

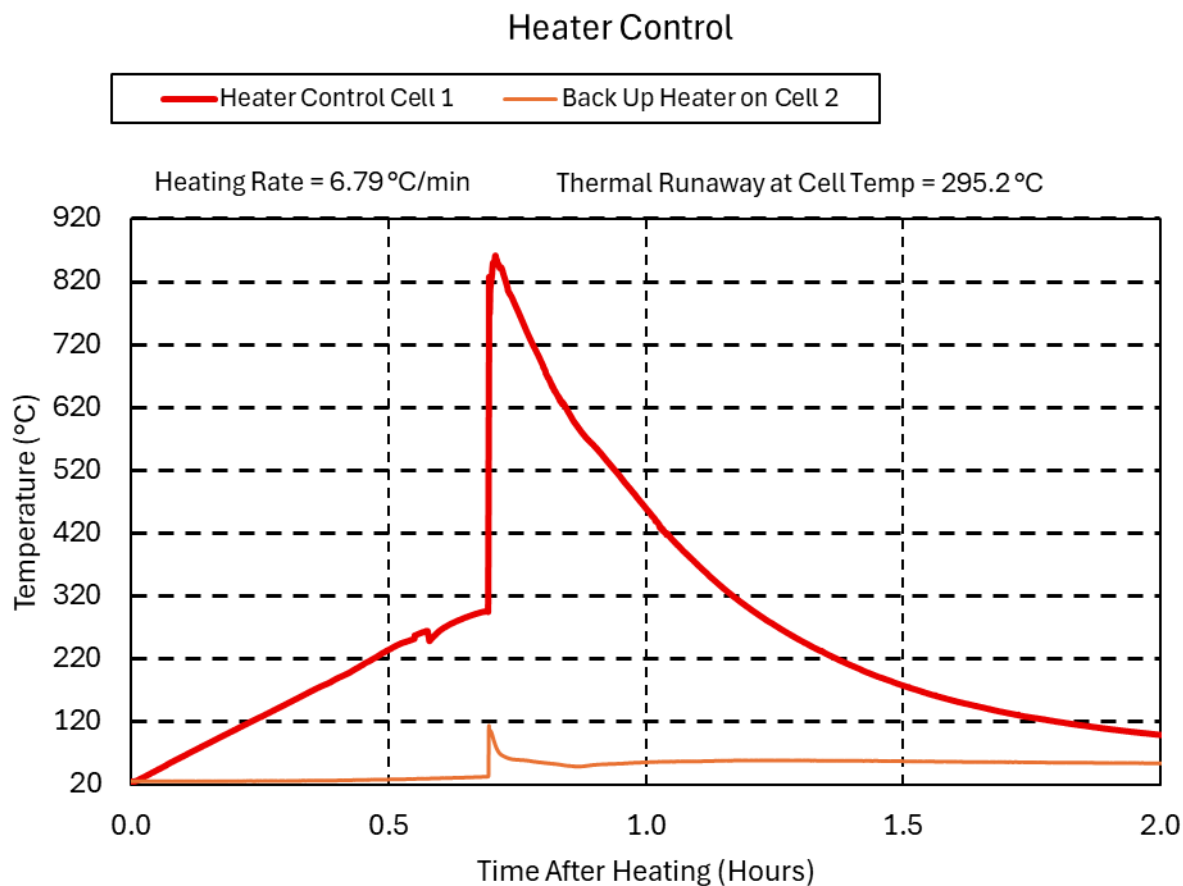
Gaps in the data occurred due to noise from selected TC channels, as the offending channels were identified and disconnected some batch data just before and after thermal runaway has been omitted.

**Figure 3.1: Heater temperature on Cell 1 and Cell 2 (not heated, only backup)**

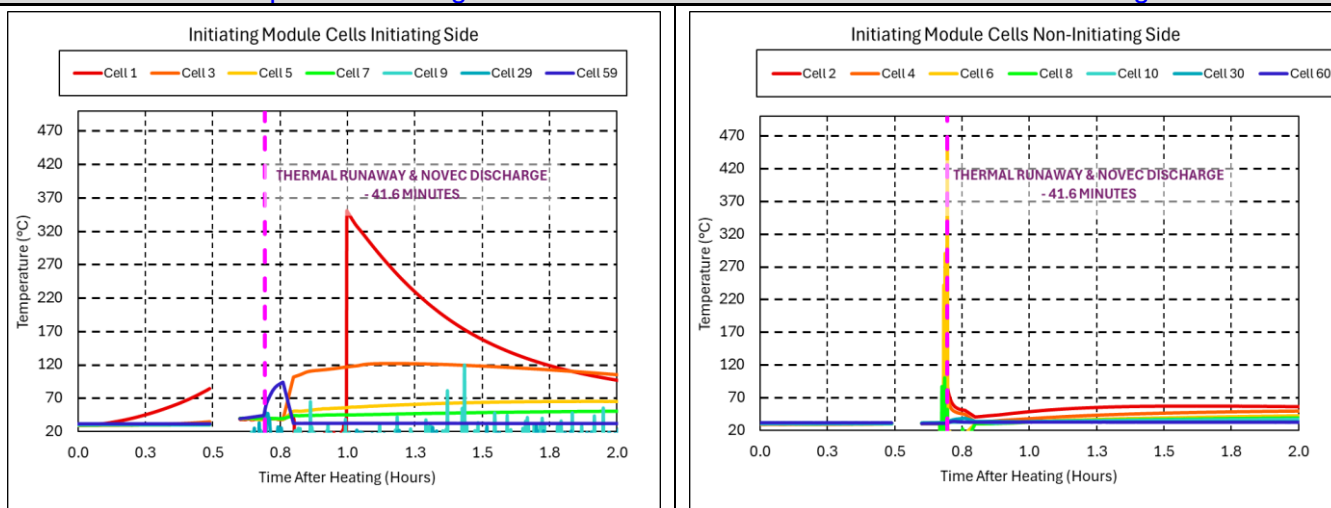
Gaps in the data occurred due to noise from selected TC channels, as the offending channels were identified and disconnected some batch data just before and after thermal runaway has been omitted.

**Figure 3.2 Temperatures of Cells in the Initiating Module**

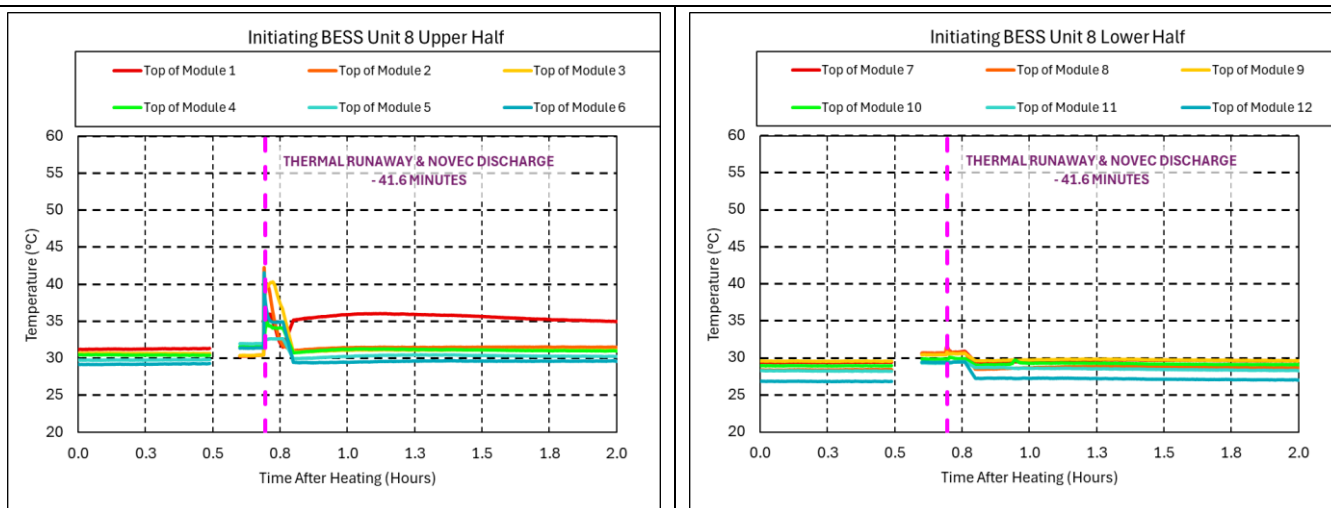
**Figure 3.3 Temperatures of Modules in the Initiating Rack (Unit 8)**

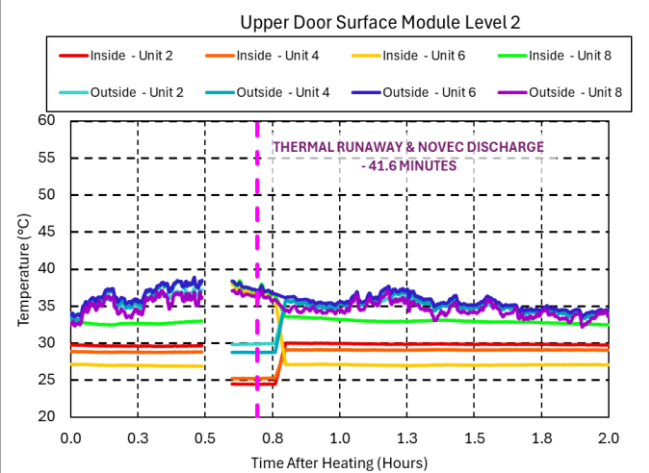
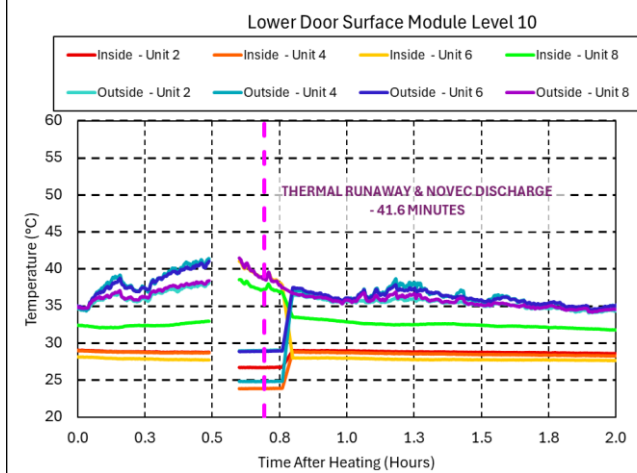
Gaps in the data occurred due to noise from selected TC channels, as the offending channels were identified and disconnected some batch data just before and after thermal runaway has been omitted.

**Figure 3.6 Temperatures of The Inner and Outer Surface of the Door**

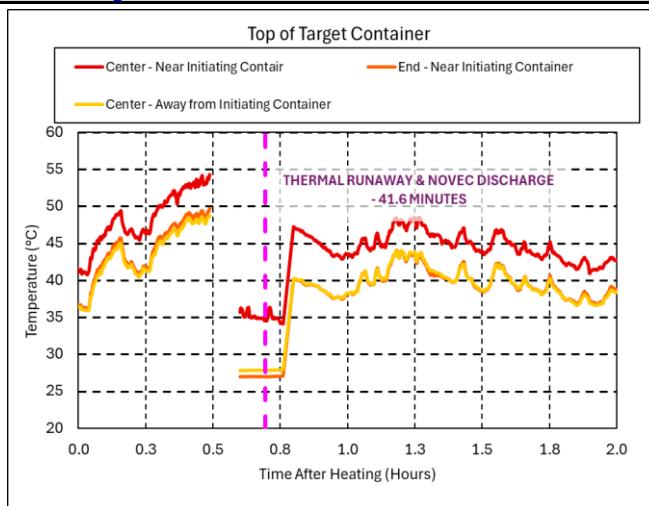
Gaps in the data occurred due to noise from selected TC channels, as the offending channels were identified and disconnected some batch data just before and after thermal runaway has been omitted.

Figure 3.8 Temperatures on the top surface of the target container

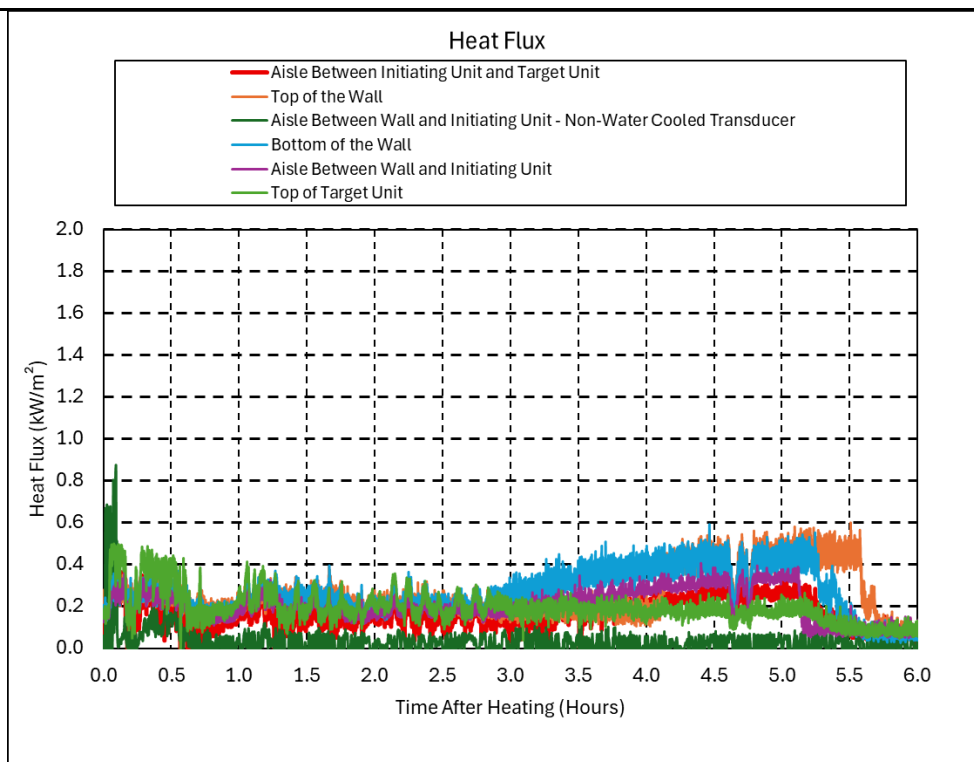
**Figure 8.1 Heat Fluxes measured at various locations**
