**June 14, 2024 CSA Group test report on AES  
deflagration panels**

## Laboratory Test Data - Internal Deflagration Test Report

Master Contract:	6023038	Model:	AES Spec CEN-E5S Enclosure	Page number 1 of 22
Project / Network:	80202693	Description:	Container BESS

### Executive Summary

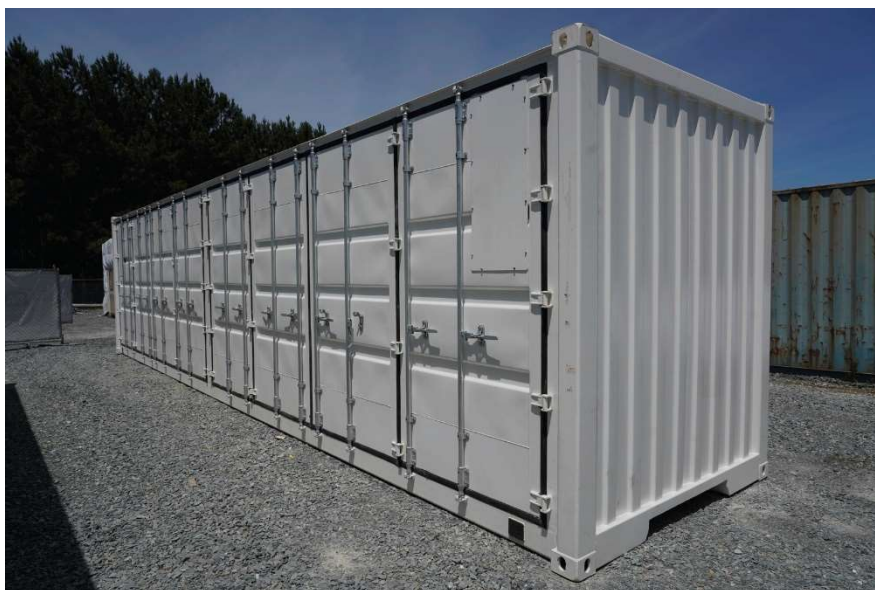
Figure 1: [Photograph of the DUT enclosure](#)

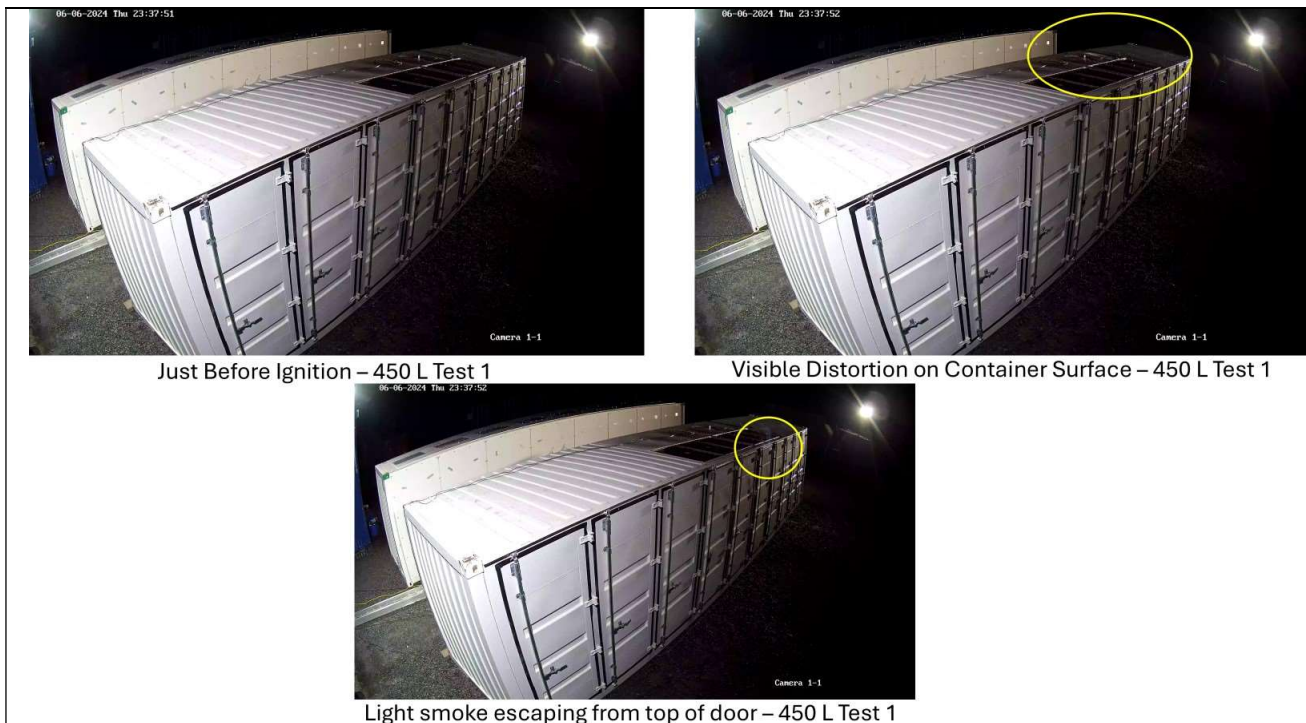
**Figure 8: Container stress distortion and light smoke escaping from the door – Test 1**

\*\*\* Test 1 did not activate the deflagration panels but a small puff of smoke escaped the container through a door seal. Test 2 released all three panels, caused the internal barrier wall to collapse, and produced an external flame. No other damages to container or the inert fill materials were observed.

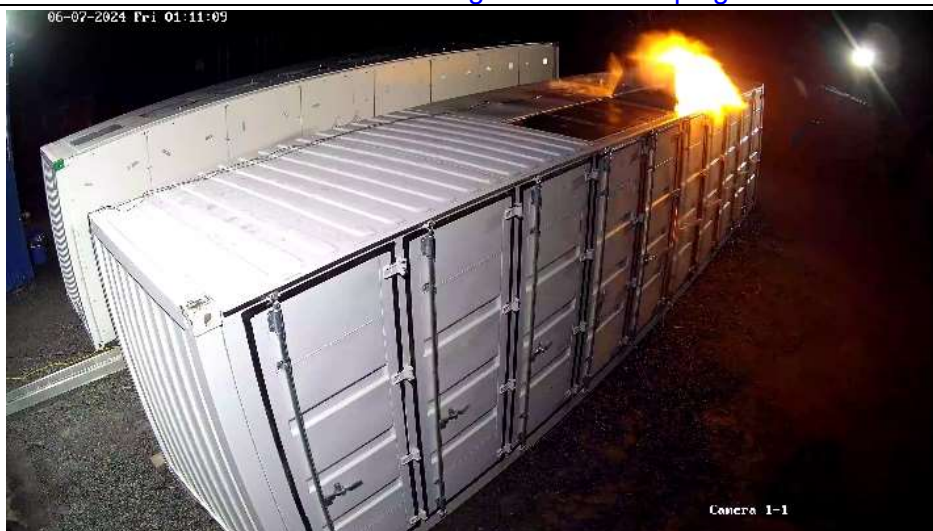
**Figure 9: Flames ejected from deflagration panels as viewed from the rear of the container – Test 2**

The test was then repeated with a larger gas air volume of 750 L. Ignition of the 750 L volume resulted in maximum pressures of 3.13 psi and release of all three deflagration panels on the top of the container and ejection of a visible flame. This test also resulted in minor damage to the internal barrier wall of the container. No other damages to container or the inert fill materials were observed.

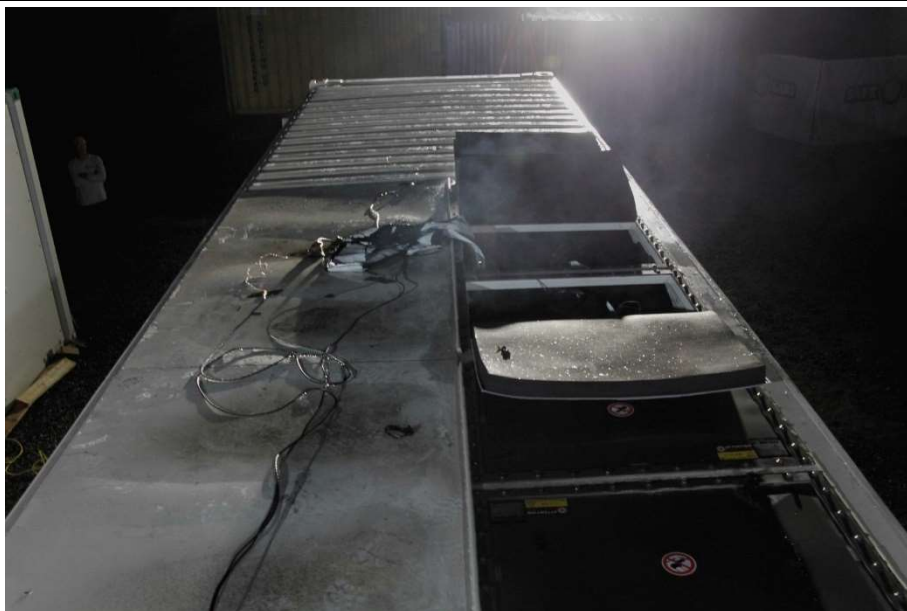
Figure 10: Deflagration panels post-test 2

Post-test analysis consisted of inspecting the DUT for the extent of damage. The deflagration panels were only activated during the second test (750 L). The internal divider wall in the center of the container also collapsed during Test 2. The collapse of the wall would provide a volume for expansion of hot gases and reduction of overall measured test pressure in the container if the collapse occurred earlier than or faster than the activation of the deflagration panels. No other damages to container or the inert fill materials were observed.

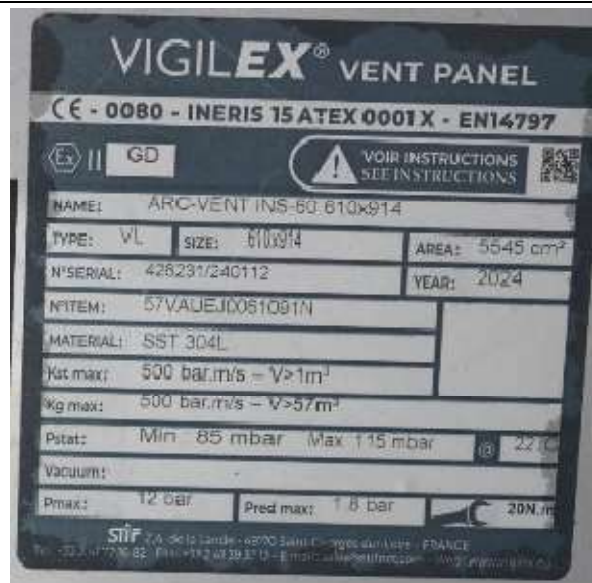
Figure 1.4: Vent panel label (top of container)

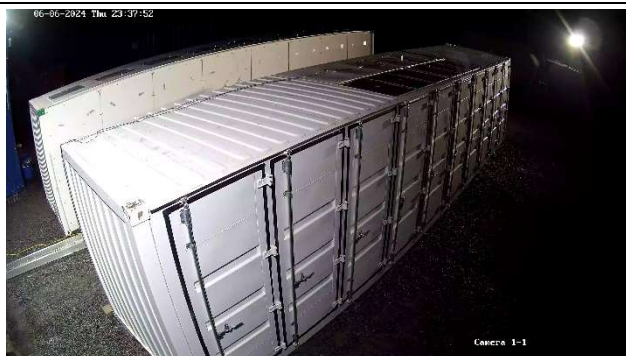
**Figure 1.7: DUT at time of ignition, note small puff of smoke from top of door (23:37:52) (Camera 1-1)**

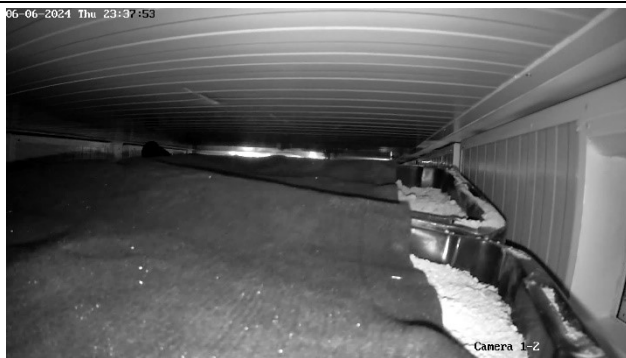
**Figure 1.9: Inside of DUT immediately after ignition, flame still visible as light in back of DUT (23:37:53) (Camera 1-2)**

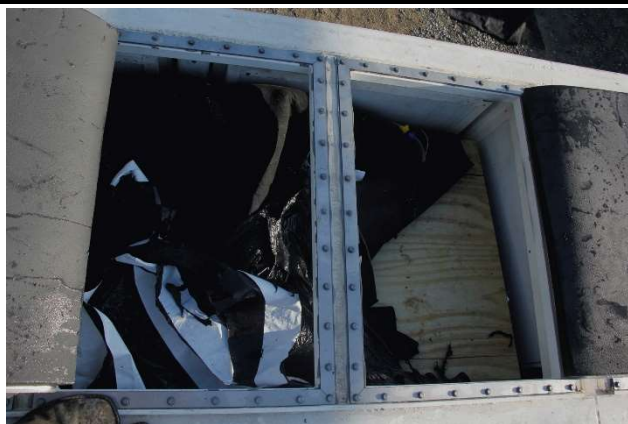
Figure 127: Inside of deflagration panel through roof after test 2 showing remains of gas containment vessel inside of DUT

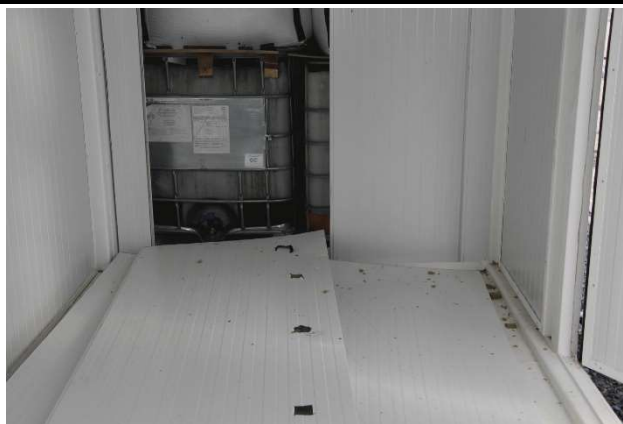
Figure 1.28: Inside of DUT after test 2 showing collapsed divider wall

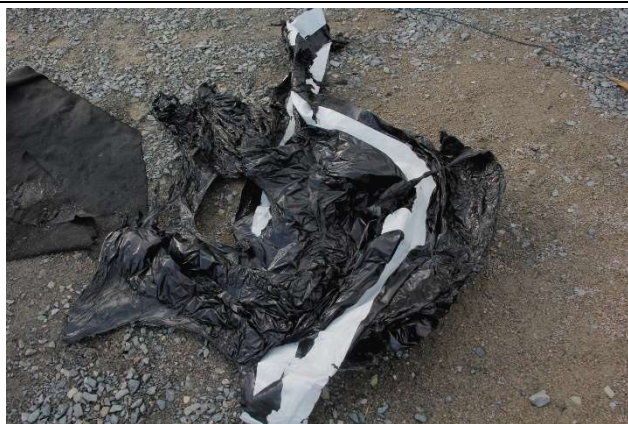
Figure 1.29: Gas containment vessel removed from DUT after test 2
