# Aquatic Resources Inventory Report for the Rancho Viejo Solar Project in Santa Fe County, New Mexico

MAY 2022

PREPARED BY  
**SWCA Environmental Consultants**

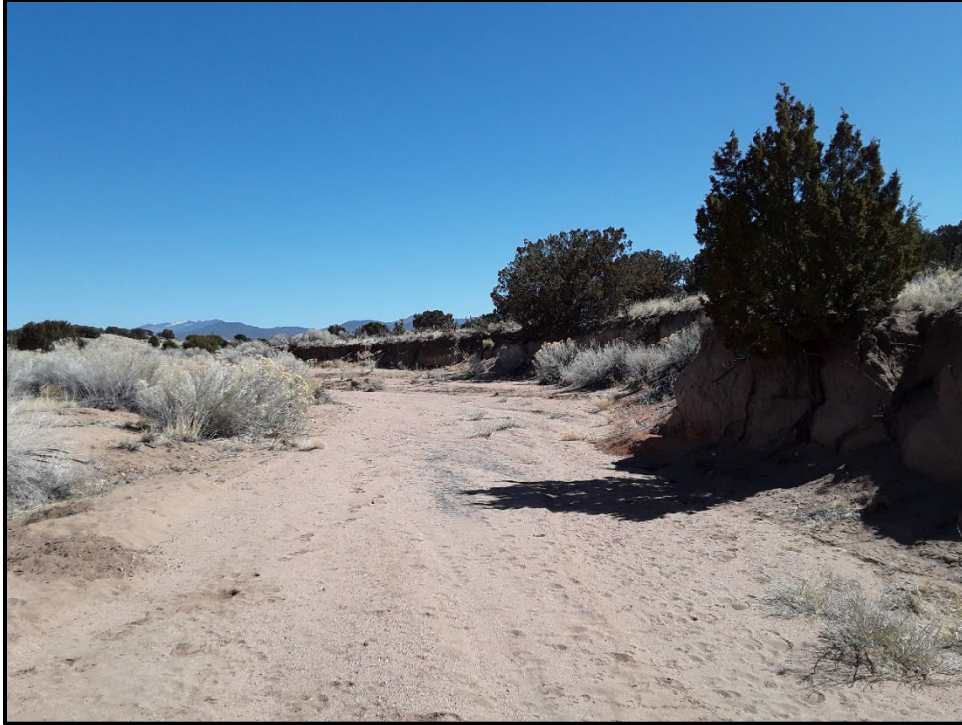
**Figure C-5. NHD-mapped water feature and NWI-mapped riverine wetland feature (Gallina Arroyo) from north of the proposed project area, facing northeast (upstream).**

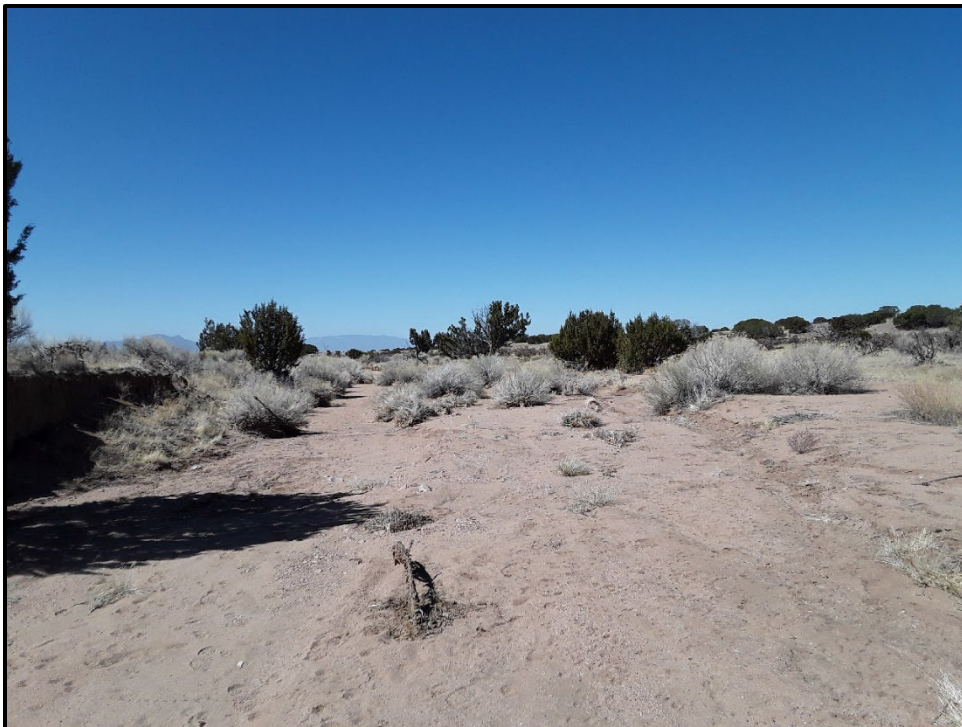
**Figure C-6. NHD-mapped water feature and NWI-mapped riverine wetland feature (Gallina Arroyo) from north of the proposed project area, facing southwest (downstream).**

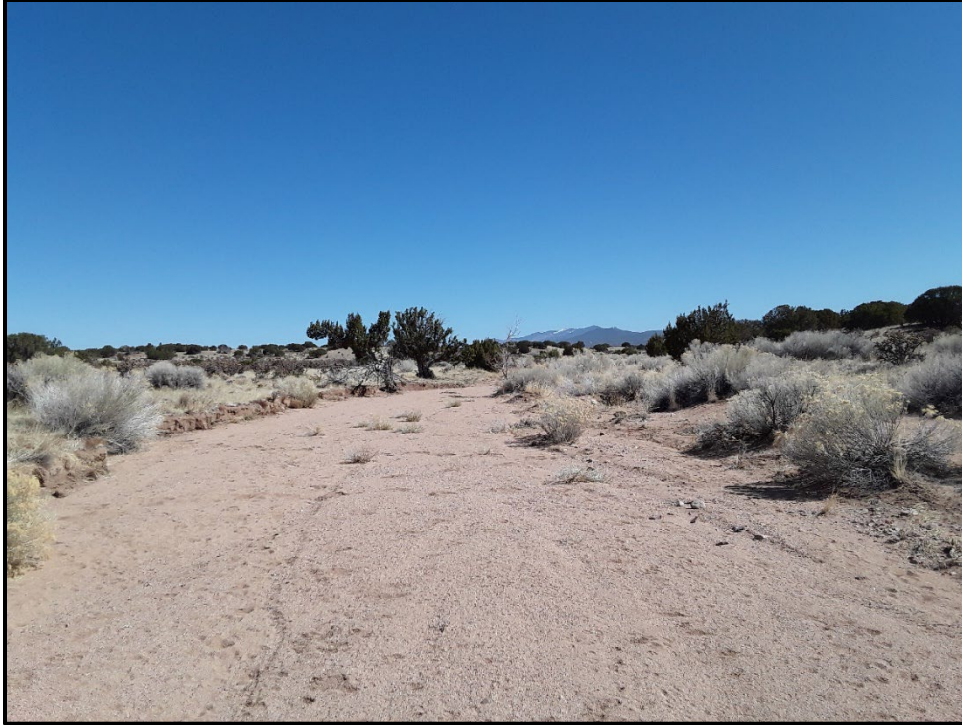
**Figure C-7. NHD-mapped water feature and NWI-mapped riverine wetland feature (Gallina Arroyo) from within the proposed project area, facing northeast (upstream).**

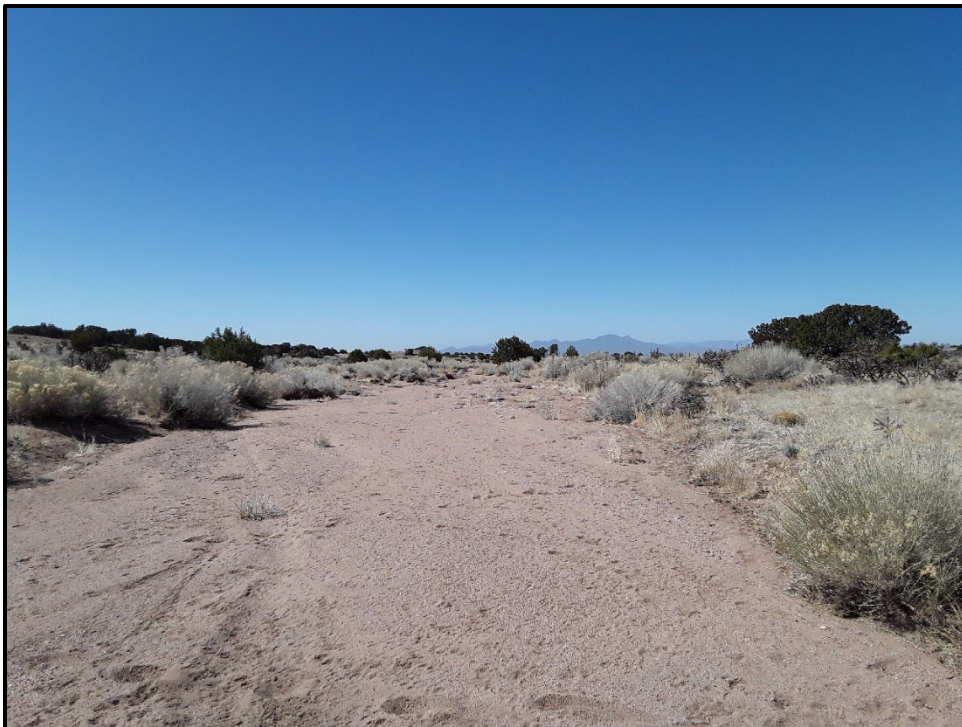
**Figure C-8. NHD-mapped water feature and NWI-mapped riverine wetland feature (Gallina Arroyo) from within the proposed project area, facing southwest (downstream).**

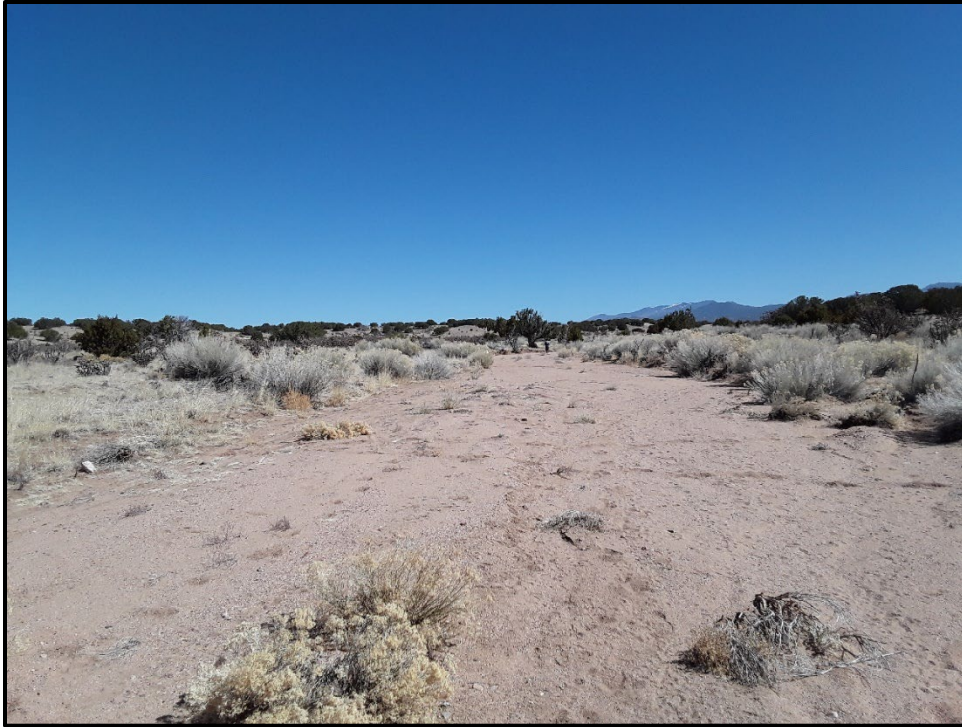
**Figure C-9. NHD-mapped water feature and NWI-mapped riverine wetland feature (Gallina Arroyo) from south of the proposed project area, facing northeast (upstream).**

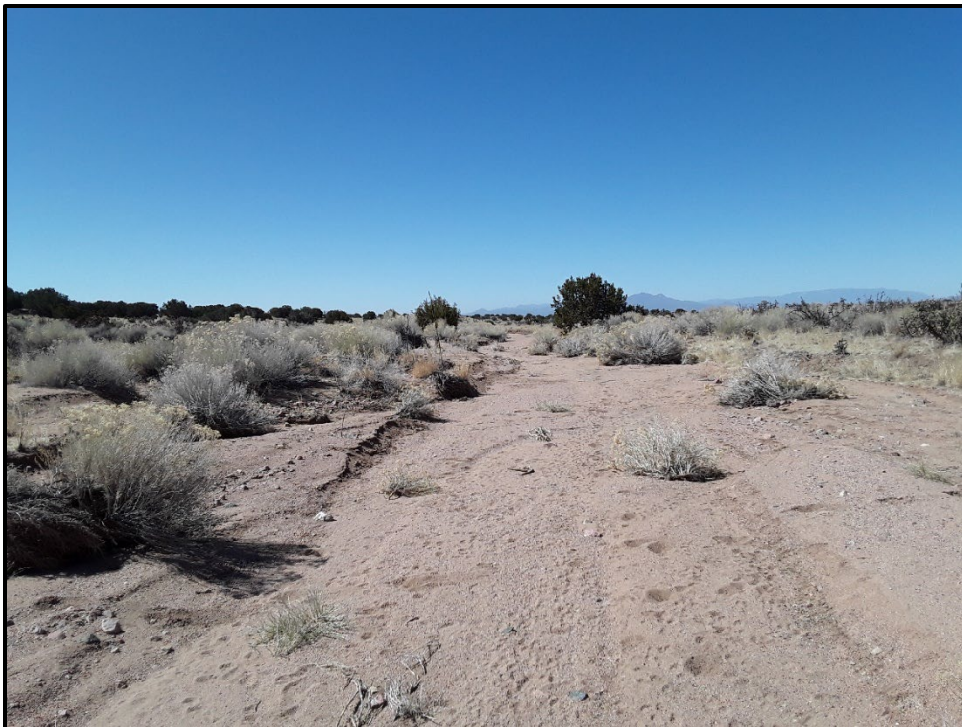
**Figure C-10. NHD-mapped water feature and NWI-mapped riverine wetland feature (Gallina Arroyo) from south of the proposed project area, facing southwest (downstream).**
