1 DRAFT FINAL
2 Site Inspection Report
3 Army Aviation Support Facility
4 Santa Fe, New Mexico

5
6
7 Site Inspection for Perfluorooctanoic Acid (PFOA), Perfluorooctanesulfonic Acid (PFOS),
8 Perfluorohexanesulfonic Acid (PFHxS), Perfluorononanoic Acid (PFNA), Hexafluoropropylene
9 oxide dimer Acid (HFPO-DA), and Perfluorobutanesulfonic Acid (PFBS) at ARNG Installations
10 Nationwide

11
12 **February 2023**

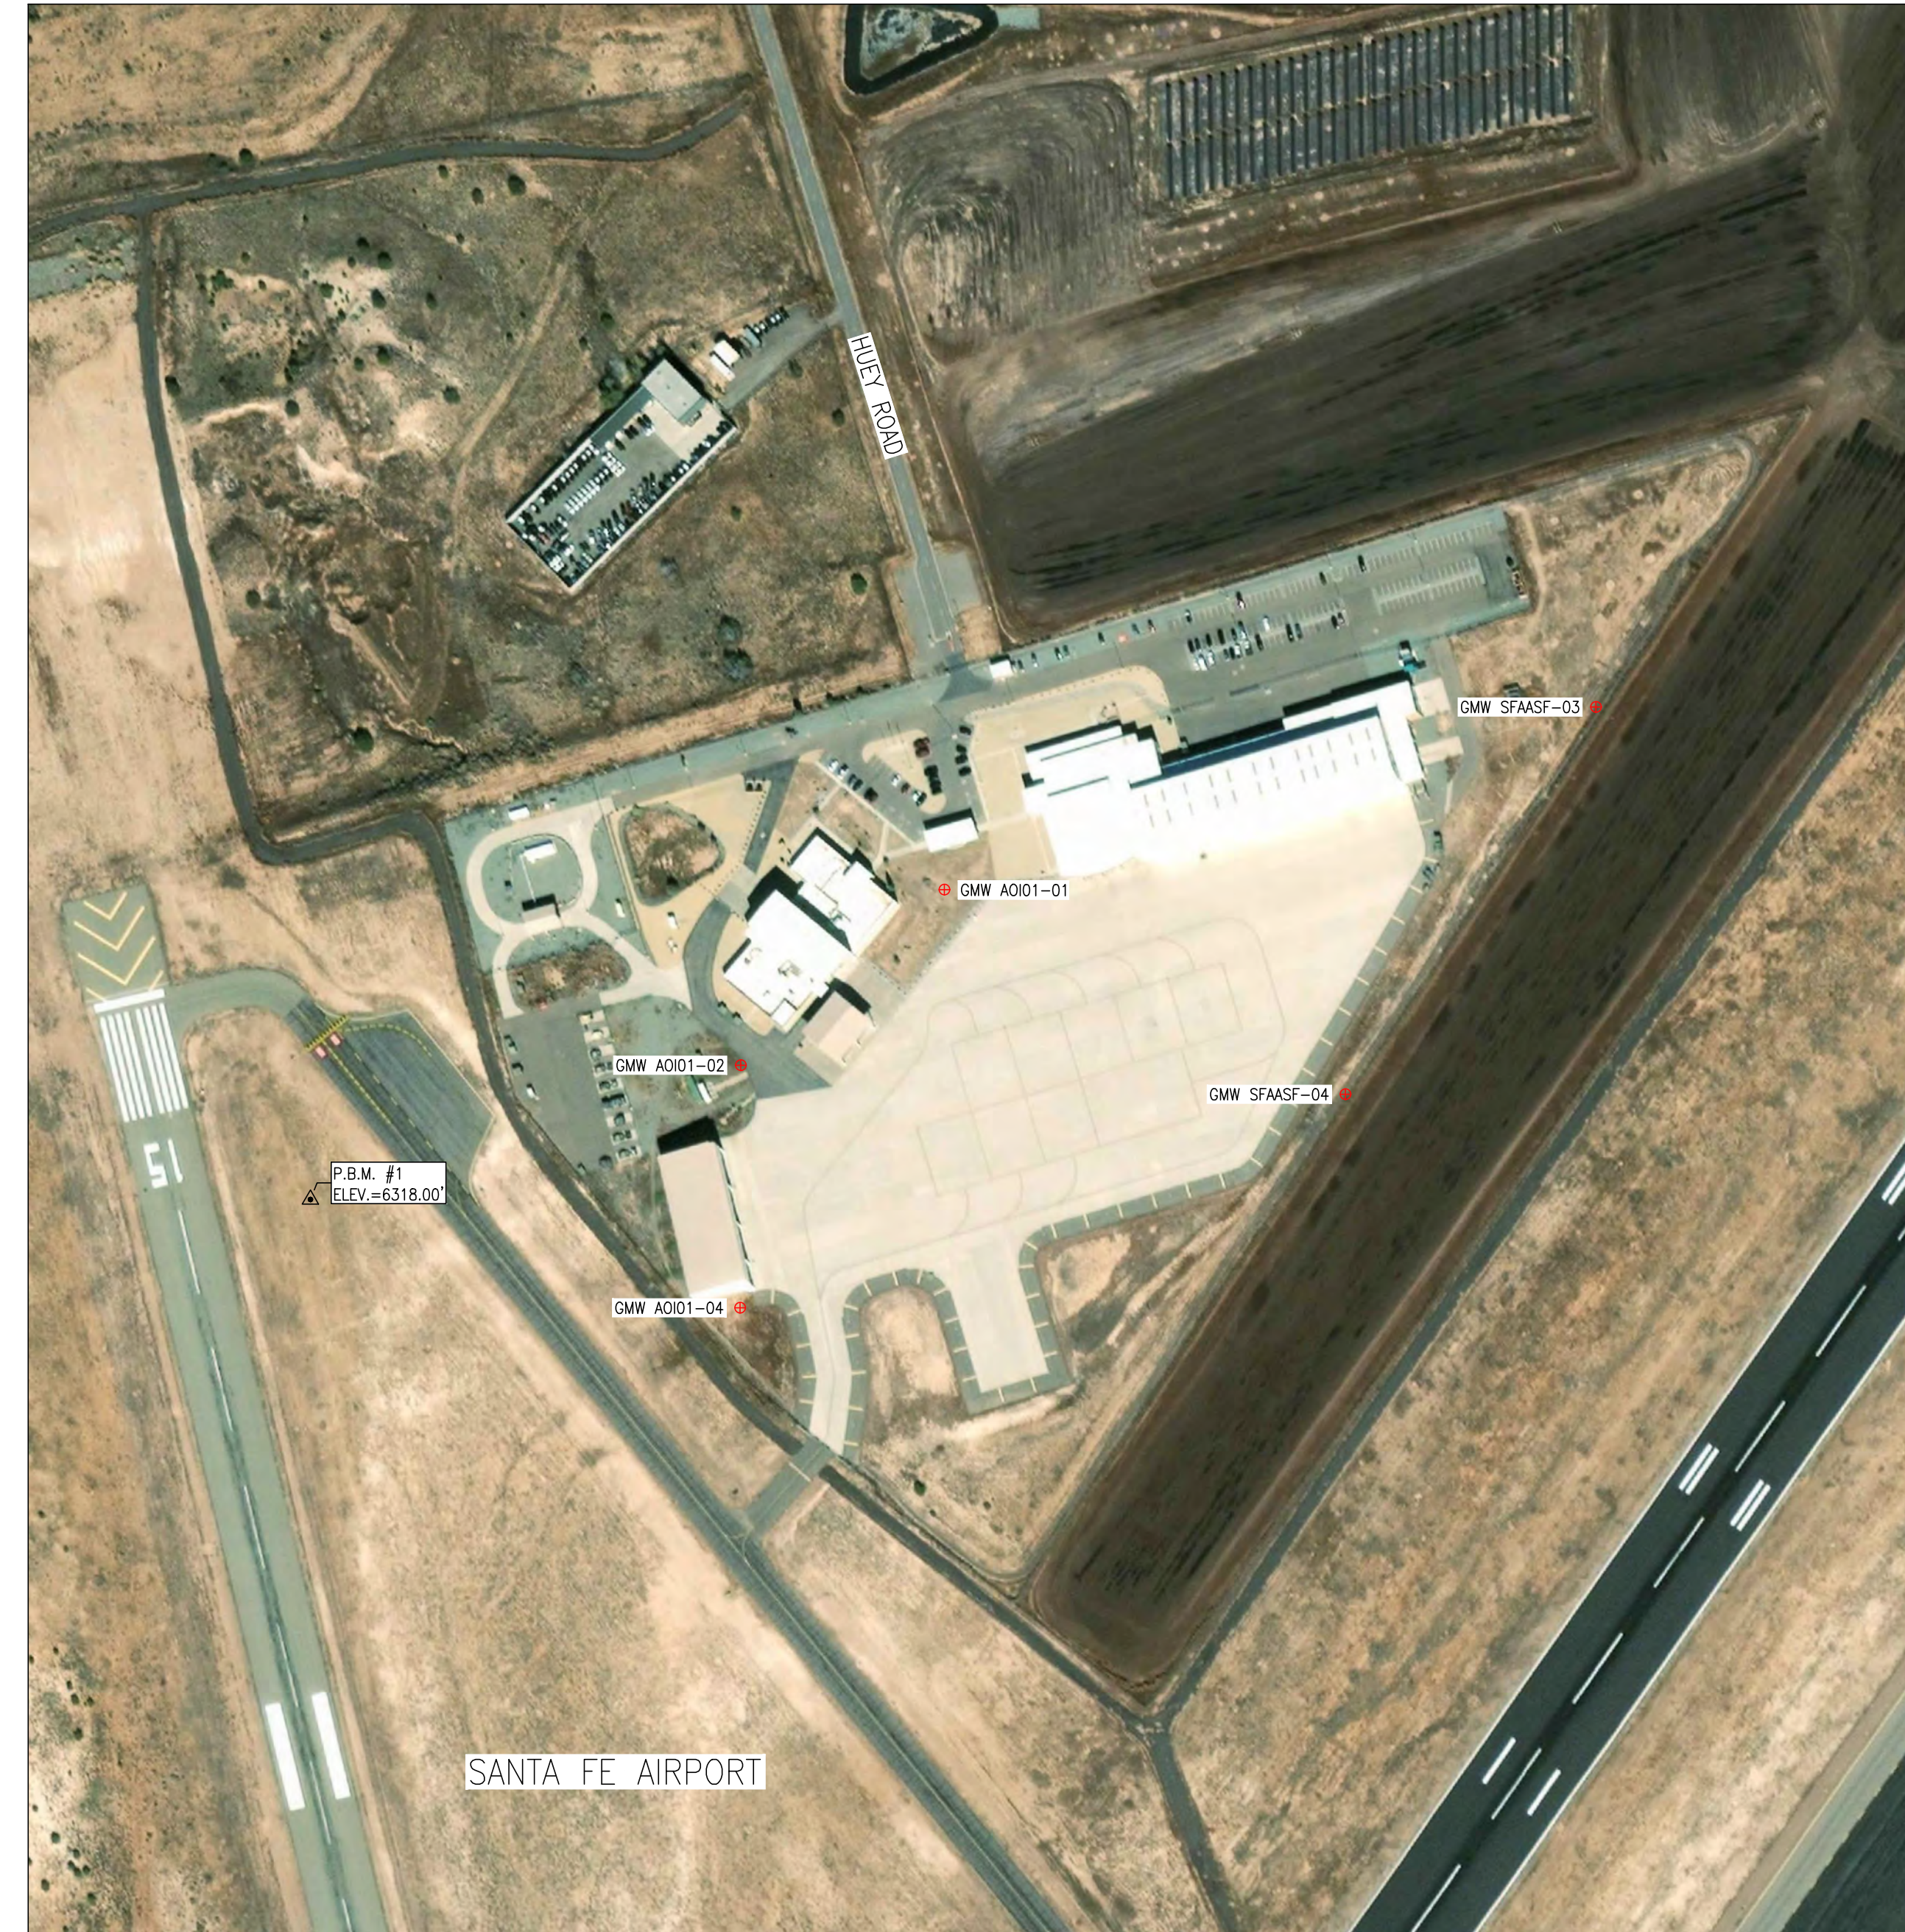
MONITORING WELL LOCATIONS WITH AERIAL IMAGERY

1. AN UNCLASSIFIED SURVEY FOR WELL LOCATIONS WAS PERFORMED ON JUNE 3, 2022. THIS IS NOT A BOUNDARY SURVEY OR RIGHT-OF-WAY SURVEY.
2. WELL LOCATIONS ARE NAD 83 GRID COORDINATES (NEW MEXICO CENTRAL ZONE).
3. SITE LOCATED WITHIN THE SANTA FE MUNICIPAL AIRPORT, SANTA FE COUNTY, NEW MEXICO.
4. THE PHOTOBASE IMAGE, DEPICTED ON THIS SURVEY, WAS IMPORTED FROM GOOGLE EARTH WEB SITE. THIS PHOTOBASE IMAGE IS SHOWN TO PROVIDE A GENERAL SITE ORIENTATION AND MAY NOT REFLECT THE CURRENT SITE CONDITIONS.
5. THE PURPOSE OF THIS SURVEY IS TO ESTABLISH NEW MEXICO STATE PLANE GRID COORDINATES AND ELEVATIONS FOR THE LOCATIONS OF THE NEWLY INSTALLED AND EXISTING GROUNDWATER MONITORING WELLS.

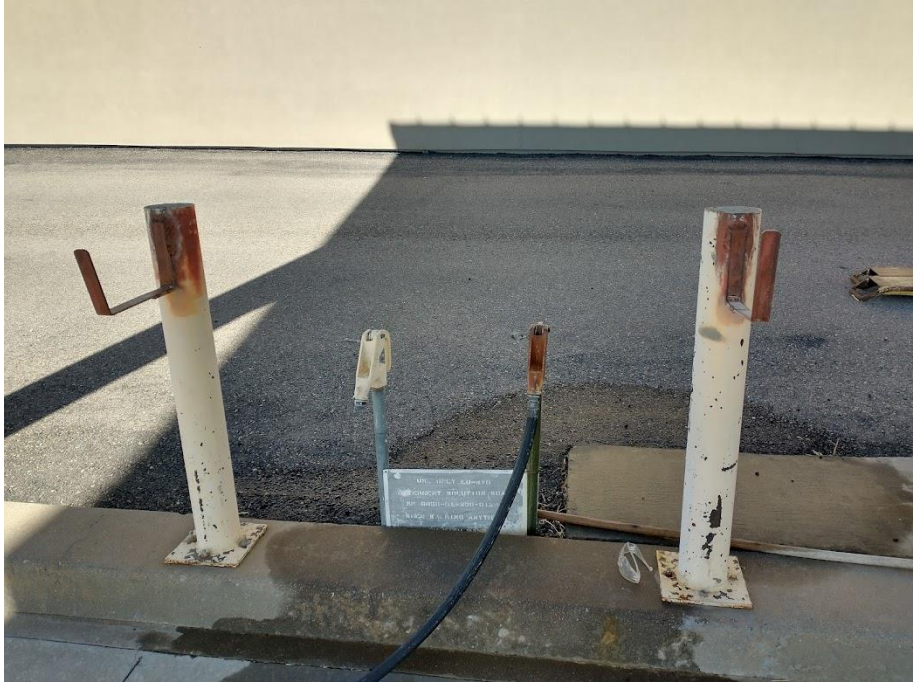
<p>Orientation: northwest</p>		
<p>Photograph No. 02</p> <p>Date 02/07/2022 Time 1200</p> <p>Description: EA Engineering advancing boring at SFAASF-04 with hand auger.</p>	 	
<p>Orientation: south</p>

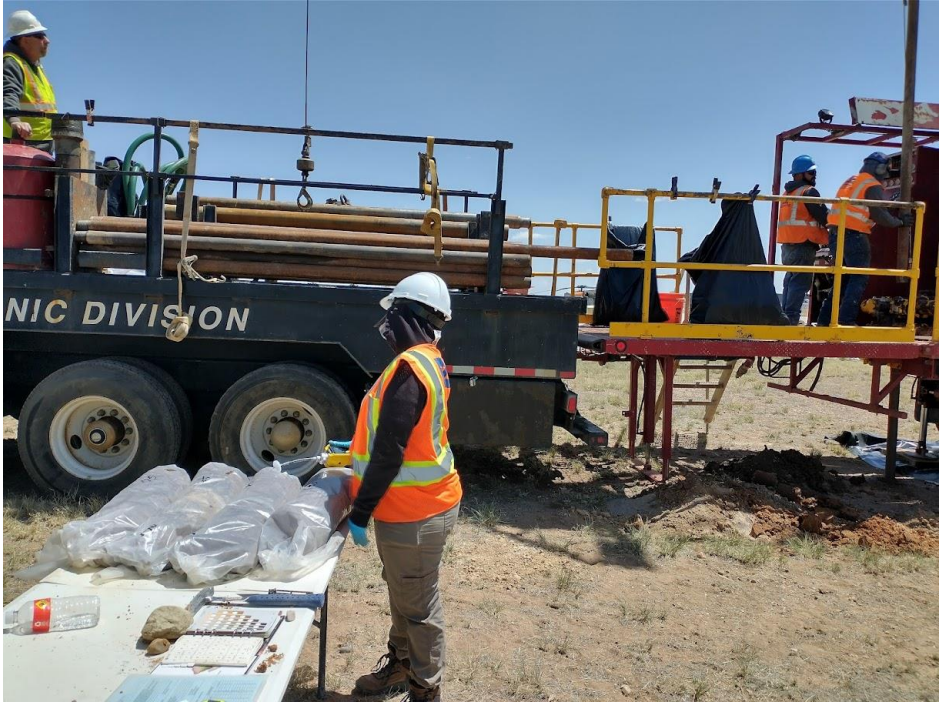
<p>Orientation: south</p>		
<p>Photograph No. 06</p> <p>Date 04/29/2022 Time 0850</p> <p>Description: EA Engineering logging soil cuttings during the drilling of SFAASF-04.</p>

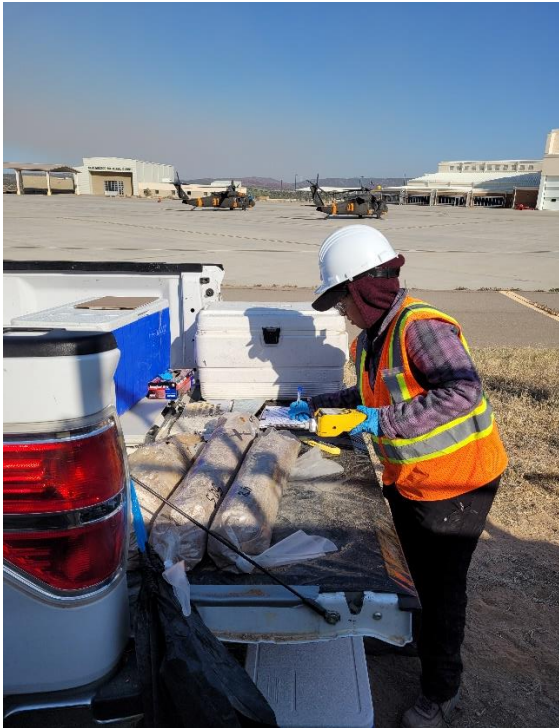
Appendix C - Photographic Log		
Site Inspection for PFAS	Santa Fe Army Air Support Facility	Santa Fe, NM
<p>Photograph No. 07</p> <p>Date 05/04/2022 Time 1000</p> <p>Description: Direct push drill rig advancing soil boring AOI01-06B.</p>

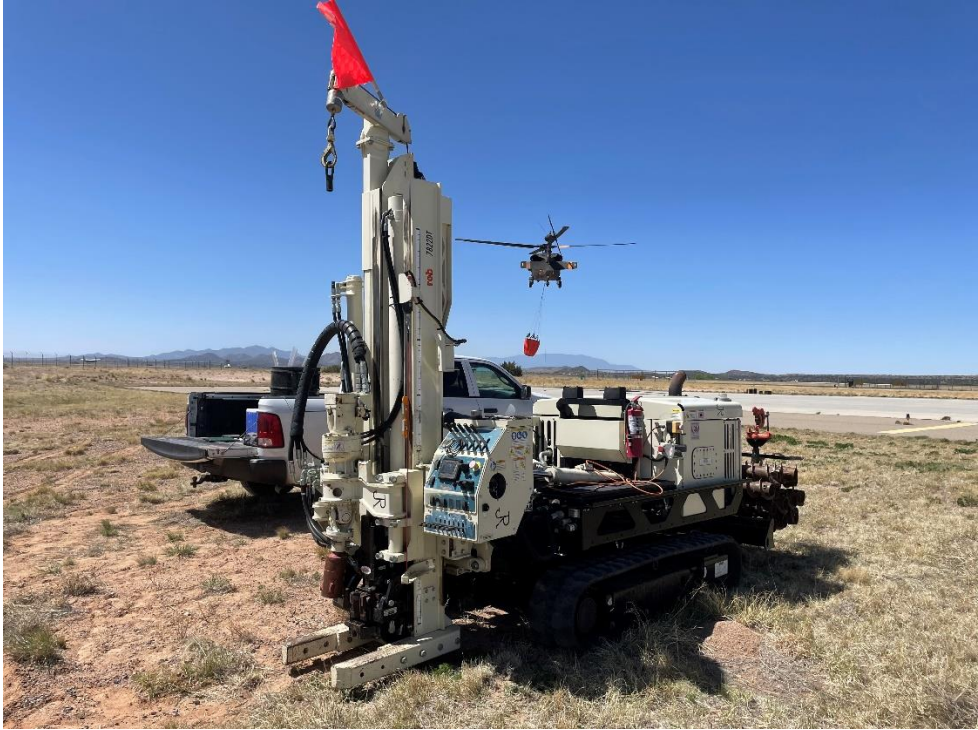
<p>Orientation: southwest</p>		
<p>Photograph No. 08</p> <p>Date 05/09/2022 Time 1550</p> <p>Description: Concrete form created over well AOI01-04 in preparation of pouring the concrete pad.</p>

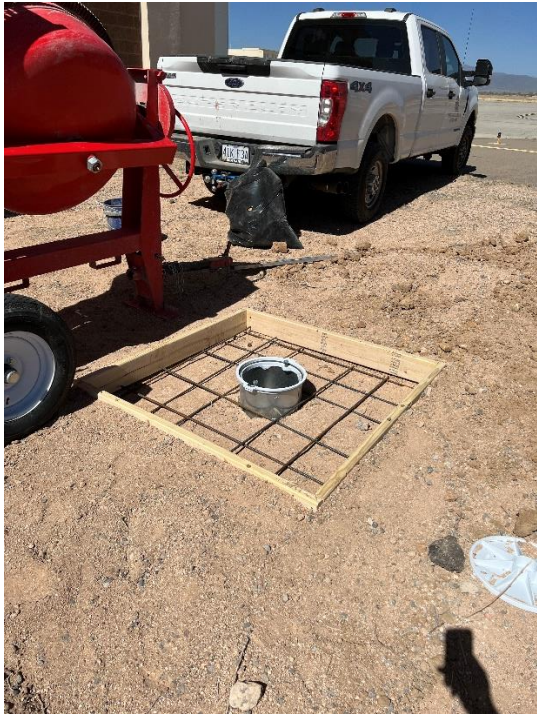
Appendix C - Photographic Log		
Site Inspection for PFAS	Santa Fe Army Air Support Facility	Santa Fe, NM
<p>Photograph No. 09</p> <p>Date 05/09/2022 Time 1650</p> <p>Description: Completed pad for well AOI01-04</p>

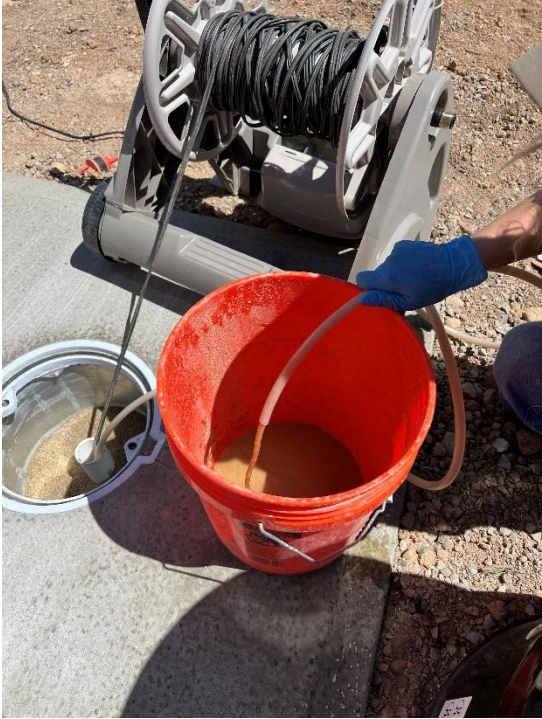
Appendix C - Photographic Log		
Site Inspection for PFAS	Santa Fe Army Air Support Facility	Santa Fe, NM
<p>Photograph No. 11</p> <p>Date 05/10/2022 Time 1440</p> <p>Description: Developing well AOI01-02. Initially groundwater was turbid with sediment.</p>

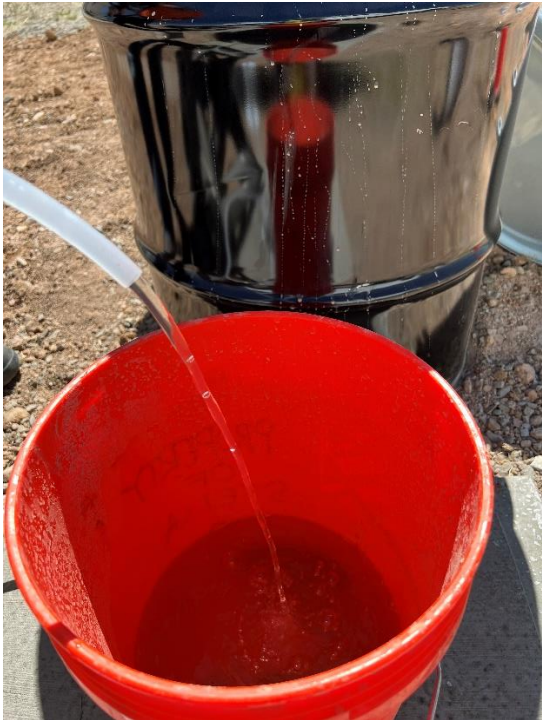
<p>Orientation: north</p>		
<p>Photograph No. 12</p> <p>Date 05/10/2022 Time 1530</p> <p>Description: Developing well AOI01-02. As developing continues sediment is removed from the well resulting in clear groundwater.</p>

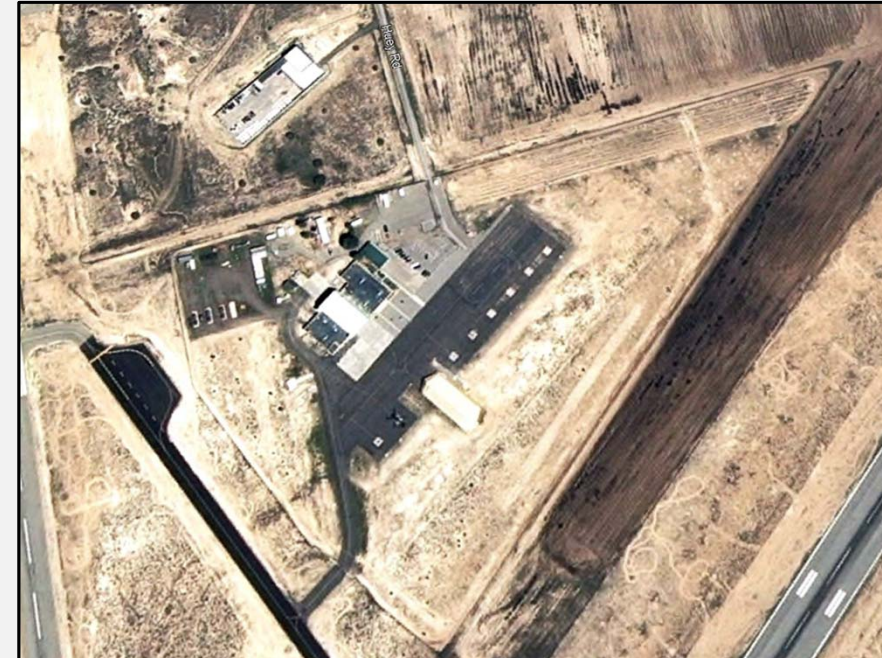
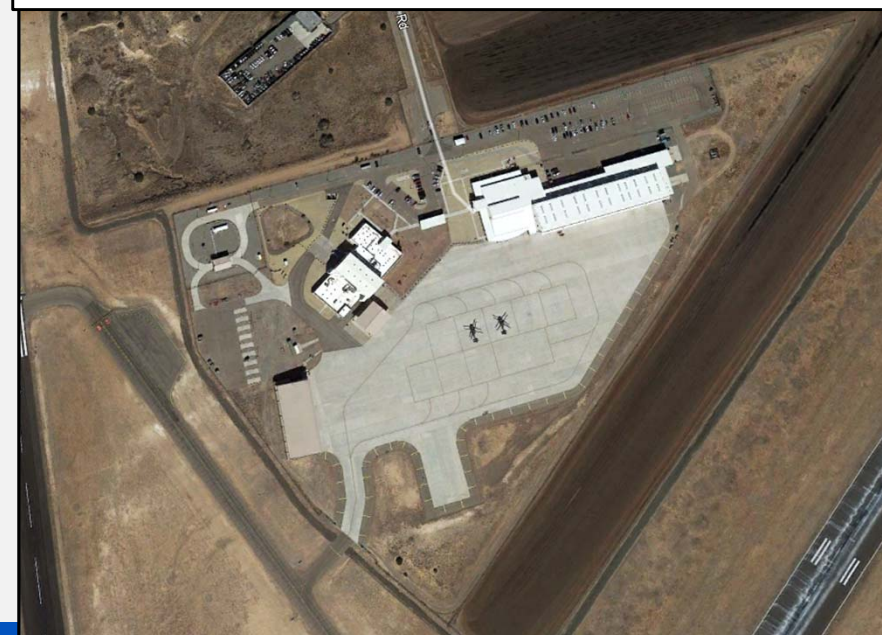
The installation prior to renovations in 2009 (top) and the current footprint (bottom)
