## MEMORANDUM

**Resolution 2015-\_\_\_, a Resolution Adopting Minimum Acceptable Facility Condition Scores In Accordance With The Facility Asset Management System Created Pursuant to Resolution No. 2013-40, and Presentation of the State of the County Facility Inventory (Public Works/Terry Lease)**

Santa Fe County Facilities Condition Assessment 2014

# Facilities Condition Assessments

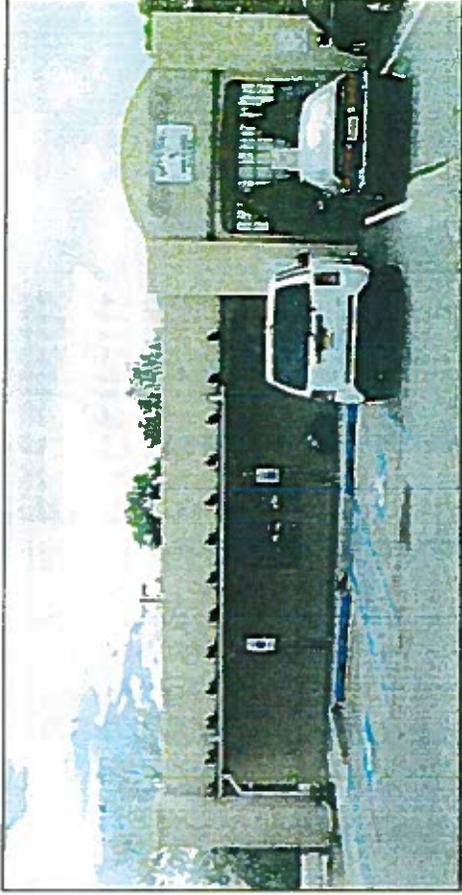
949 West Alameda, Santa Fe

■ **FCI Score**  
**\$96,052**  
**\$1,122,765**  
**= 0.086 – Fair**

- **Site:** **84.4% = Satisfactory**
- **Physical Plant:** **93.5% = Excellent**
- **Adequacy for Operations:** **93.6% = Excellent**
- **Total:** **91.3% = Excellent**

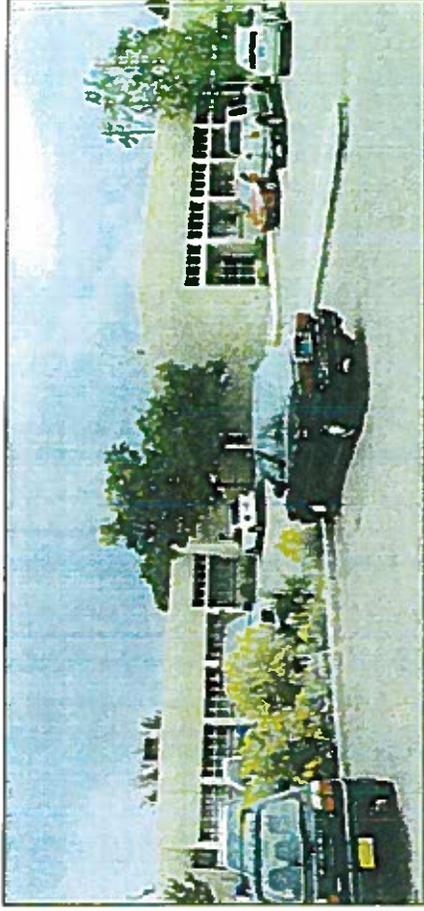
605 Letrado, Santa Fe

■ FCI Score  
\$1,766,828  
\$3,978,960  
= 0.444 – Poor

■ ARC Score  
■ Site: 79.5% = Satisfactory  
■ Physical Plant: 74.7% = Satisfactory  
■ Adequacy for Operations: 68.4% = Borderline  
■ Total: 73.4% = Satisfactory

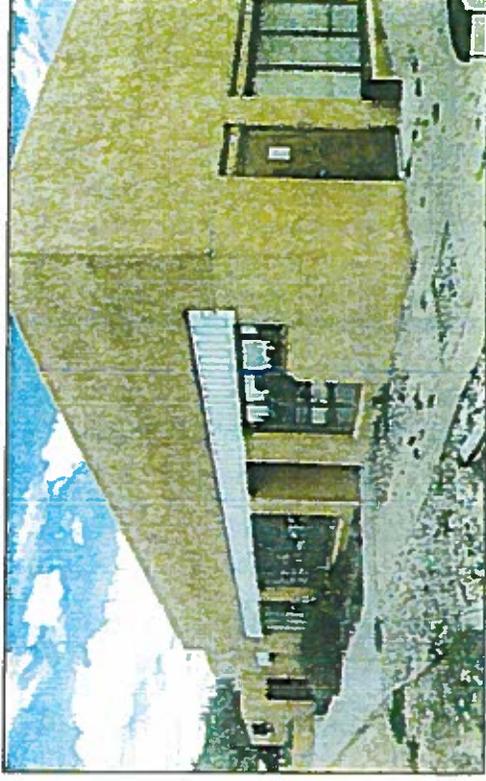
4250 Airport Road, Santa Fe

■ FCI Score  
\$8,561,512  
\$15,013,532  
= 0.570 – Poor

- Site: 75.4% = Satisfactory
- Physical Plant: 71.7% = Satisfactory
- Adequacy for Operations: 64.0% = **Borderline**
- Total: 69.6% = Satisfactory
