Communities of La Cienega & La Cieneguilla Road Safety Audit Santa Fe, NM

Draft Report
January 2026

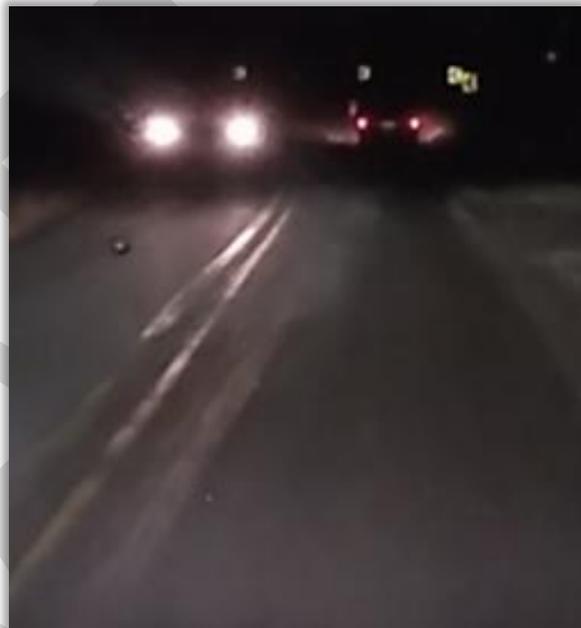
Figure 49: Westbound Intersection View

From the crash data analysis and during the nighttime field review of the study corridor, it was observed that nighttime visibility is a serious challenge, especially on these narrow and winding roads within the communities. Safety lighting at the intersections and delineation features along the horizontal curves significantly improve the visibility of the roadway. Currently, the intersection lacks sufficient lighting, which reduces driver awareness of roadway geometry, signage, and potential conflicts during nighttime or adverse weather conditions. Insufficient illumination is particularly hazardous for vulnerable road users such as pedestrians and cyclists, and older drivers. Installing lighting will improve safety, visibility, and overall intersection safety. Enhanced delineation treatments can alert drivers to upcoming curves, the direction and sharpness of the curve, and appropriate operating speed. Figure 48 through Figure 52 shows the existing curve protection and delineation inadequacy.

- Based on the data analysis and the field review, we recommend installing safety lighting at these four intersections, as shown in Figure 53 through Figure 56, i.e.; Los Pinos Road and I-25 Frontage Road, Las Estrella and I-25 Frontage Road, Entrada La Cienega and I-25 Frontage Road, and Paseo Real and Los Pinos Road. Two luminaires at the intersection of Los Pinos Road and I-25 Frontage Road, two luminaires at the intersection of Las Estrellas and I-25 Frontage Road, three luminaires at the intersection of Entrada La Cienega and I-25 Frontage Road, and two luminaires at the intersection of Paseo Real and Los Pinos Road. The approximate locations of the luminaires are shown in the figures below. In accordance with NMDOT standards, the luminaires shall be night-sky-compliant with full cutoff, as required by the New Mexico Night Sky Protection Act. Typically, NMDOT does not bear the ongoing cost of illumination electrical service; therefore, a lighting agreement must be established between the communities, the County, and NMDOT to successfully install luminaires at this intersection.

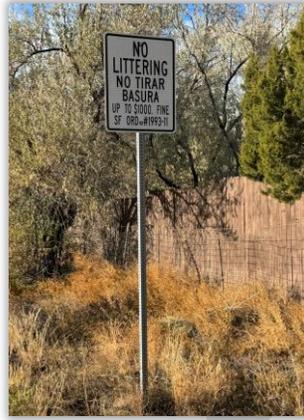
Figure 81 Littering Prohibition sign on Paseo Real
