Tesuque Roads Safety Study.

Final Report | Jan. 2023

Tesuque Roads Safety Study

Final Report

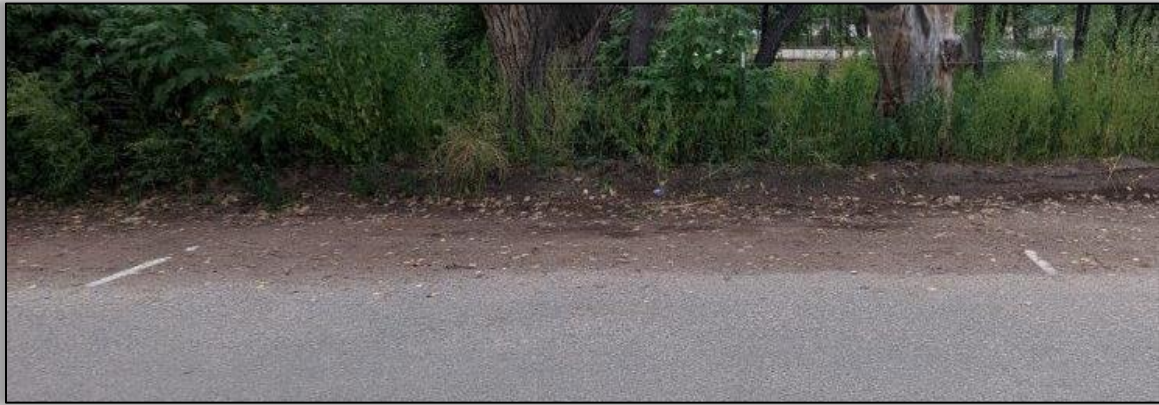
Figure 40: Marked parking spaces on Bishops Lodge Road

Section 3 is perceived as the hub of Tesuque, with regular visits from locals and visitors; the demand for parking in this area is high. While there is parking on Arroyo Griego Road, additional parallel parking is available on Tesuque Village Road and Bishops Lodge Road. However, the pavement markings are covered by sediment, as shown in Figure 36. Additionally, visitors that create ad hoc parking that poses a safety challenge by adversely impacting the intersection sight distance like the red vehicle in Figure 37. This challenge is related to the infrastructure on Arroyo Griego Road but deserves its own attention.

Several of the recommended countermeasures regarding parking piggyback off previously discussed countermeasures in Tesuque. These countermeasures include removing sediment and maintaining pavement marking visibility. Additionally, this recommendation involves striping all available parking spaces in Section 3 and posting signs indicating “Compact Parking Only” where applicable. These countermeasures can significantly improve the parking dynamics on Arroyo Griego Road. These countermeasures can be enhanced by raising the parking areas with rolled curbs and adding additional signs to direct motorists to the parallel parking on Tesuque Village and Bishops Lodge Roads.

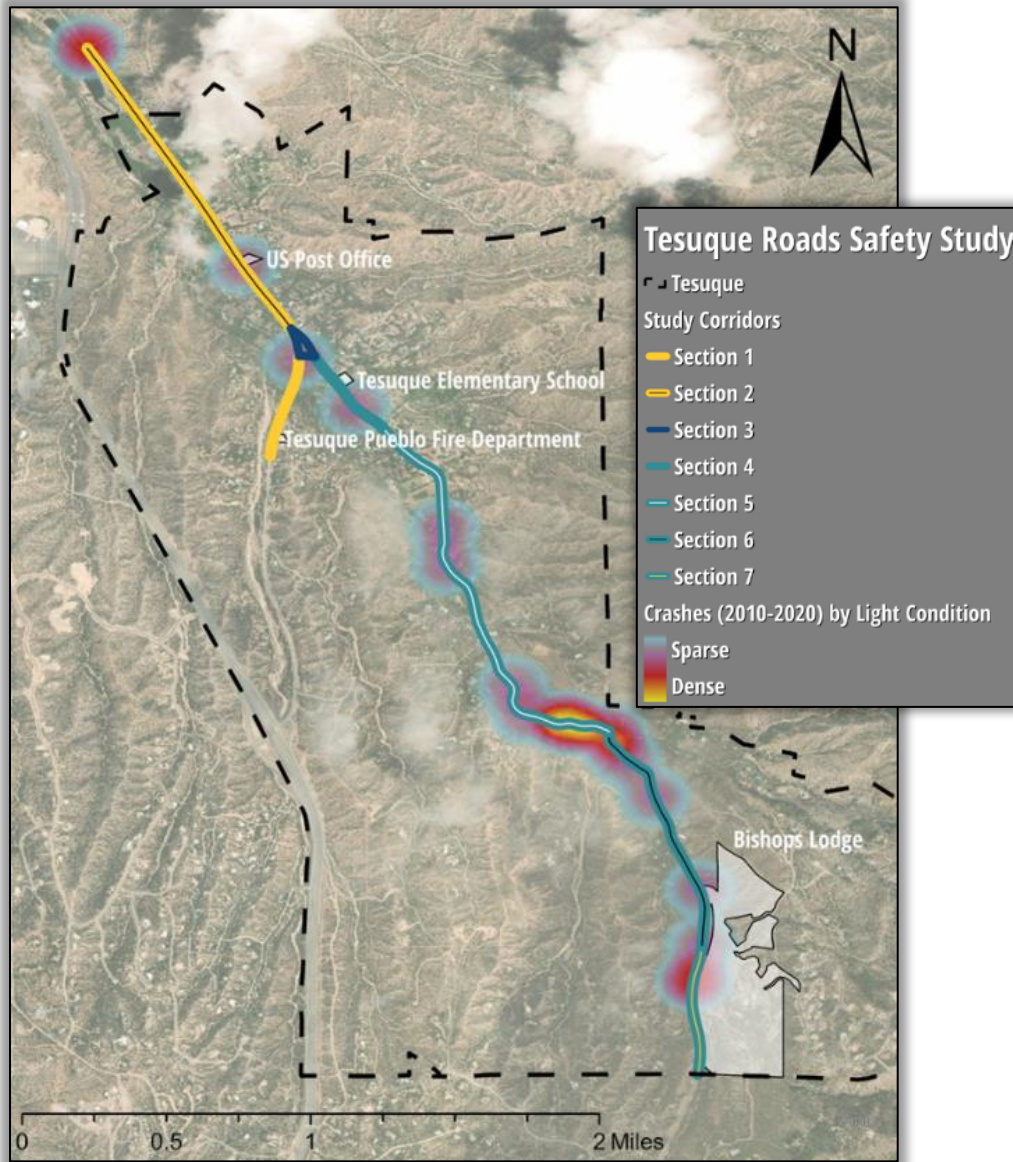
Figure 47: Crash Heat Map for Crashes in Low Light Conditions by Section

This road segment is inadequately illuminated, as evidenced by the heavy concentration of crashes in low-light conditions. Figure 47 shows a heat map of crashes occurring in Dark-Not Lighted, Dusk, or Dawn conditions.

Given that this segment bisects residential properties, overhead luminaries are not desired. However, residents are concerned about increasing low-light visibility. As such, the first recommendation is to install roadside reflective delineators to highlight the curvy roadway alignment. The reflective delineators must be installed according to MUTCD standards outlined in section 3F.04. Moreover, reflectors should call attention to objects in the clear zone of the roadway, the area adjacent to the traveled way. AASHTO’s Roadside Design Guide guides clear zone widths based on volume, speed, and roadside slope. Lastly, edge line striping should be six inches wide as opposed to the standard of four inches when approaching and traversing curves with limited sight distances. This countermeasure highlights horizontal curves and calls the motorists' attention to areas that demand compliance with the posted speed limit.

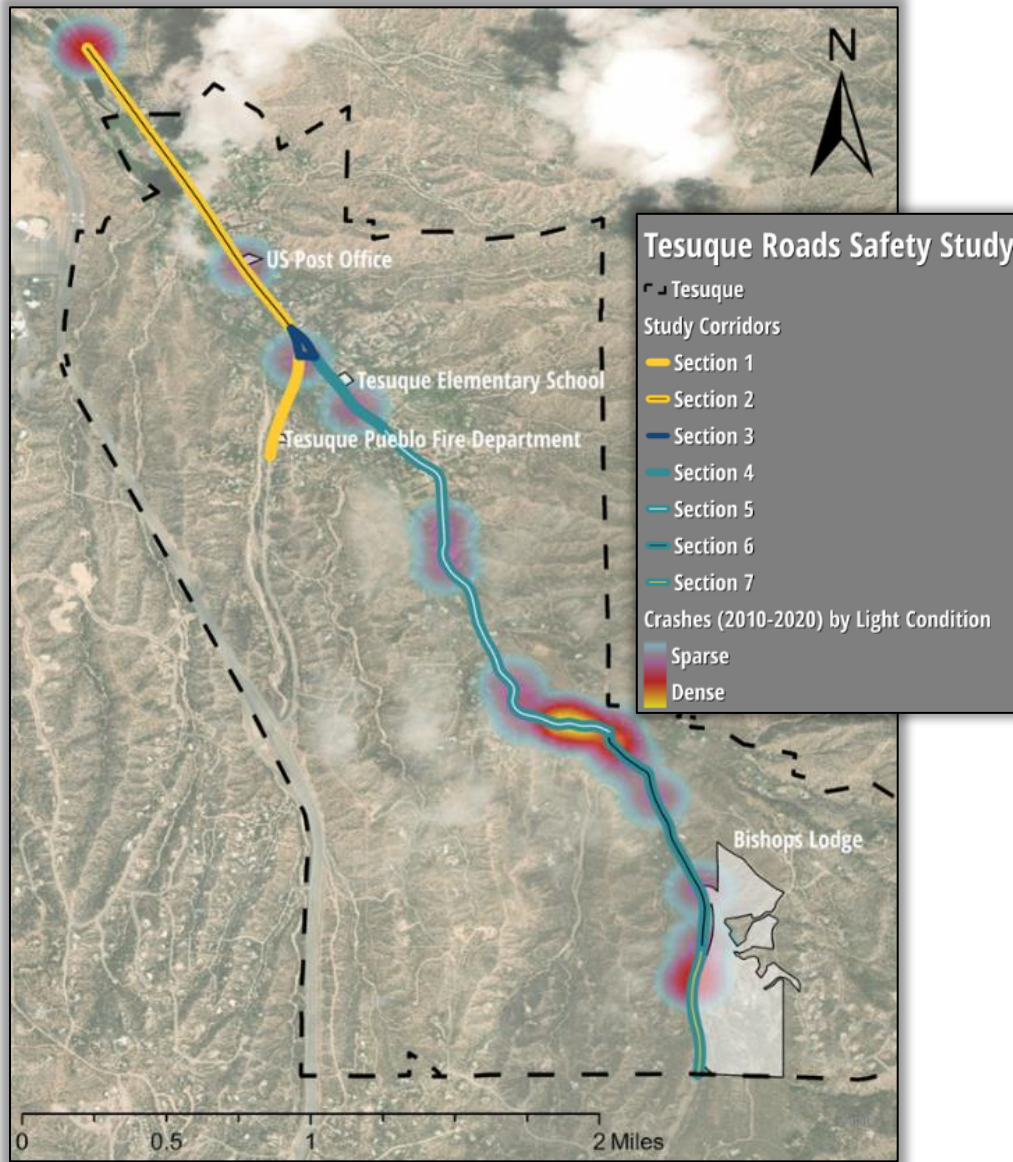
Figure 51: Crash Heat Map for Crashes in Low Light Conditions by Section

This inadequate illumination from Section 5 continues in Section 6. Figure 51 shows a heat map of crashes occurring in Dark-Not Lighted, Dusk, or Dawn conditions.

This segment also bisects residential properties, deeming overhead luminaires undesirable. In Section 6, the project team recommends the installation of roadside reflective delineators to highlight the curvy roadway alignment. The reflective delineators must be installed according to MUTCD standards outlined in section 3F.04. Additionally, reflectors should call attention to objects in the clear zone of the roadway, the area adjacent to the traveled way. The reflectors should be installed according to AASHTO’s Roadside Design Guide. As in Section 5, edge line striping should be six inches wide as opposed to the standard of four inches when approaching and traversing curves with limited sight distances to highlight horizontal curves and call the motorists' attention to areas that demand compliance with the posted speed limit.

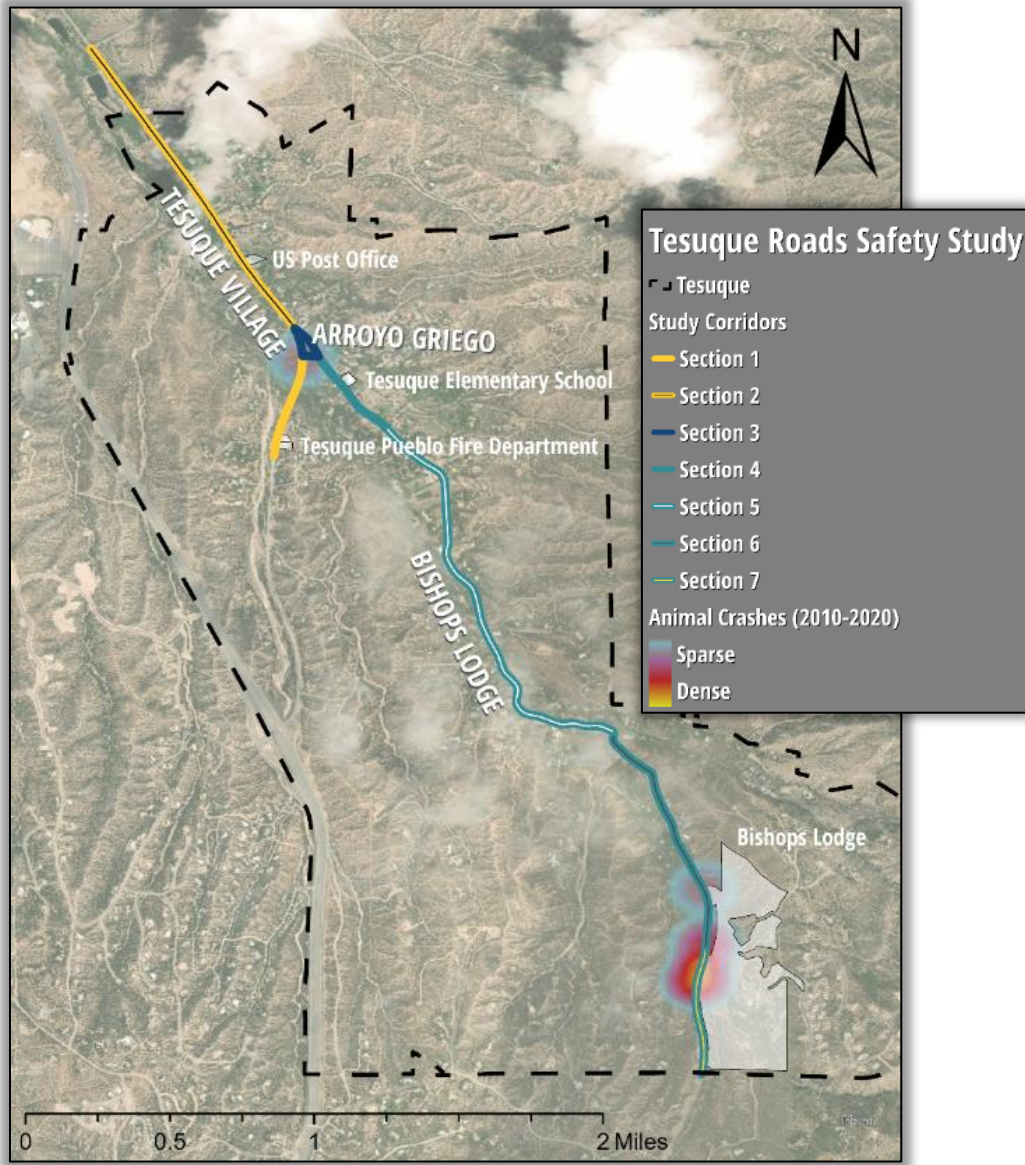
Figure 52: Crash heat Map for Crashes Involving Animals

Figure 52 is a heat map of crashes involving animals. High concentrations of these types of crashes occur in Section 6.

The recommended countermeasure is replacing the existing 30" by 30" signs with oversized 36" by 36" ones. These oversized signs should be enhanced with flashing warning beacons to alert motorists of frequent animal crossings in this area.
