Rancho Viejo Blvd

Rancho Viejo Blvd from SR14 to Avenida Del Sur

Current Year: 2017
Inspection Date: 11-10-2017
Evaluator MP

Richards Ave

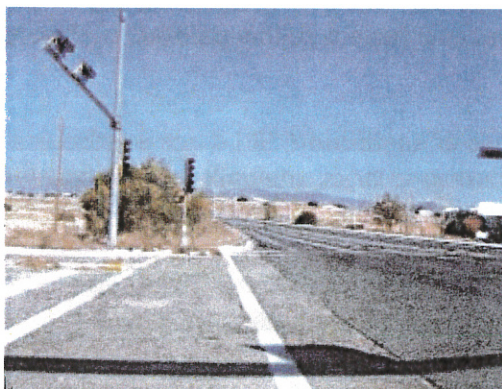
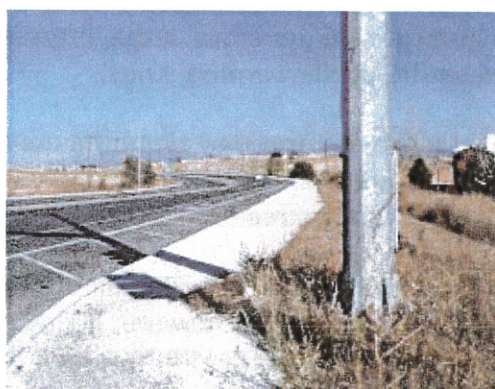
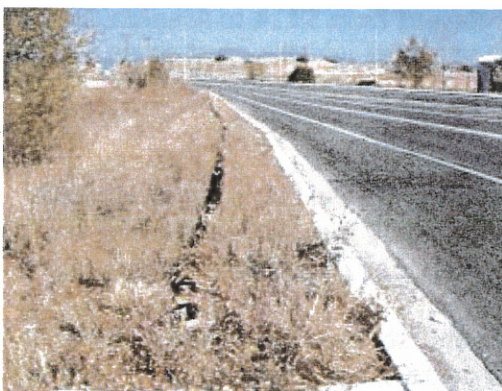
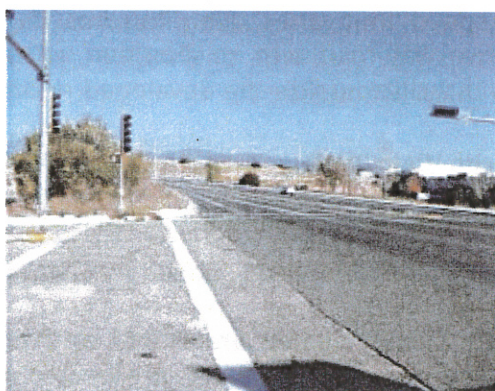
Photos

daily vehicular traffic and is controlled with traffic signal lights. The signal lights are mounted horizontal over the streets and vertical posted signals at the sidewalk corners. Vertical posted traffic lights interrupt the northeast and northwest street corners. The northeast corner has overgrown vegetation impeding the path of travel and the sidewalk wraps around the vertical posted traffic light.

The asphalt-paved roads have road and crosswalk striping. The concrete curb and gutters are filled with sand. The island divider on Rancho Viejo Boulevard disrupts the path of travel within the crosswalk.

The bus stop is located on the south side of eastbound SR14 and a striped bus lane is provided. Curb cuts are located at all intersection corners with tactile warning strips. The curb cuts are generous at the intersections and have a yellow painted curb stop between the tactile warning strips.

Sidewalks are not provided along the north side of eastbound SR14 nor westbound along the south side of SR14. Rancho Viejo Boulevard lacks sidewalks on the south or north sides of the streets.

A continuous sidewalk is located along the eastbound south side of SR14. The sidewalk varies in width; however, it is ADA compliant. Road access off of SR14 eastbound has curb cuts with tactile warning strips.

The intersection of Rancho Viejo Boulevard and Avenida Del Sur has less vehicular traffic during the day and is controlled with a four-way stop. The crosswalks are colored concrete pavers. Speed limit signs are posted at 25 MPH along both roads.

Future bus stop inlets are located on the north and south sides of Avenida Del Sur. No signage is posted. Curb cuts are located on all corners; however, no tactile warning strips are provided. The flat portion of the curb cut on the road is not level at the corners. The southwest sidewalk angled towards Rancho Viejo Market has a timber frame structure obstructing the path of travel. Beyond the structure, the concrete sidewalk is heavily cracked with an uneven surface.

No sidewalk is provided along the east side of southbound Rancho Viejo Boulevard. The sidewalks along Avenida Del Sur are not continuous to the residential housing north and south of the intersection.

Relocate the traffic lights posts out of the path of travel. Replace the concrete sidewalk and remove the yellow painted curb stop between the tactile warning strips. Add tactile warning strips at the demolition location of the curb stops. Remove island from crosswalk path and patch roadway.

A bus stop is located on the south side of State Road 14 headed east.
Install a bus shelter at the bus stop.

Install new sidewalks along east and west bound SR14.

Install new sidewalks.

Relocate the timber structure and replace the cracked sidewalk.

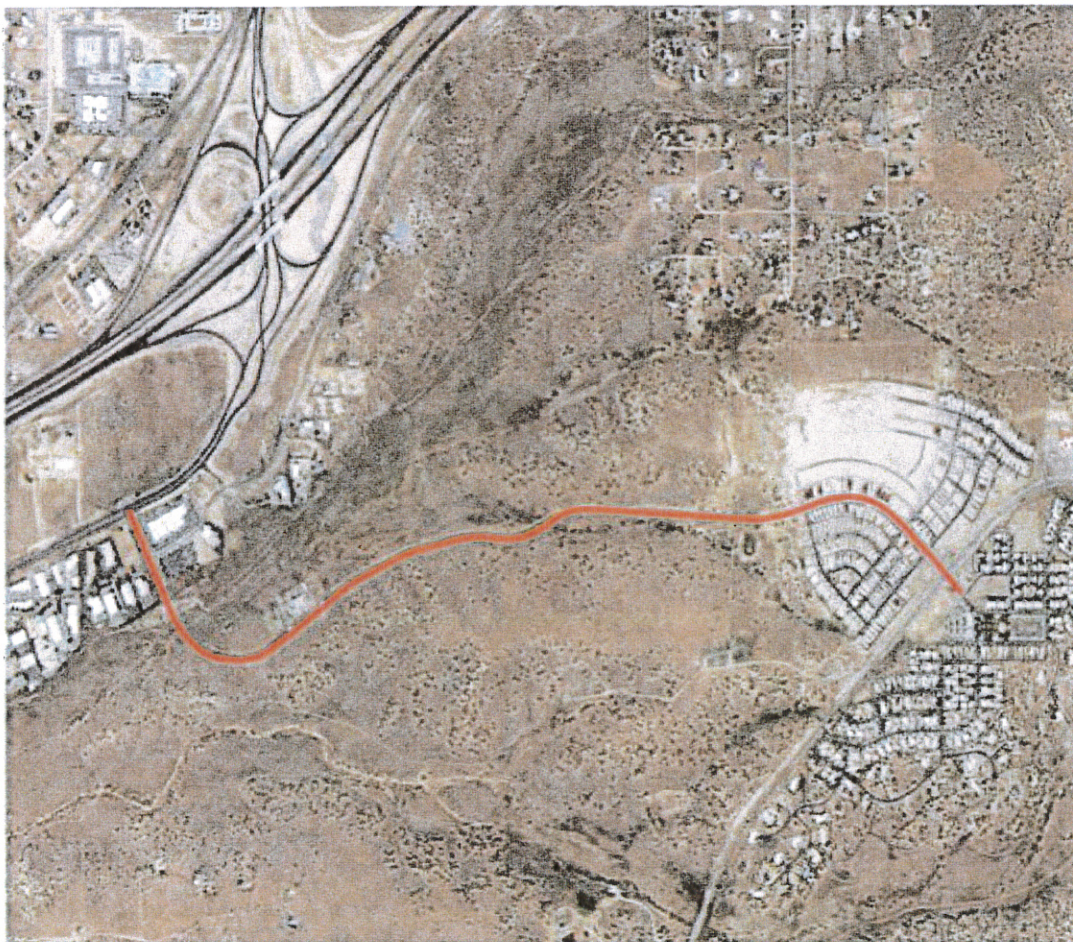
Site Plan

Rancho Viejo Blvd from SR14 to Avenida Del Sur

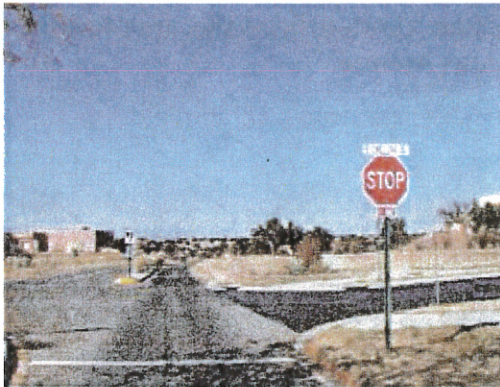
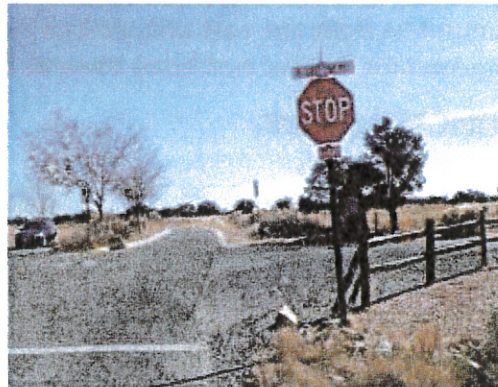
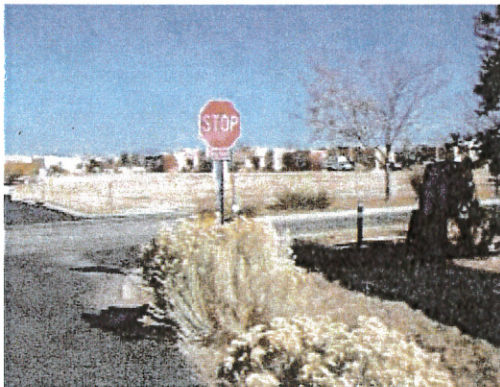
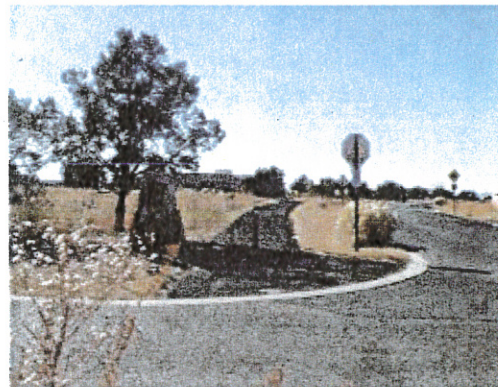
Photos

Avenue to A Va Nu Po have residential traffic, and Amy Beihl Community School and IAIA college vehicular traffic. Intersections along the residential road are controlled with two-way and four-way stop signs, however no crosswalks. The two lane asphalt road has zero clearance concrete curb and gutter. Speed limit signs are posted to far apart along Chili Line to A Va Nu Po. The road has no shoulder; no streetlights and vehicles must share the road with bicyclist outside the developed residential area.

Bus stops are not identified. Curb cuts are located at intersection corners, however no tactile warning strips are provided.

Sidewalks are provided along the developed residential areas and Amy Beihl Community School. Long stretches of undeveloped land lie between the residential communities from the east and west to the college. Limited sidewalks are provided along Avenida Del Sur northeast towards Richards Avenue.

Install sidewalks along one side of the road, until additional development calls for sidewalks on both sides of the road. Include curb ramps at drive pads and entrances.

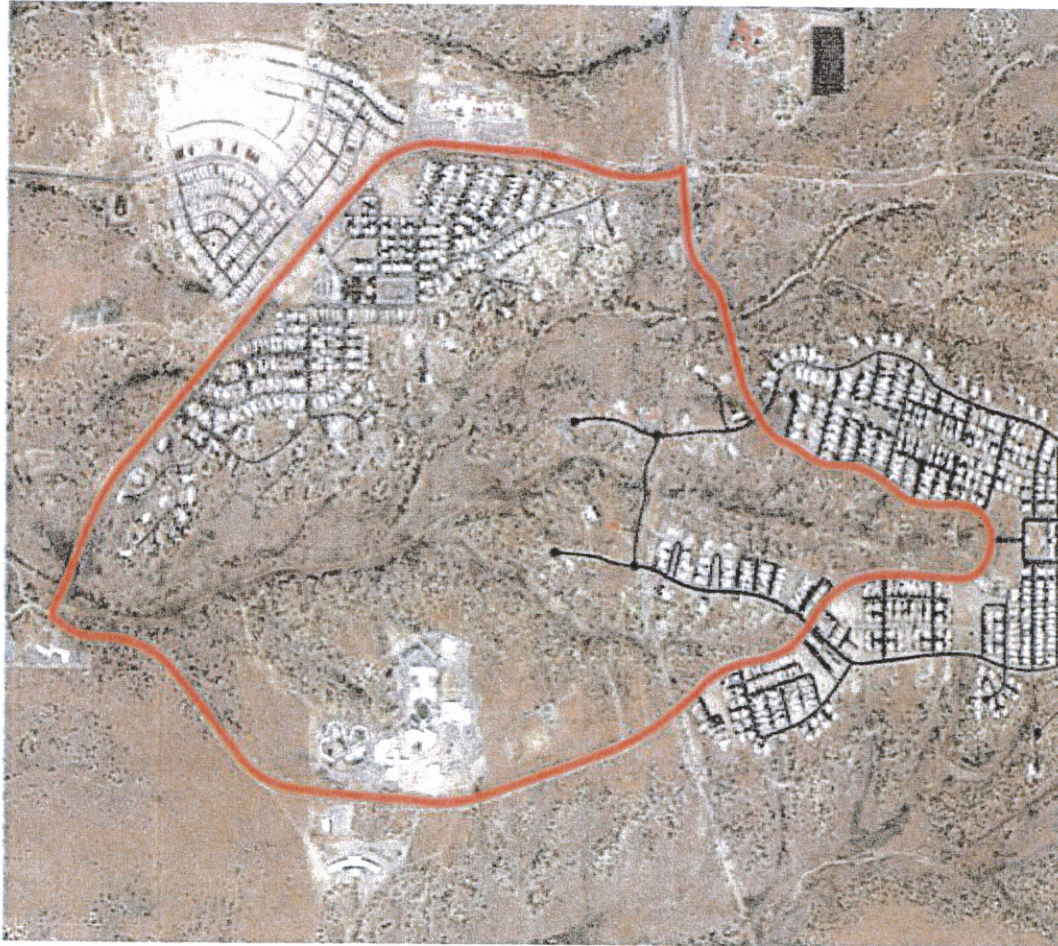
Site Plan

Richards Avenue from E Chilli Line to A Va Nue Po & Avenida Del Sur from Richards Avenue to A Va Nu Po
