SANTA FE COUNTY UTILITIES

STANDARD DETAILS

VALVE & VALVE BOX INSTALLATION

Agua Fria Area Mill & Pavement Overlay

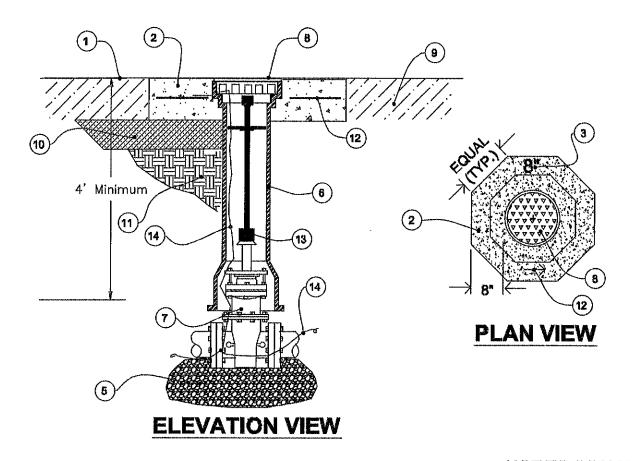
#	DESCRIPTION	#	DESCRIPTION
1	FINISH STREET GRADE	8	VALVE BOX LID
2	8" MIN DEPTH - 3000 PSI CONCRETE PAD	9	PAVEMENT
3	STAMPED LINE SIZE (2 SIZES IF REDUCING)	40	SUBGRADE
4	STAMPED ARROW INDICATING ISOLATION DIRECTION(?)	11	COMPACTED BACKFILL
5	98% COMPACTED BACK FILL 12" MINIMUM DEPTH	12	#4 REBAR
6	5-1/4 SCREWTYPE ADJUSTABLE VALVE BOX	43	EXTENSION BAR IF NECESSARY
7	GATE VALVE	14	#42 TRACING WIRE
